# IMPROVING MOTOR RELIABILITY IN NUCLEAR POWER PLANTS

VOLUME 3: FAILURE ANALYSIS AND DIAGNOSTIC TESTS  
ON A NATURALLY AGED LARGE ELECTRIC MOTOR

M. Subudhi and J.H. Taylor

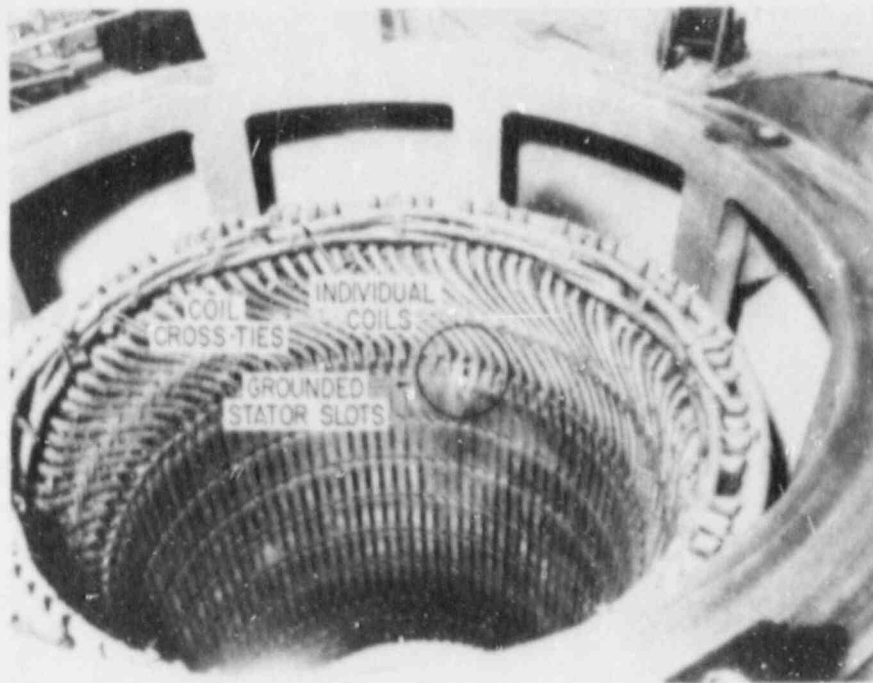
Prior to performing this study, it was not clear whether the motor failed first due to a turn to ground short, creating a current surge which failed the transformer cable, or the transformer cable failed first, resulting in an overload on the two phases in the motor winding which subsequently failed, or both motor and transformer failed simultaneously. However, the motor had been in service at this facility for over 20 years with minimal maintenance activities and without any appreciable problems. Figure 1.1 shows the failed motor stator winding and the burned out area.

Figure 1.1 - Failed HFBR 400 hp motor stator.

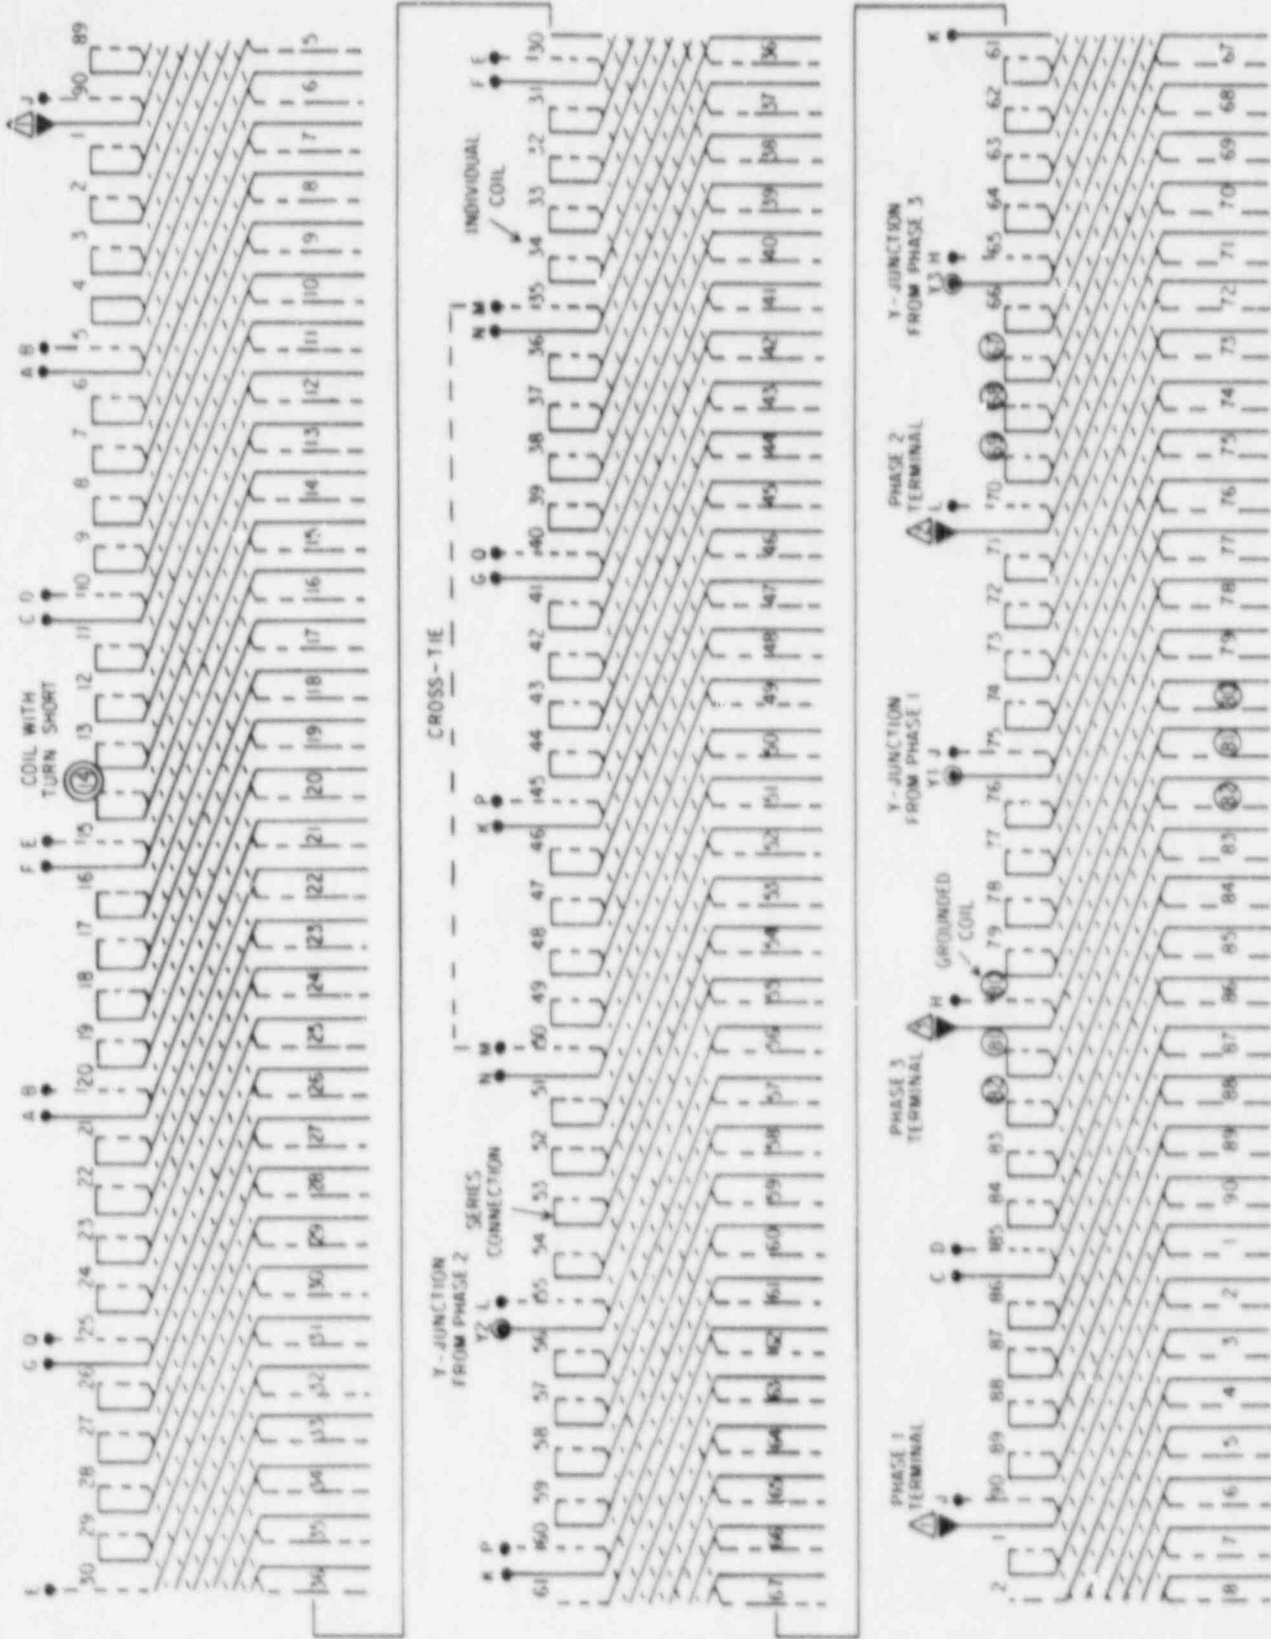
Figure 2.2 - Coil placement and failed coil locations.

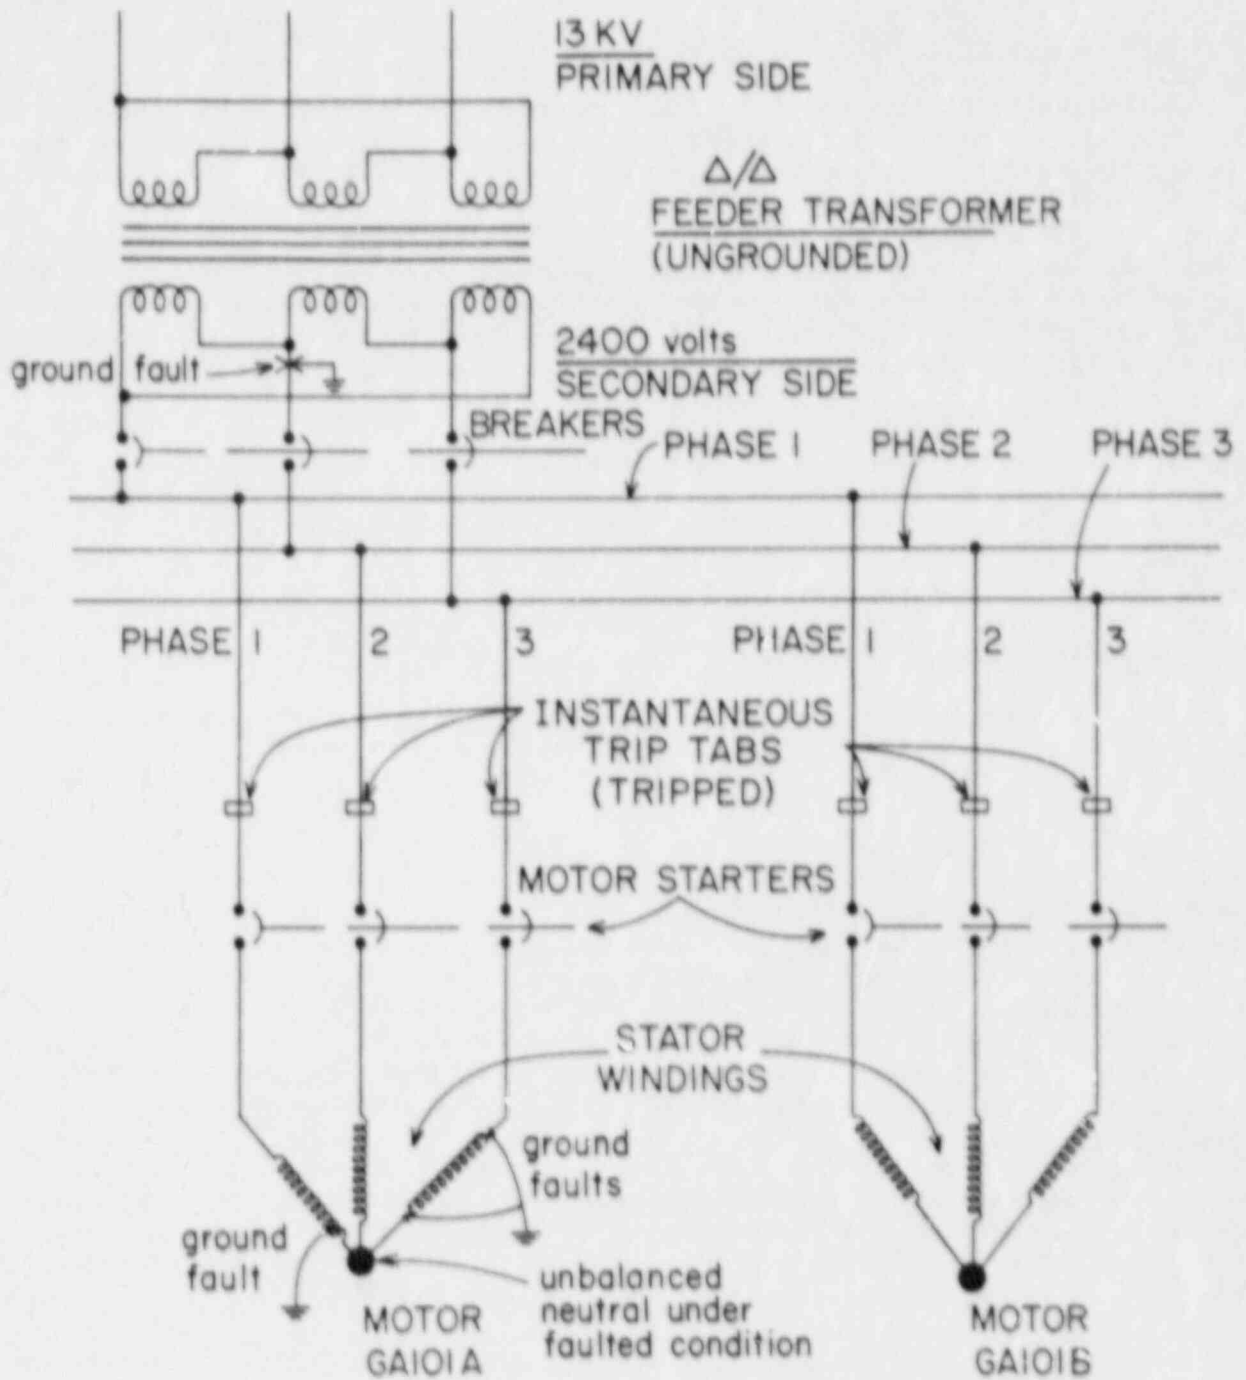
Figure 3.1 shows a schematic of the circuit between the feeder transformer and the two recirculating pump motors. The 2,400 v .t side of the  $\Delta/\Delta$  transformer and the two Y connected motors are ungrounded. Each phase from the transformer secondary consists of two cables in parallel to provide the required current carrying capacity. In such an arrangement, each phase line current is shared by the two cables. As indicated earlier, one of the two cables from the phase 2 of the transformer was found to have an open circuit and probably grounded as indicated in Figure 3.1. The post-failure tests also found that the Y-connected stator windings of motor GA101A had grounded coils in phases 1 and 3.

Figure 3.1 - Power supply to RCP motors from feeder transformer.

The above explanations lead to the conclusion that the oil saturated transformer cable grounded first and produced an arcing to ground which in turn failed the motor (mode 3). The following discussions justify this mode of system failure. Before the Phase 2 secondary transformer lead grounded, the voltage to ground on all phases was zero volts for the ungrounded system. Once one of the two cables from the Phase 2 transformer secondary grounded the voltage to ground on that phase remained at zero. This caused the corresponding phase terminal on the motor winding to be at zero potential to ground, whereas the voltage to ground at the motor terminals for phases 1 and 3 was raised to 2400 volts. The increase in potential resulted in overstressing the aged insulation in these two phases which caused them to fail. Usually the insulation between each line to ground is adequate to withstand full line-to-line voltage (i.e., 2,400 volts). However, if this voltage is applied to age-degraded insulation, it can result in failure. Insulation tests performed on the stator windings revealed weak and degraded conditions existed in a number of coils.

Based on the analysis presented, it is believed that the ground fault in the transformer cable was the initiating event leading to motor failure. The cable ground fault caused an over-voltage condition in the motor windings which resulted in failure of the age-degraded winding insulation. Since the same transformer supplies a second identical motor, it could also have experienced an over-voltage condition. The second motor is the same age as the failed motor and the high voltage could have further degraded the winding insulation. It is therefore recommended that replacement of the second motor (GA-1018) be considered in the near future.

To avoid future occurrences of this type of failure, it is additionally recommended that the motor-transformer system design be modified to include a ground. If a system ground cannot be provided, ground fault detectors should be installed.

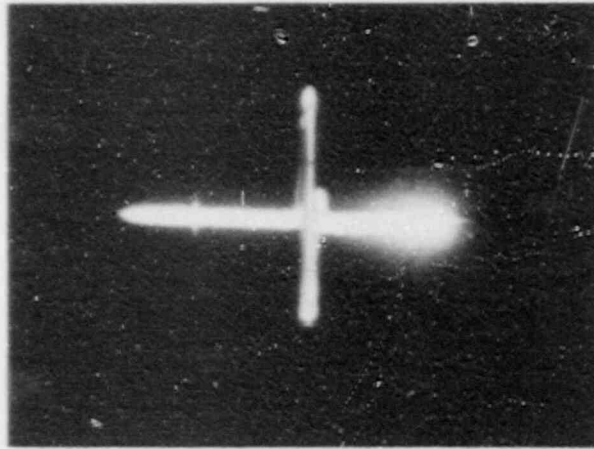
Figure 4.2 illustrates the superposition of standing voltage wave traces on the oscilloscope for four different coils tested. Coils 1 and 46 were first determined to be good coils. These coils were then used as a baseline to compare against other coils for evaluating their condition. Figure 4.2(a) indicates a perfect match between coils 1 and 46. A perfect match indicates that both coils are good since it is extremely unlikely that two coils would degrade to exactly the same degree, which is what would be required to produce the same wave pattern. Therefore, it is concluded that the insulation on

(a) COILS 1 & 46: PERFECT MATCH

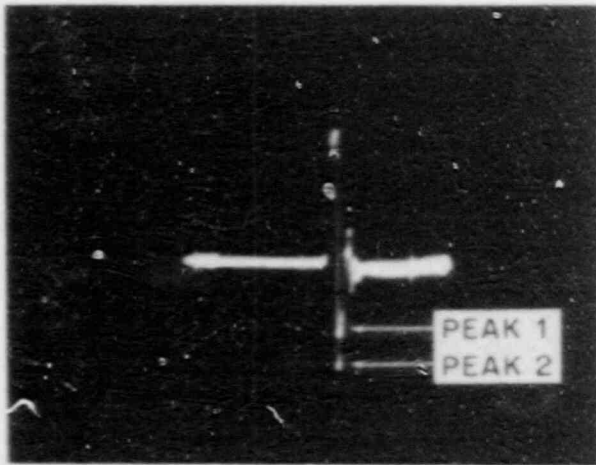
All coils in the motor were surge tested at 2,500 volts after the series connections were cut. This particular test indicated the obviously grounded coils and a turn short in coil 14.

(b) COILS 14 & 1 : SIGNAL MISMATCH (SHORT)

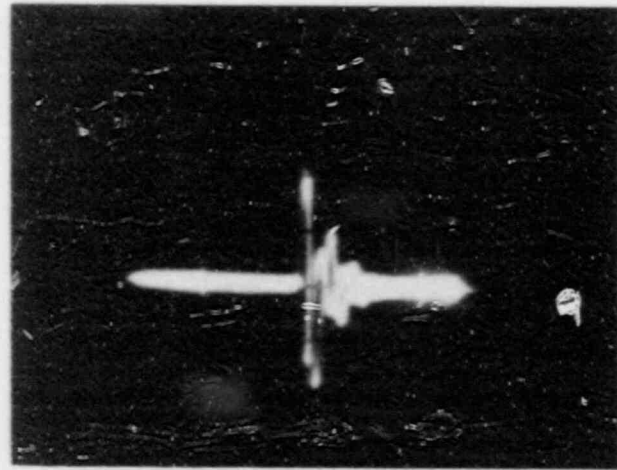
(c) COILS 1 & 67: SIGNAL MISMATCH (GROUND)

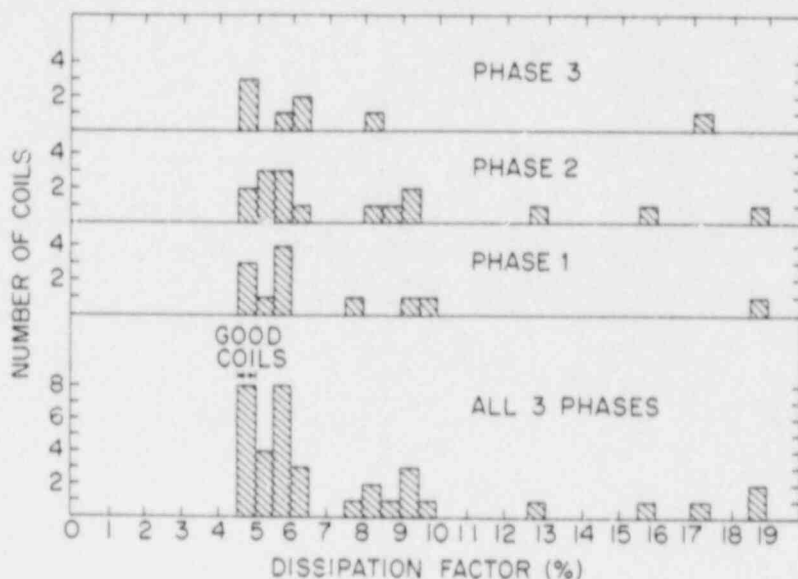
Figure 4.3 shows the distribution of the 36 coils tested at 2000 volts. Eight (8) coils were found to be good coils with dissipation factors less than 5%. Another fifteen (15) coils were found to have a dissipation factor of less than 7% and were considered to be in acceptable condition. The remaining thirteen (13) coils exhibited aging in their insulating materials. These coils (70-79, 84, 87, and 88) are presumed to have developed cracks and voids in their insulation resulting in the higher dissipation factors.

Figure 4.3 - Dissipation factor at 2000 volts.

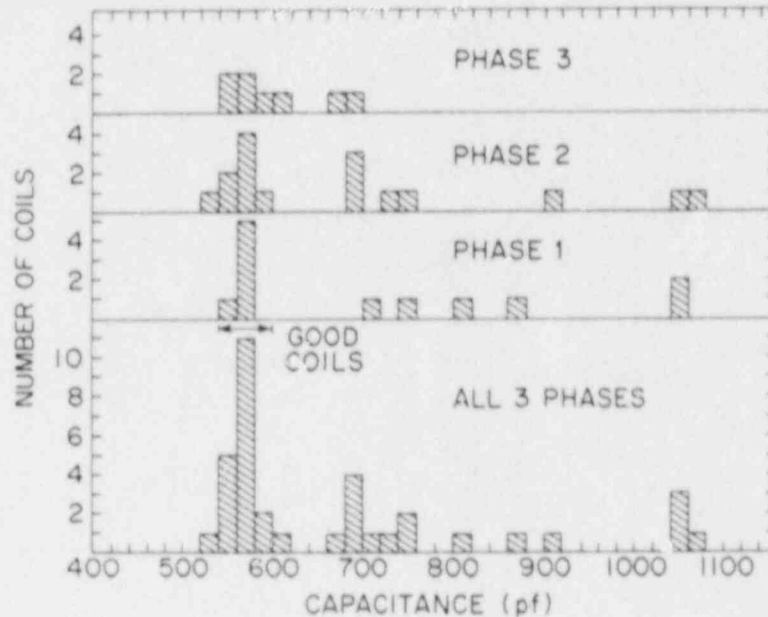
The distribution of capacitance values among the 36 tested coils is shown in Figure 4.4. As shown, twenty (20) of the coils indicated normal values while the remaining sixteen (16) coils exhibited higher capacitance in their insulating materials. From the above discussion, it can be concluded that

these 16 coils have probably experienced thinning in their insulation materials due to their age and environmental conditions. Of the 16 coils with high capacitance, coils 46, 47, 70-79, 84, 87, 88, and 89 are definitely showing signs of insulation thinning.

Figure 4.4 - Capacitance at 2000 volts.

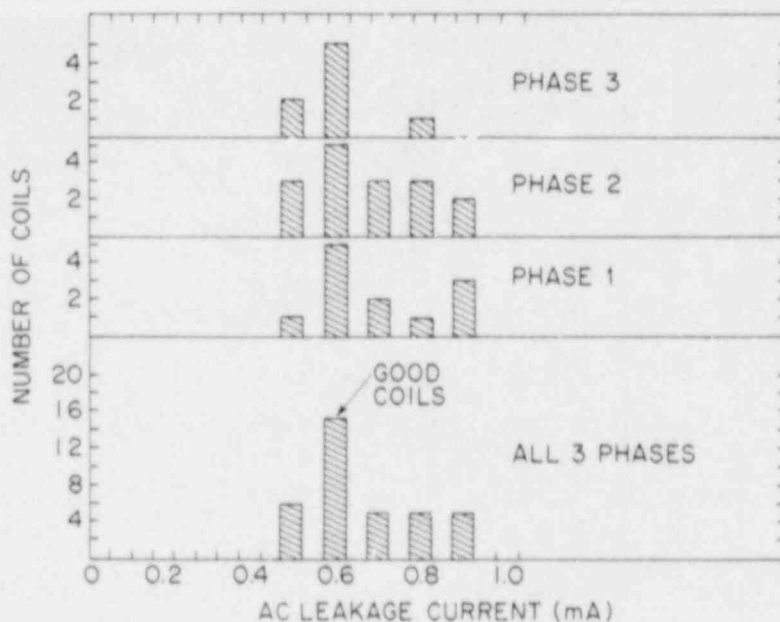
Figure 4.5 shows the distribution of leakage current for the 36 coils tested. As shown, fifteen (15) of the coils indicated a higher leakage current at an impressed voltage of 2,000 volts than the baseline data presented in Table 4.3 (0.6 mA @ 2000 v). Comparing the data from Table 4.1 with Table 4.2, it is seen that all of these coils have also indicated higher dissipation factors and/or capacitance values. This is consistent with expected results since increased dissipation factor or capacitance would indicate the insulation is in a degraded condition. The degraded insulation should show an increased leakage current. The ac leakage current test, therefore, verified the findings of the dissipation factor and capacitance tests.

Figure 4.5 - Ac leakage current at 2000 volts.

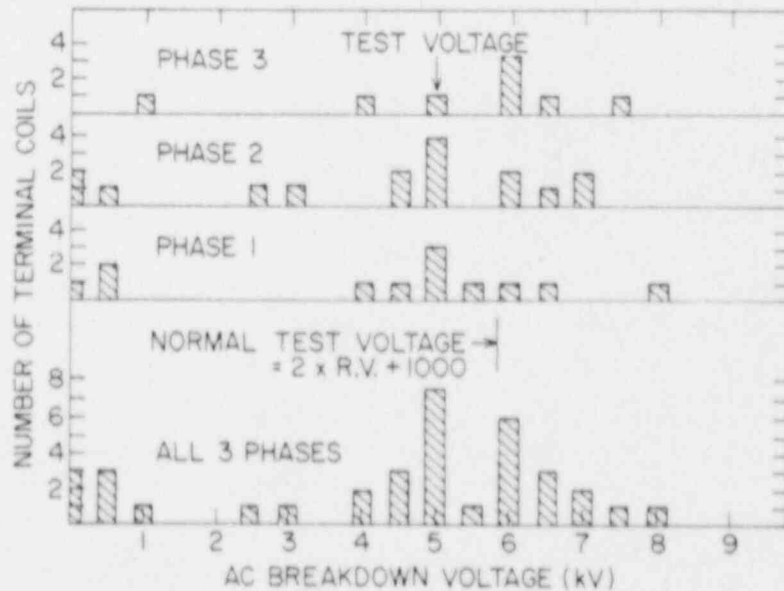
The remaining coils (71-79, 87-88) in Table 4.4 showed a significant increase above baseline for all three test parameters. This indicates coils have experienced degradation by thinning as well as by an increase in cracks and voids.

Figure 4.6 - Ac high potential test.

From the above results it is concluded that both the ac dissipation factor and capacitance tests are useful to determine and trend insulation degradation. It is recommended that one of these tests be considered for inclusion in a maintenance program. The ac leakage current test is also useful in determining insulation integrity, although it does not provide information as to the mechanism for degradation. It should be noted that coils with increased leakage current will develop larger  $I^2R$  heating effects which could accelerate the aging process and contribute to early failure. Leakage current could, therefore, be an important parameter to monitor.
