QUALITY ASSURANCE PROGRAM
MANAGEMENT CORRECTIVE ACTION REPORT
MCAR-1

REPORT NO.: 47

SUBJECT: MCAR 47 (Issued 1/29/81)
Auxiliary Building Seismic Analysis

PROJECT: Consumers Power Company
Midland Plant Units 1 and 2
Bechtel Job 7220

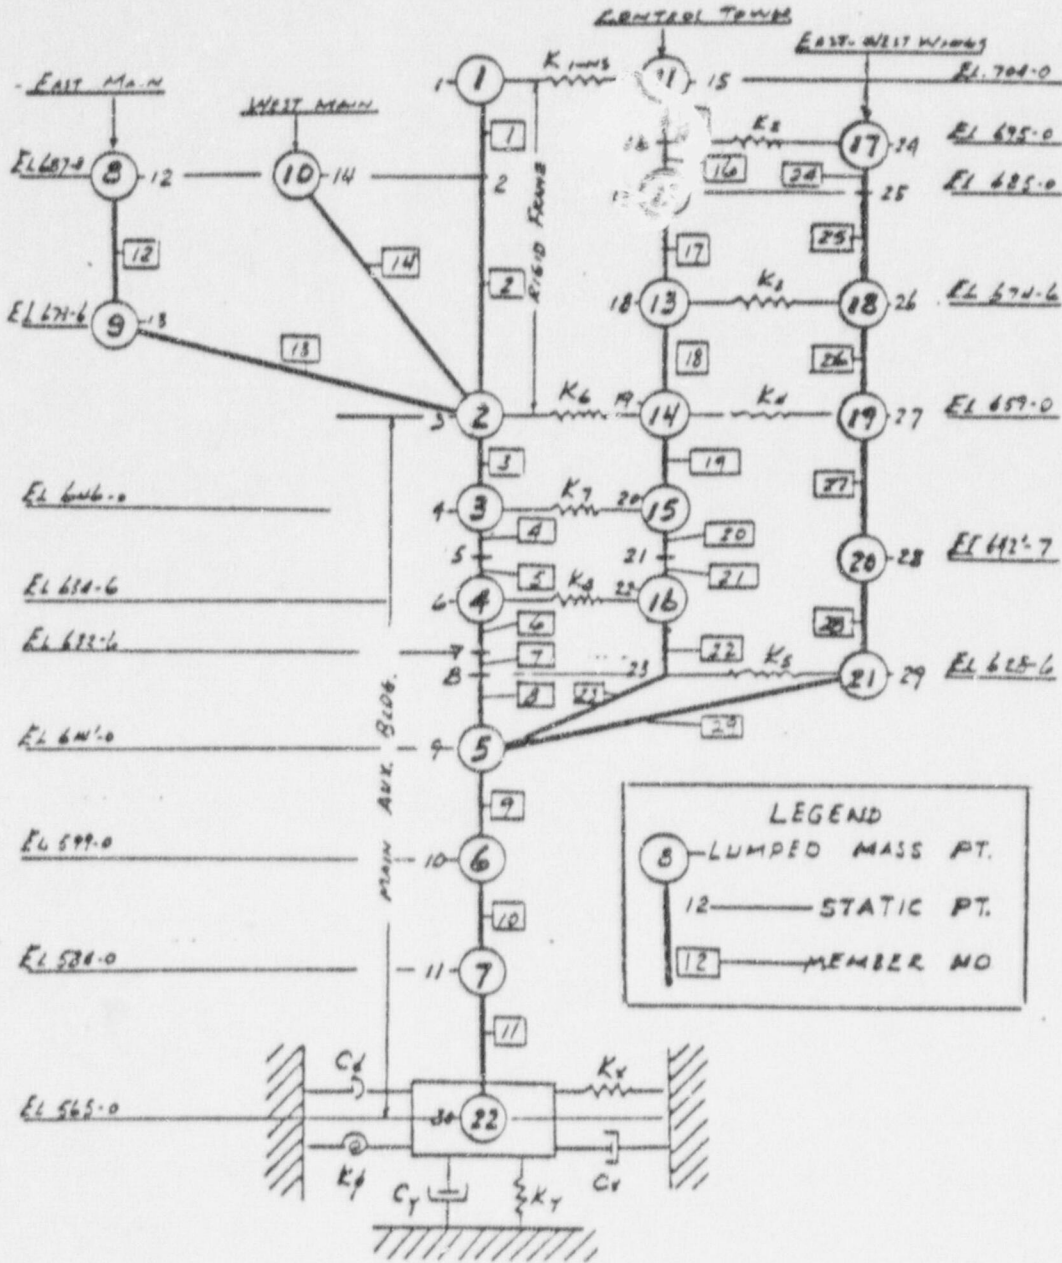
FIGURE 47-1
 REVISED LUMPED MASS MODEL OF
 THE AUXILIARY BUILDING FOR THE
 NORTH-SOUTH EARTHQUAKE
 MIDLAND PLANT UNITS 1&2
 CONSUMERS POWER COMPANY

An investigation into the north-south 1977 seismic model (FSAR Figure 3.7-10) has been initiated to determine the possible changes in the building forces and the floor response spectra curves due to modeling the structural connections between the control tower and the main auxiliary building (el 614' to 659') and separating the structural properties for each portion (Figure 47-1). The east-west and vertical dynamic models are not affected.

The investigation with this model as shown in Figure 47-1 considers:

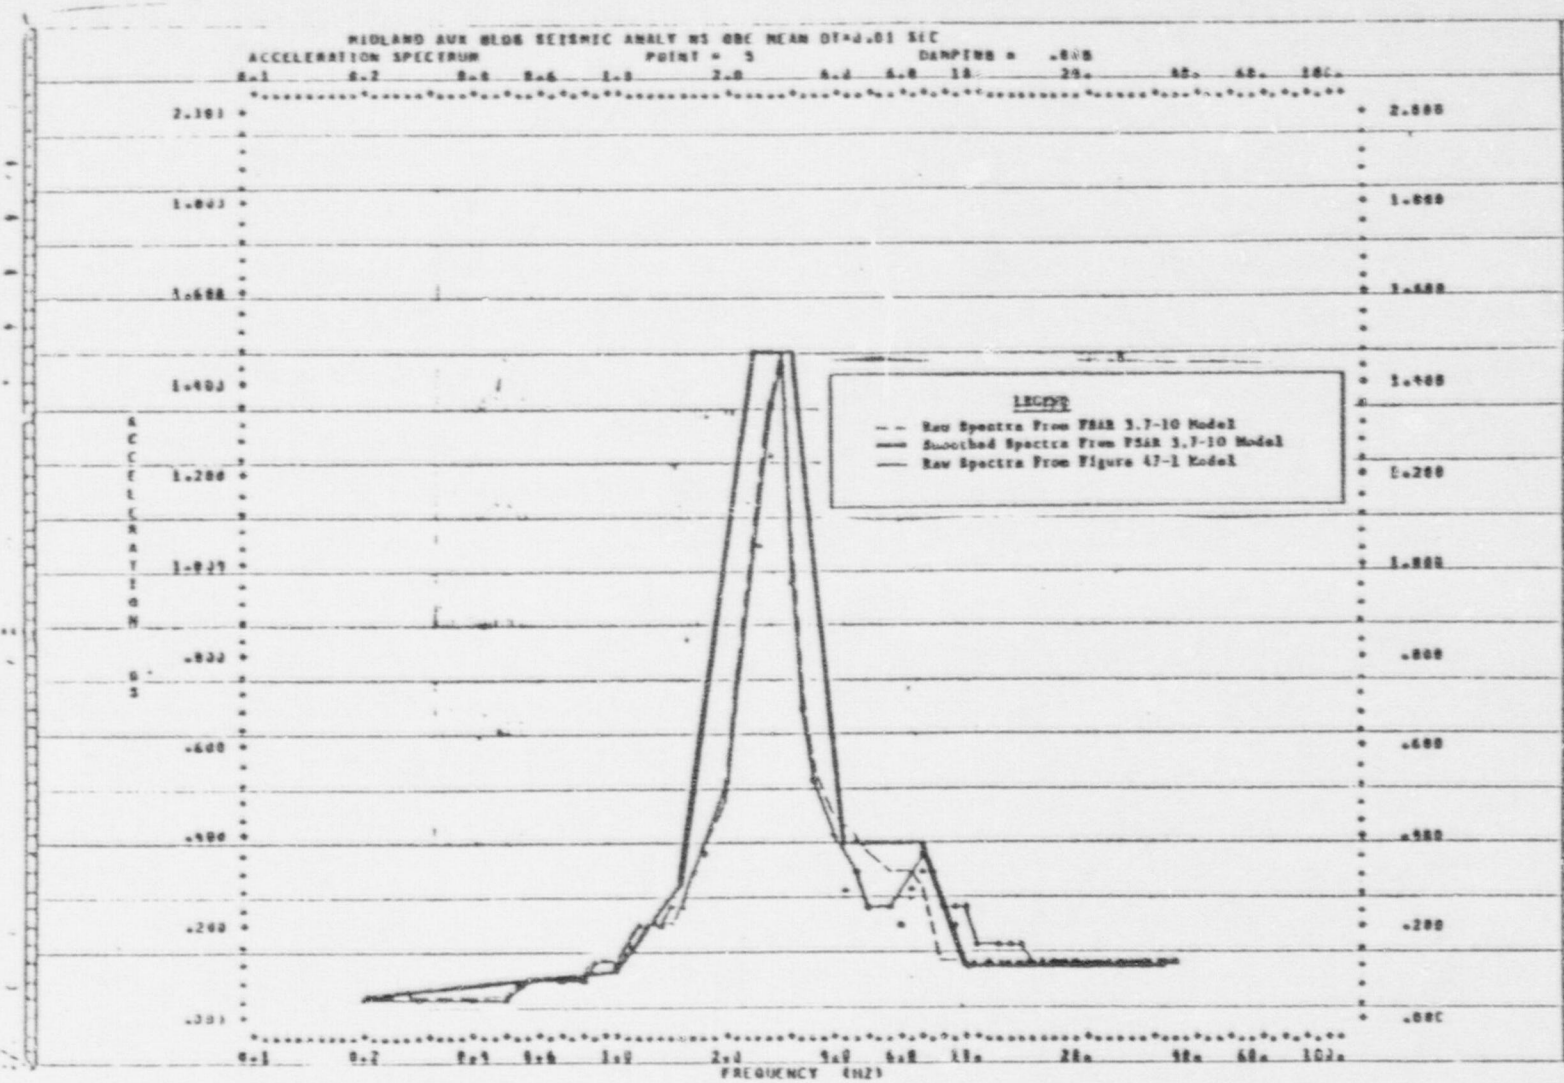
FIGURE 47-2

- 4) A comparison of the in-structure response spectra curves has been made and indicates that the majority of the floor spectra curves have little or no change as shown by Figures 47-2 and 47-3. The greatest changes were confined to the structural steel superstructure, control tower, and electrical penetration areas above el 659' as shown by Figures 47-4, 47-5, and 47-6. The potential safety impact of these changes is being evaluated for selected piping systems and equipment located in these areas. These piping systems and equipment were selected based upon the potential for greatest change.
