SUBJECT: REVIEW OF PRELIMINARY ACCIDENT SEQUENCE PRECURSOR ANALYSIS OF  
OPERATIONAL EVENT AT LASALLE COUNTY STATION, UNITS 1 AND 2

**LER No. 373/96-007, -008**

Event Description: Concrete sealant fouls cooling water systems

TITLE (4): Foreign Material Injected Into Service Water Tunnel Causes Dual Unit Shutdown Due to Inadequate Work Control

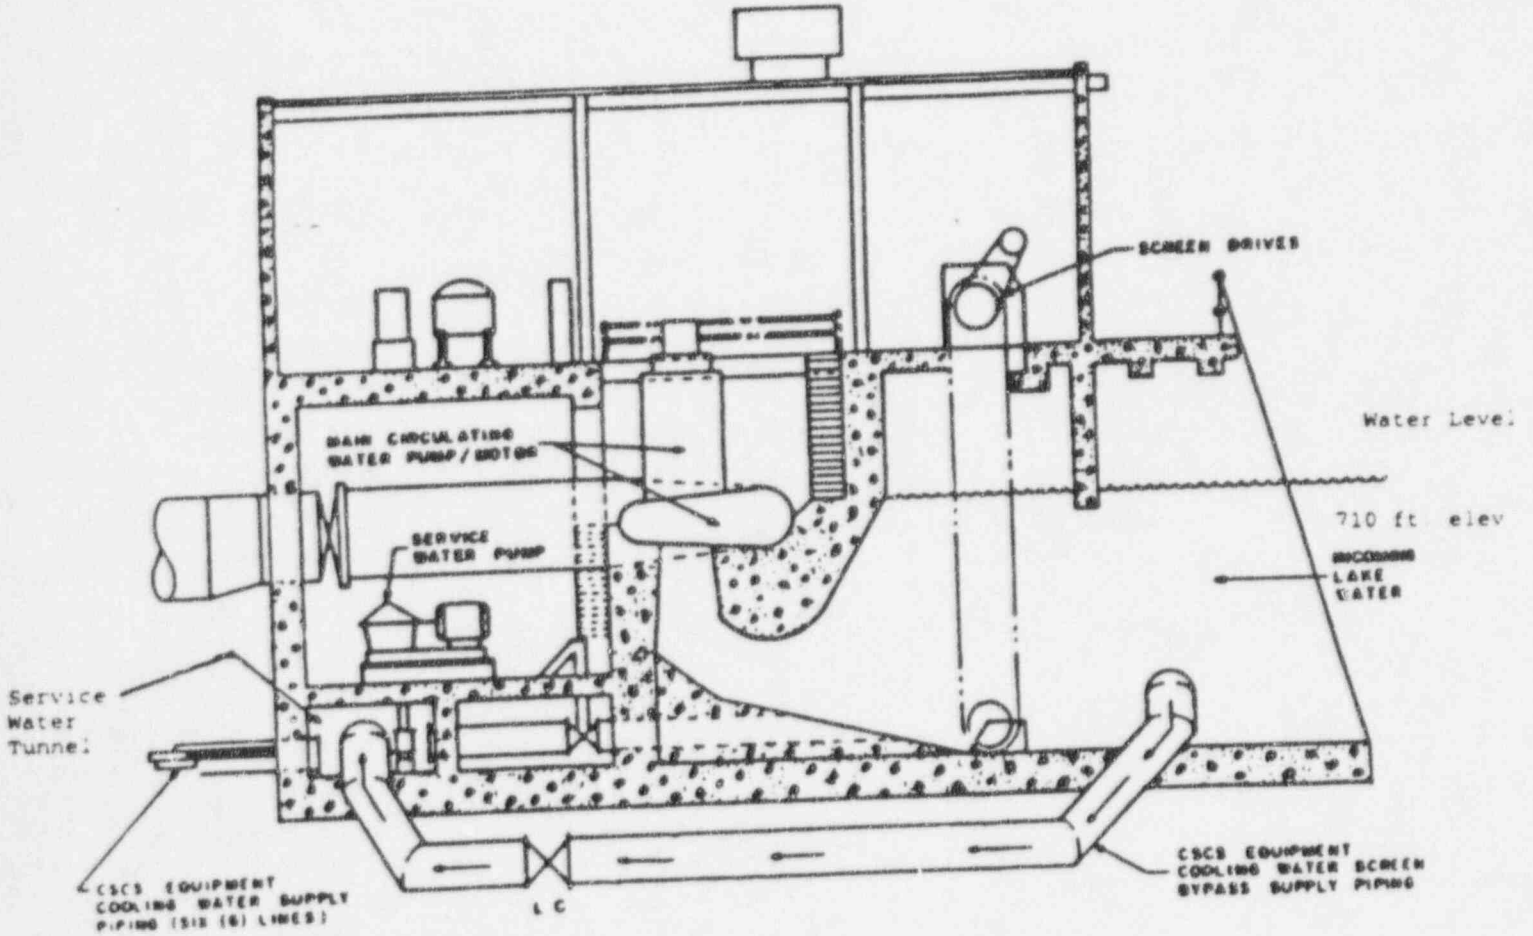
Lake Screen House Cross-section View

While doing floor repairs, the workers started fixing cracks on the top or ceiling of a service water tunnel which runs the length of the building approximately 20 feet below lake level (see sketch). This tunnel supplies cooling water to both the non-essential and essential (safety-related) cooling water pumps at the plant. As they repaired these cracks, the large amount of water at pressure indicated to the workers that a large void was present. The workers believed that they were working on a concrete floor laid over soil. They proceeded to drill five holes through the ceiling of the service water tunnel and inject sealant. Instead of being injected into a void under the building floor, the material was injected into the tunnel accumulating on the ceiling and floor or dispersing into the cooling water.

Based upon the observation of sealant material in the trash basket which collects the strainer backwash water and through discussions with the workers performing crack repair in the Lake Screen House, it was now concluded that sealant material was the probable cause of the problems with the strainers and fire pumps, not the corn cob material. When the strainers were again backwashed, it became clear from the material collected in the flush water that sealant material was the predominant foreign material. Chemical analysis of samples collected from several locations including the OB Diesel Fire Pump confirmed this. These samples did not reveal any "corn cob" material.

1. Floor and wall repair work in the Lake Screen House was stopped.
2. The service water tunnel was cleaned and inspected.
3. Essential Service Water Systems and balance of plant equipment that could have been impacted by the intrusion of sealant were inspected, cleaned and tested to ensure that the systems and equipment would function as designed.

4. The structural integrity of the Seismic-Class I service water tunnel was evaluated to ensure that repair activities had not degraded the structure.
5. An Engineering Policy was published which outlined repair and controls associated with building structural repairs and use of sealants as a temporary or permanent repair requiring engineering review and approval.
