SUBJECT: SUMMARY OF MEETING WITH WESTINGHOUSE TO DISCUSS FUEL
PERFORMANCE ISSUES

WESTINGHOUSE / NRC MEETING

FUEL PERFORMANCE ISSUE

Westinghouse Fuel Performance Seabrook Cycle 5

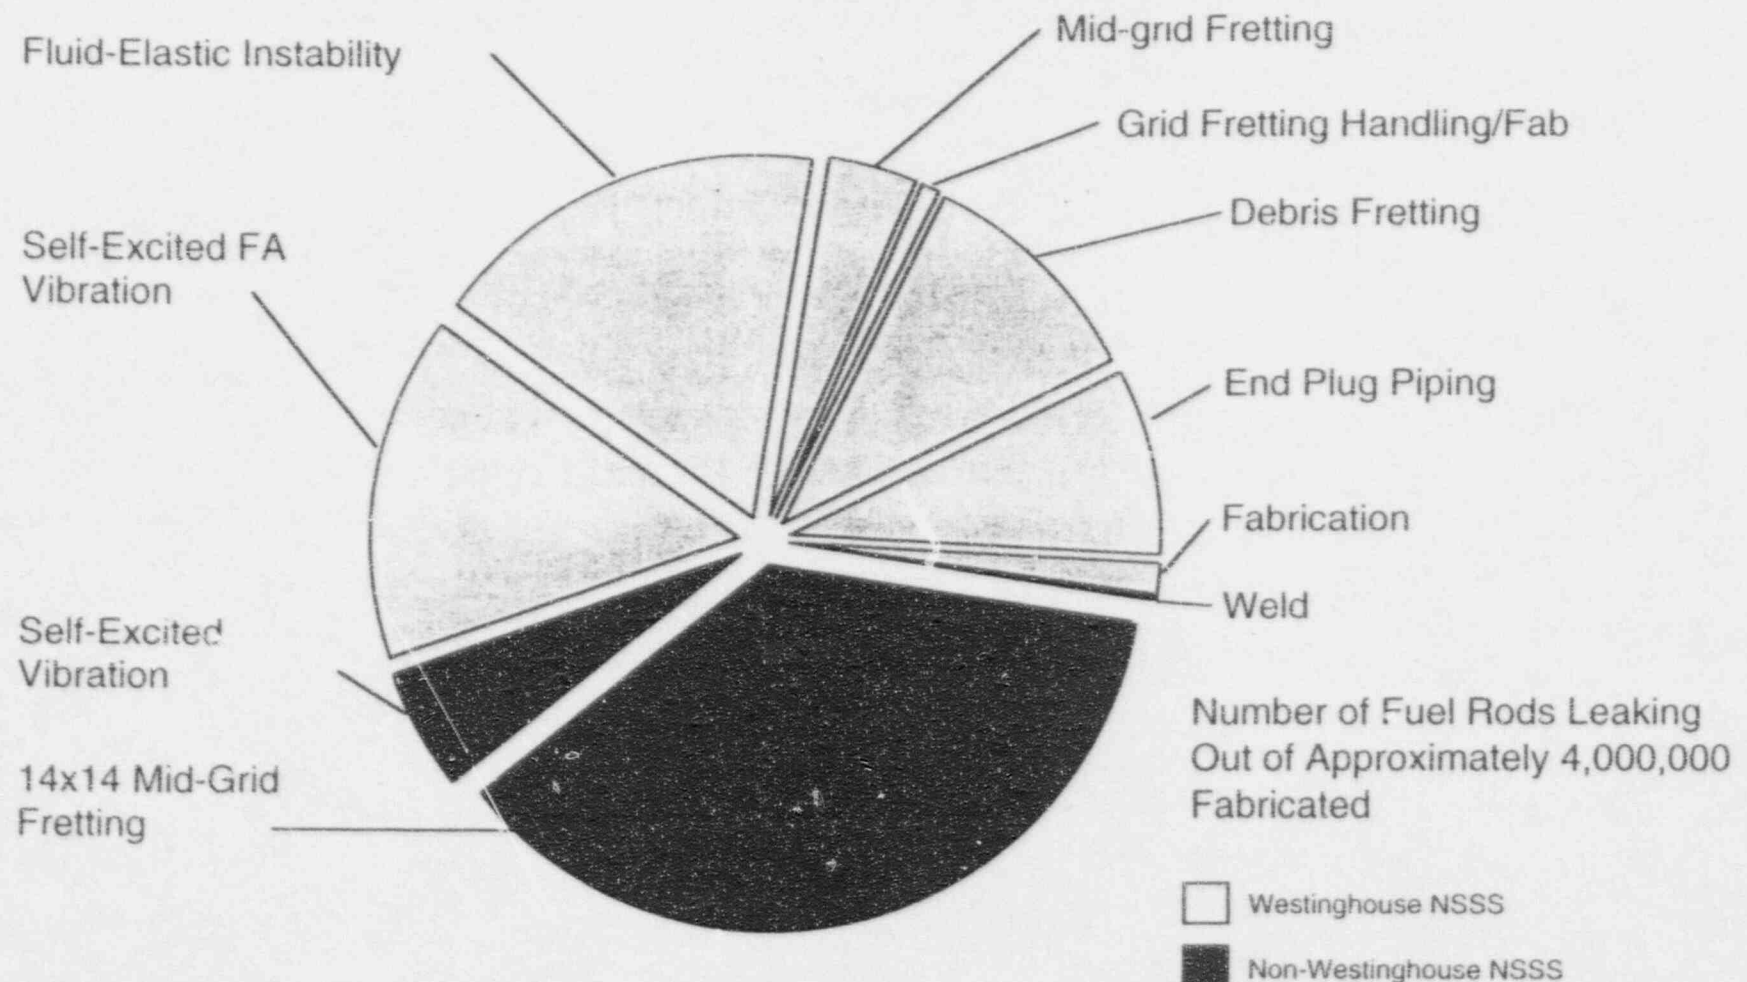
Leakage Mechanisms

- Focus on fuel fabricated in 1988 and later
- Greater than 4,000,000 fuel rods fabricated over this period
- A total of (<) fuel rods identified as leaking (Ⓜ)NSSS)
 - 15% debris fretting related
 - 55% grid-rod fretting related
 - 23% self-excited fuel assembly vibration
 - 12% end plug piping
 - 2% “Hydride Only”/weld related

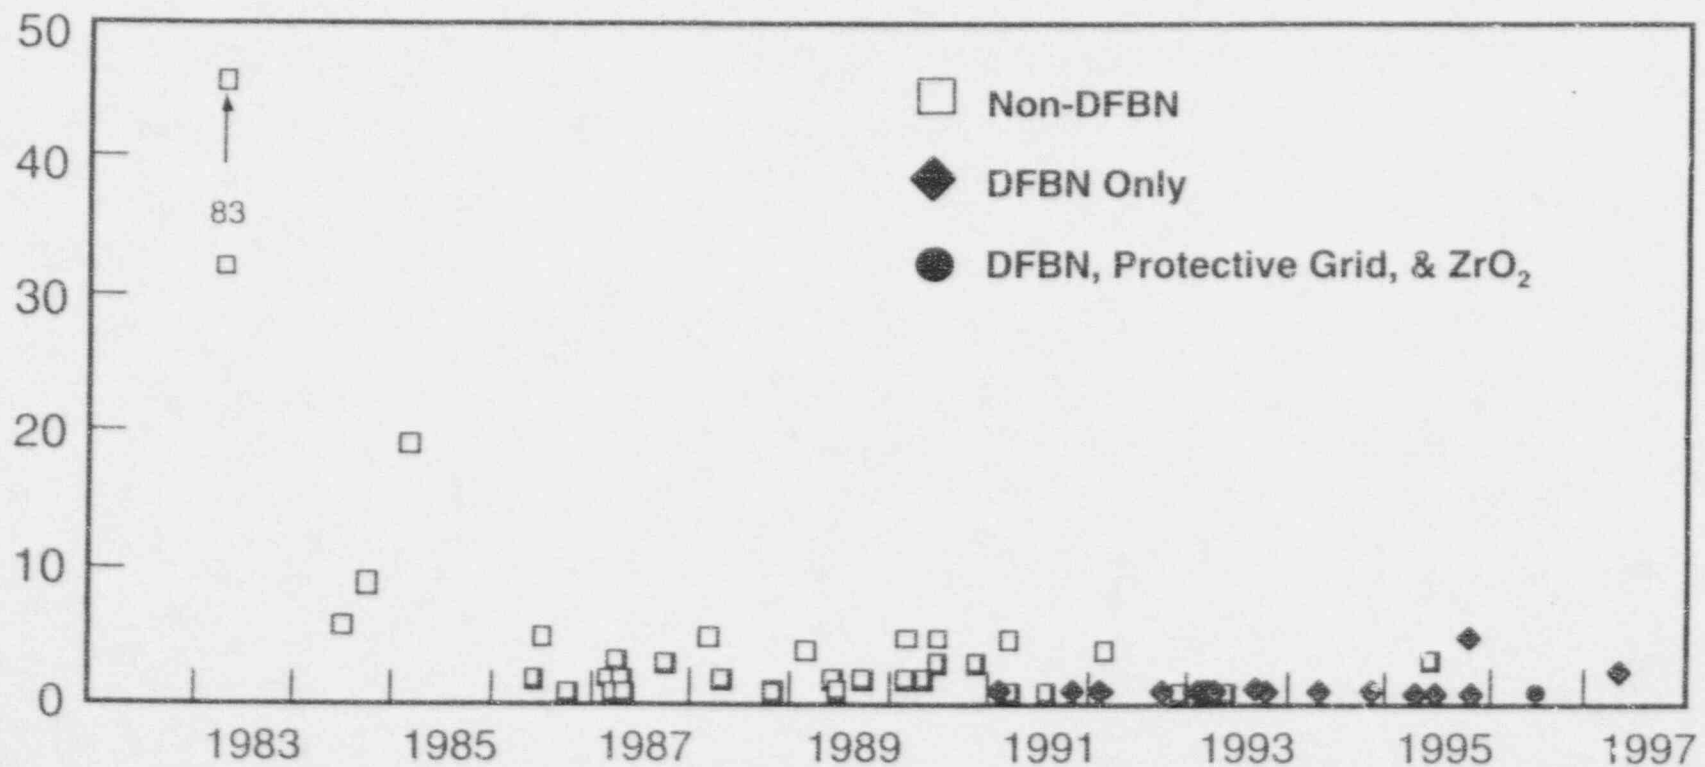
Debris-Induced Fretting Defects in Westinghouse-Fueled PWRs (1982-1997)

Mitigating features + FME practices have addressed mechanism

- Actions: DFBN, protective bottom grid, ZrO_2 coating
- Status: DFBN – Introduced 1988;
Protective Grid – Introduced 1993;
 ZrO_2 Coating – Introduced 1993;
Features plus FME practices have been beneficial

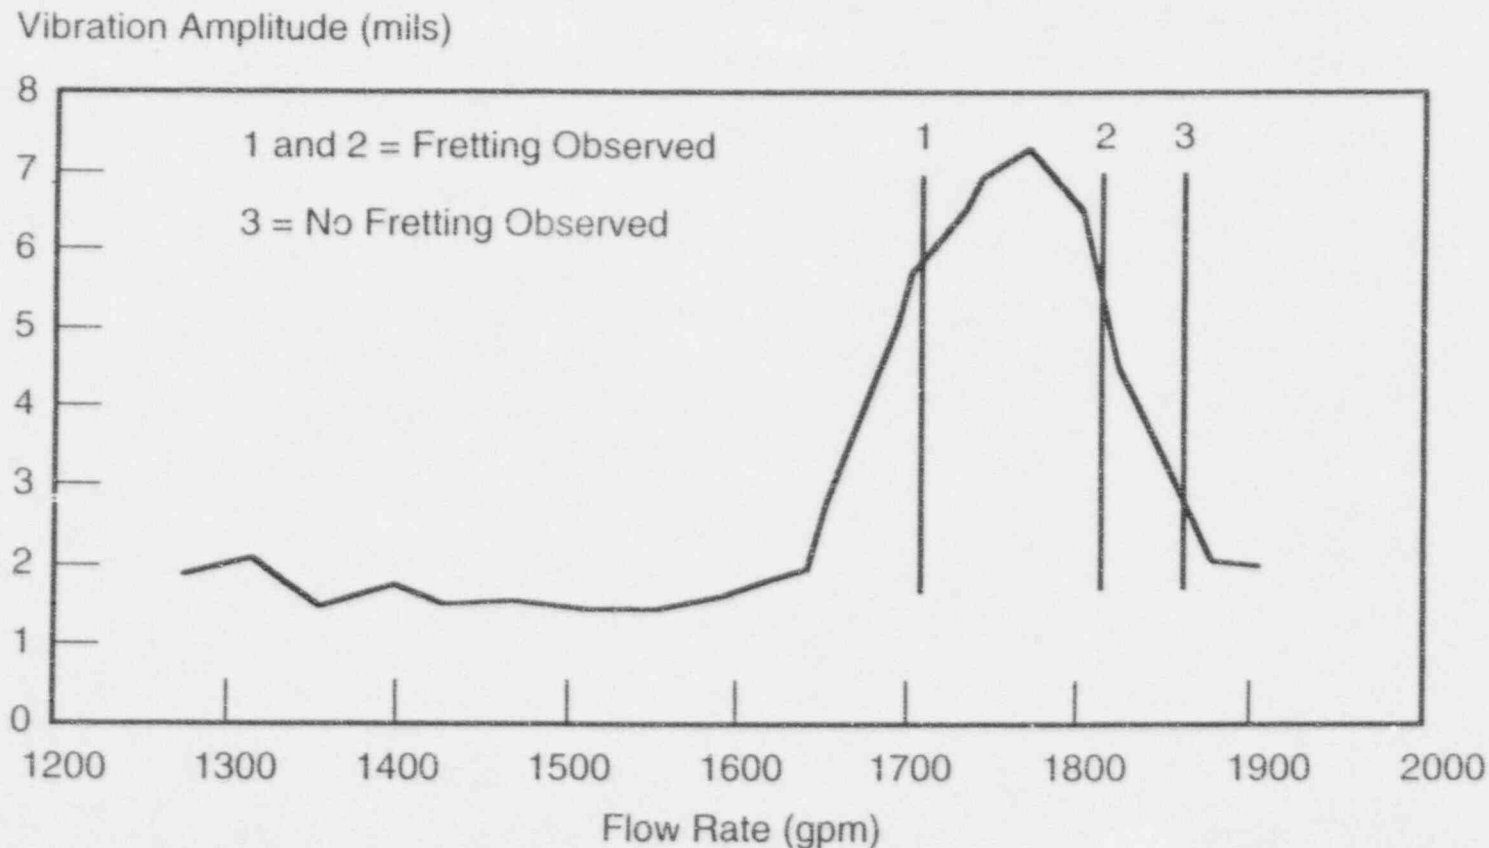
17x17 Vantage 5H Fuel Assembly Vibration Without Corrective Action

- Mechanism active in narrow flow range
- Plants outside flow range have not observed mechanism

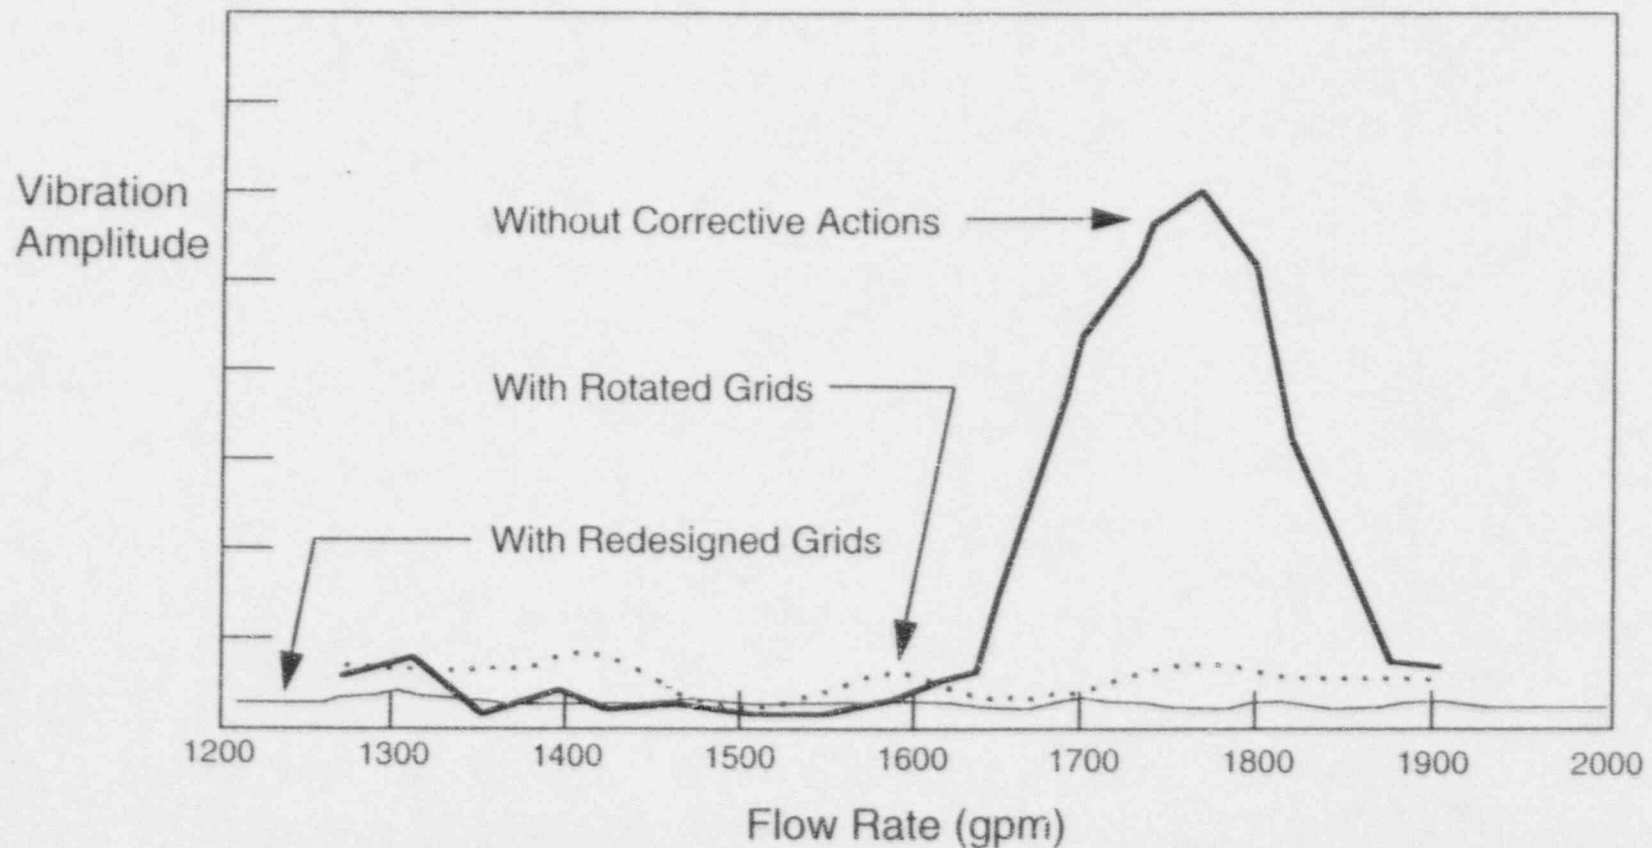
17x17 VANTAGE 5H Fuel Assembly Vibration With and Without Corrective Actions

- Corrective actions eliminate vibration
- All other (w) designs do not show mechanism in flow test

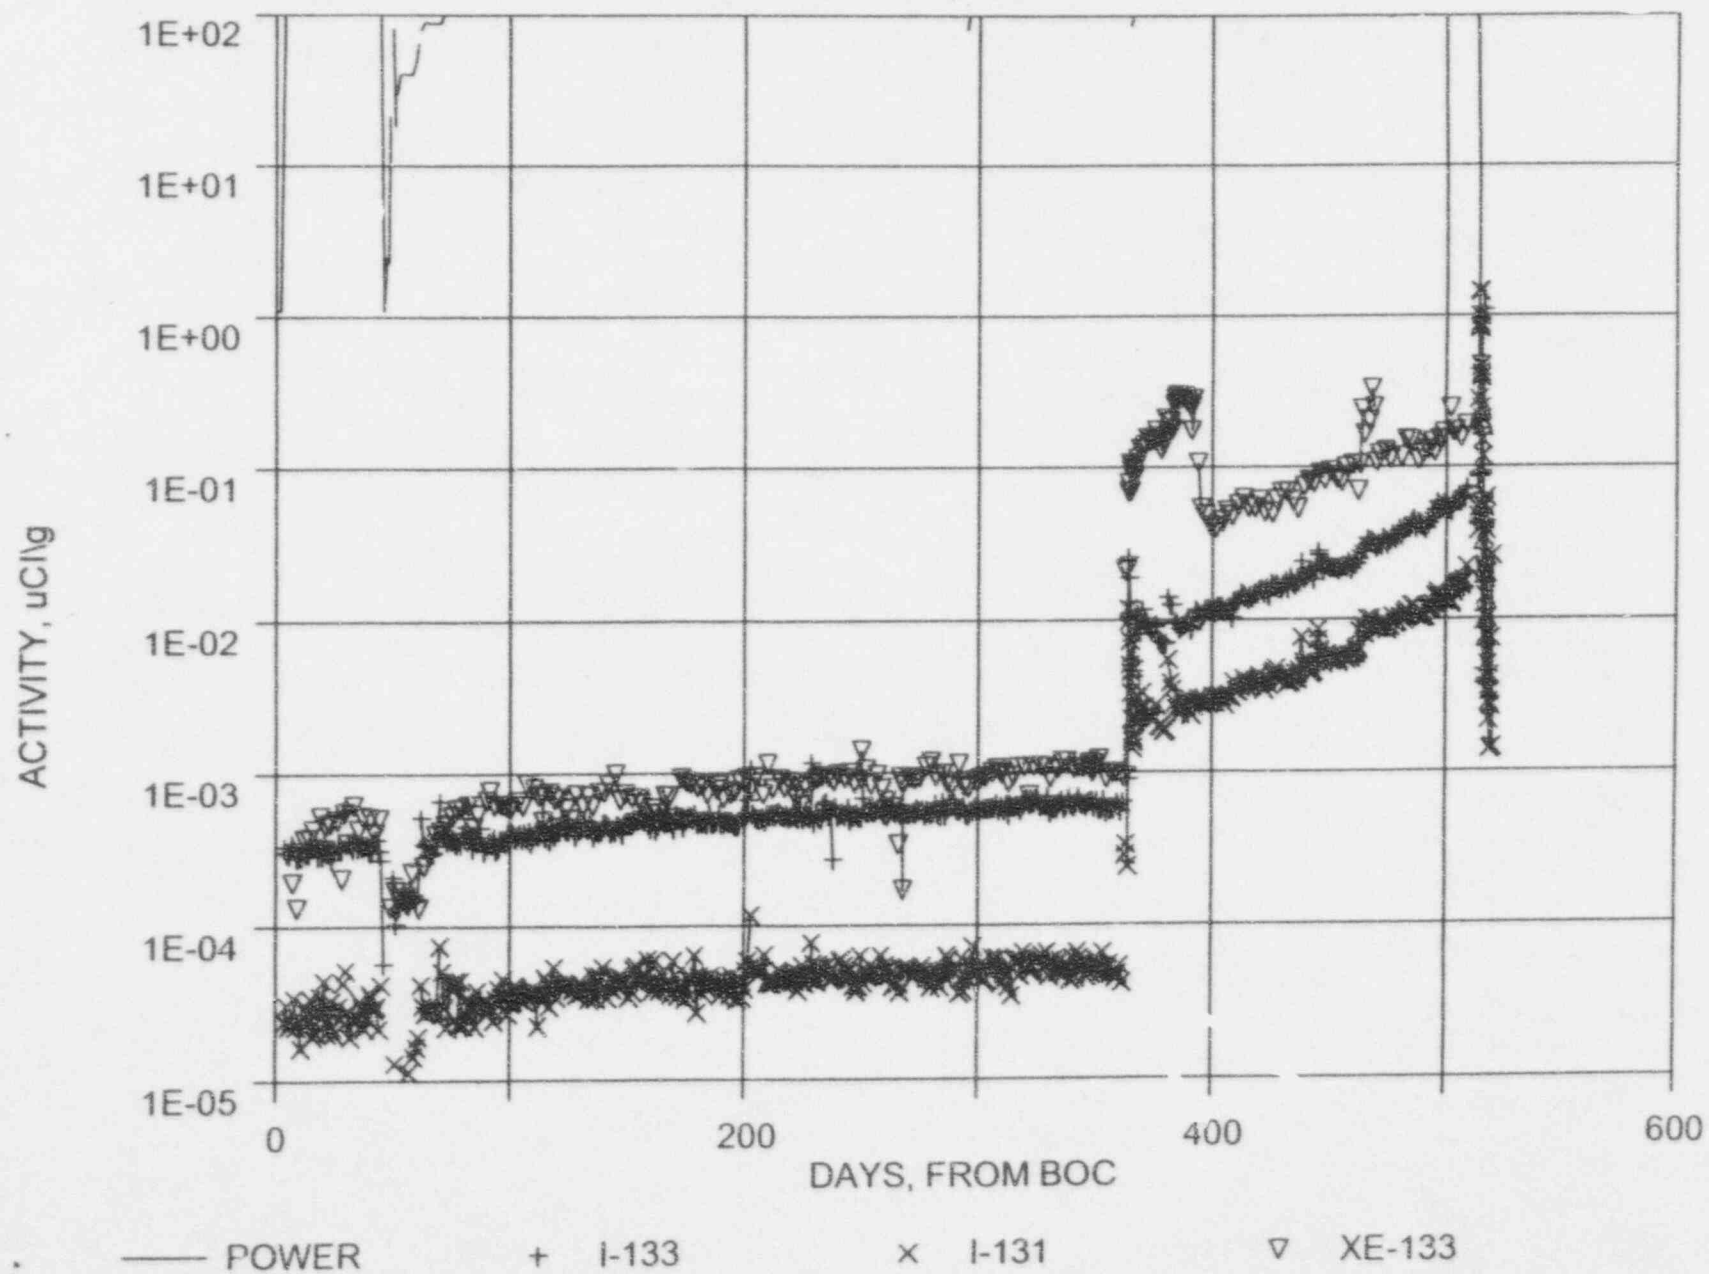
Coolant Activity in Cycle 5

- No evidence of significant coolant activity until 362 days into the cycle
- Sudden step change indicating open defects
- Xe peaks early during the event show at least two distinct failure events
- Continuous increase indicates fuel degradation worsening

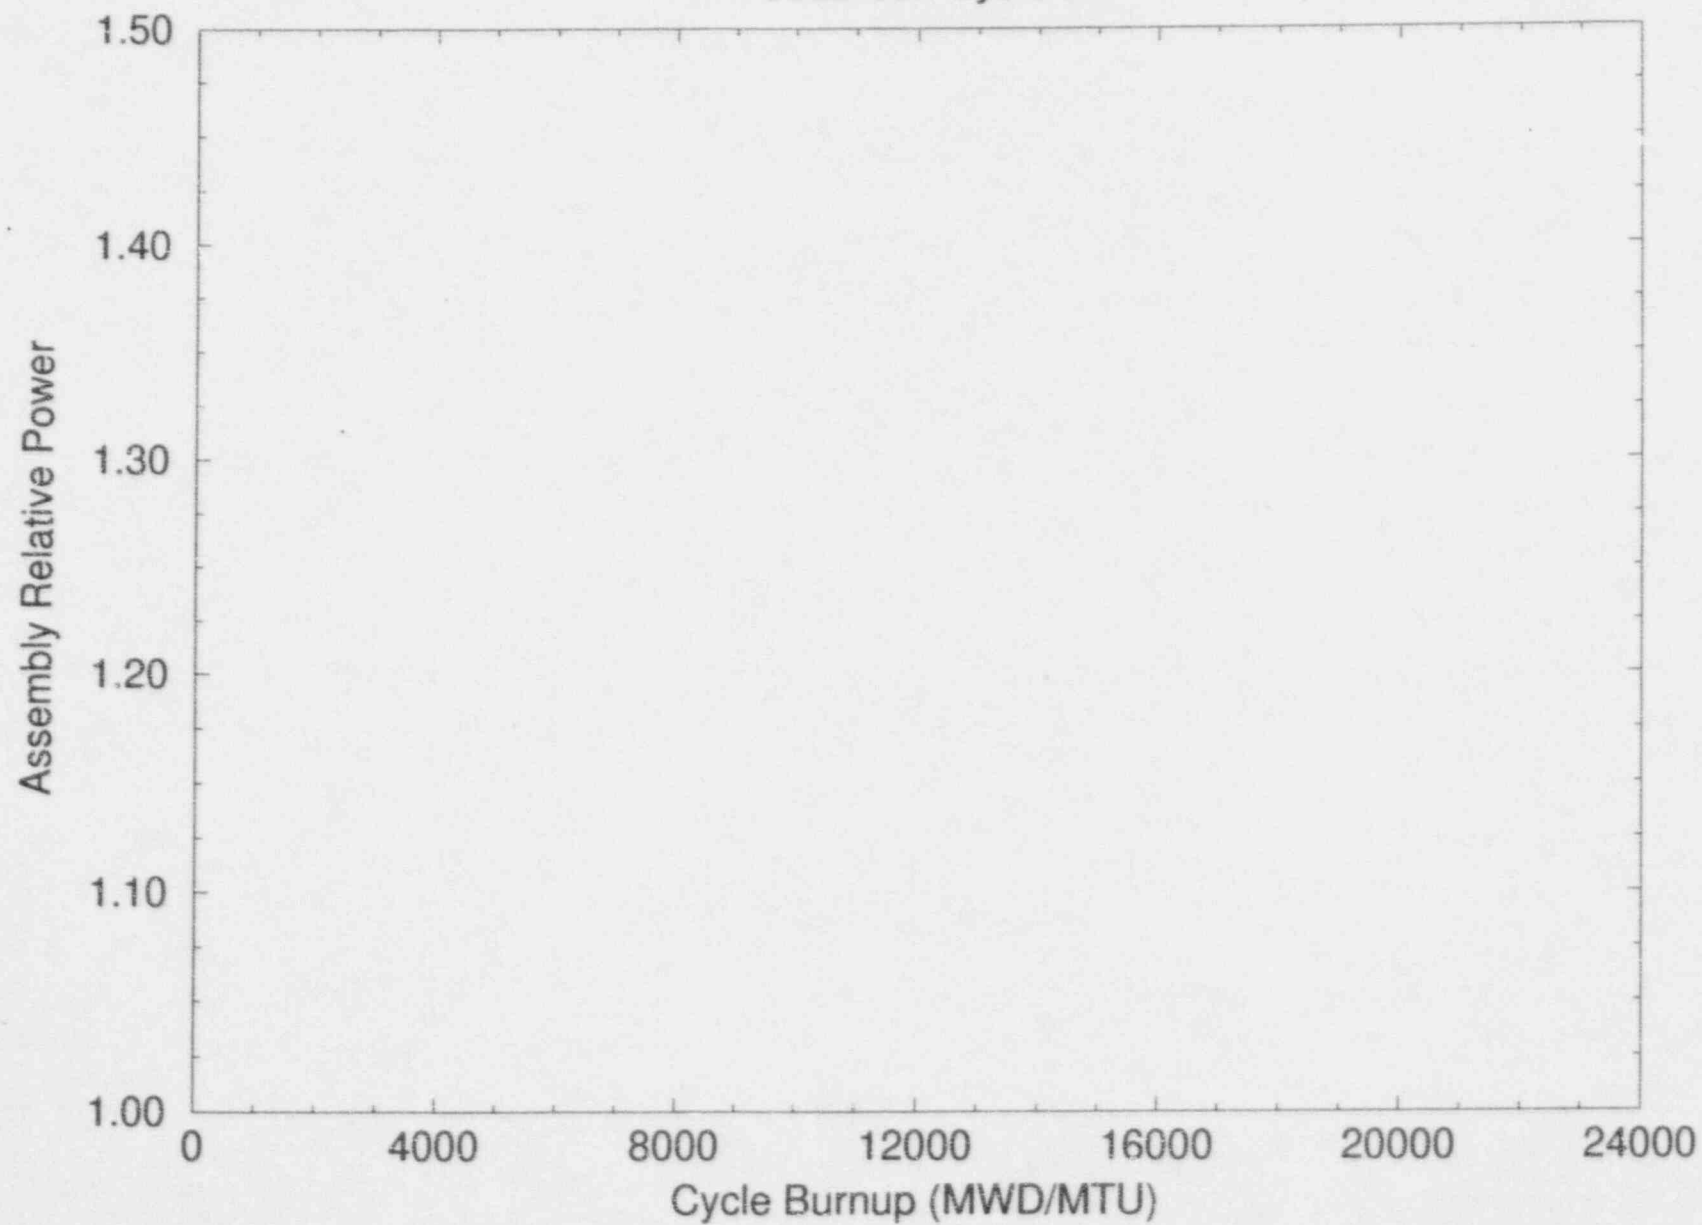
Predicted Assembly Power
Seabrook Cycle 5

- Failures do not appear attributable to mechanical damage such as grid-rod fretting or debris fretting
- Manufacturing records do not show commonality of note
- Failed rods were high power rods in lead assemblies containing IFBA, adjacent to thimble tubes
