BRUNSWICK STEAM ELECTRIC PLANT, UNIT NO. 1
DOCKET NO. 50-325/LICENSE NO. DPR-71
ASME BOILER AND PRESSURE VESSEL CODE, SECTION XI
IN-SERVICE INSPECTION PROGRAM RELIEF REQUEST
SERVICE WATER PIPING NON-CODE REPAIR

BRUNSWICK STEAM ELECTRIC PLANT, UNIT NO. 1
DOCKET NO. 50-325
OPERATING LICENSE NO. DPR-71
ASME BOILER AND PRESSURE VESSEL CODE, SECTION XI
IN-SERVICE INSPECTION PROGRAM RELIEF REQUEST
SERVICE WATER PIPING NON-CODE REPAIR

THROUGH-WALL FLAW EVALUATION
FOR SERVICE WATER SYSTEM LINE 1-SW-133-6-157

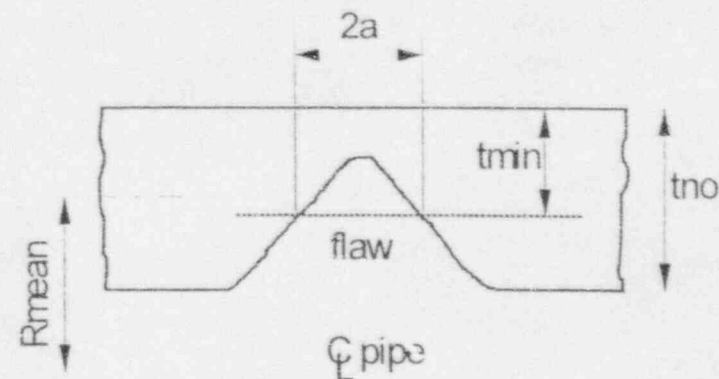
Since the through wall flaw is too small to detect with the instrumentation available, it will be conservatively assumed to be .5" (2a).

The wear rate is estimated to be 0.02" per year based on the NDE reading taken in 93. The min wall reading of 0.077" to through wall occurred in 4 years.

The predicted flaw area at the time of the spring '98 outage B112R1 will not be greater than the above assumed 0.5". Therefore this flaw is acceptable till B112R1.

t _{min}	Since	17	<=	35	ksi (in) ^{.5}	OK
t _{min}	Since	2a	<=	3in & 15% of pipe circumference - OK		
0.3t _{nom}	Since	5	<=	35	ksi (in) ^{.5}	OK
0.3t _{nom}	Since	2a	<=	3in & 15% of pipe circumference - OK
