NUREG/CR-0309
ORNL/NUREG-38

**Test of 6-in.-thick Pressure Vessels.
Series 3: Intermediate Test
Vessel V-7B**

OAK RIDGE NATIONAL LABORATORY
OPERATED BY UNION CARBIDE CORPORATION - FOR THE DEPARTMENT OF ENERGY

Manuscript Completed – October 6, 1978

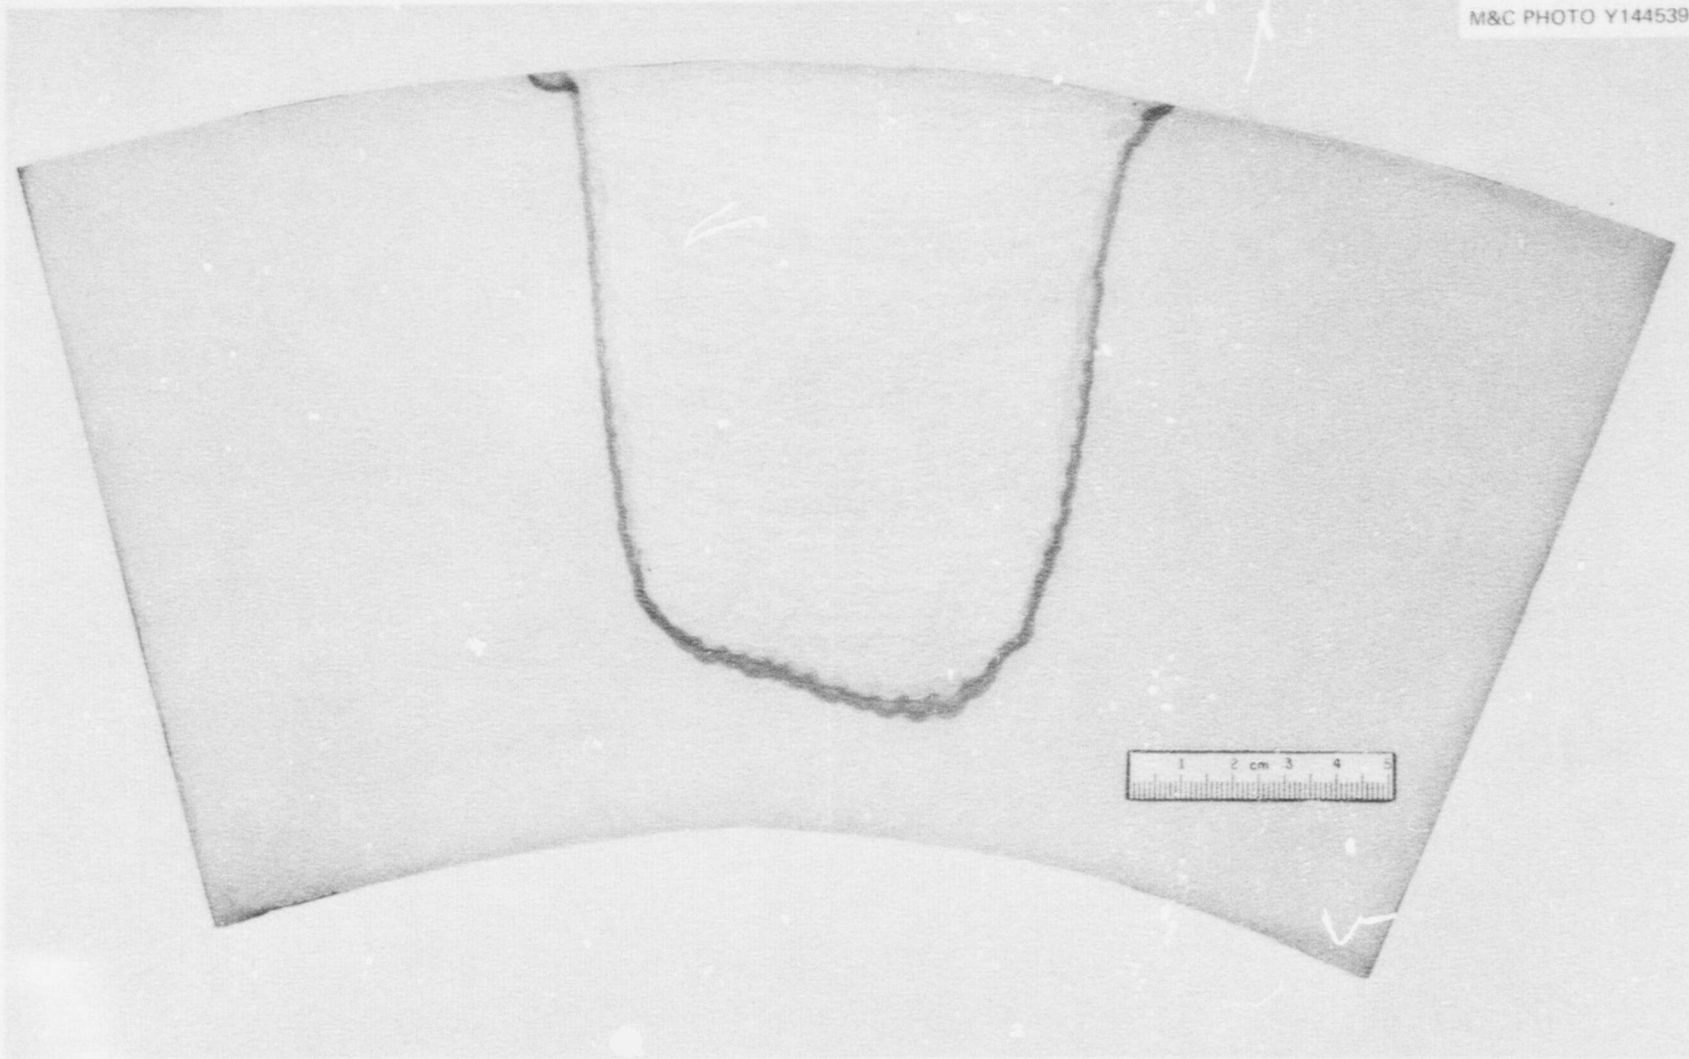
Fig. 2.9. Cross section of the prototypical half-bead weld repair for vessel V-7B. The sides of the cavity in this piece are more irregular than in the vessel because the V-7B cavity was not machined.

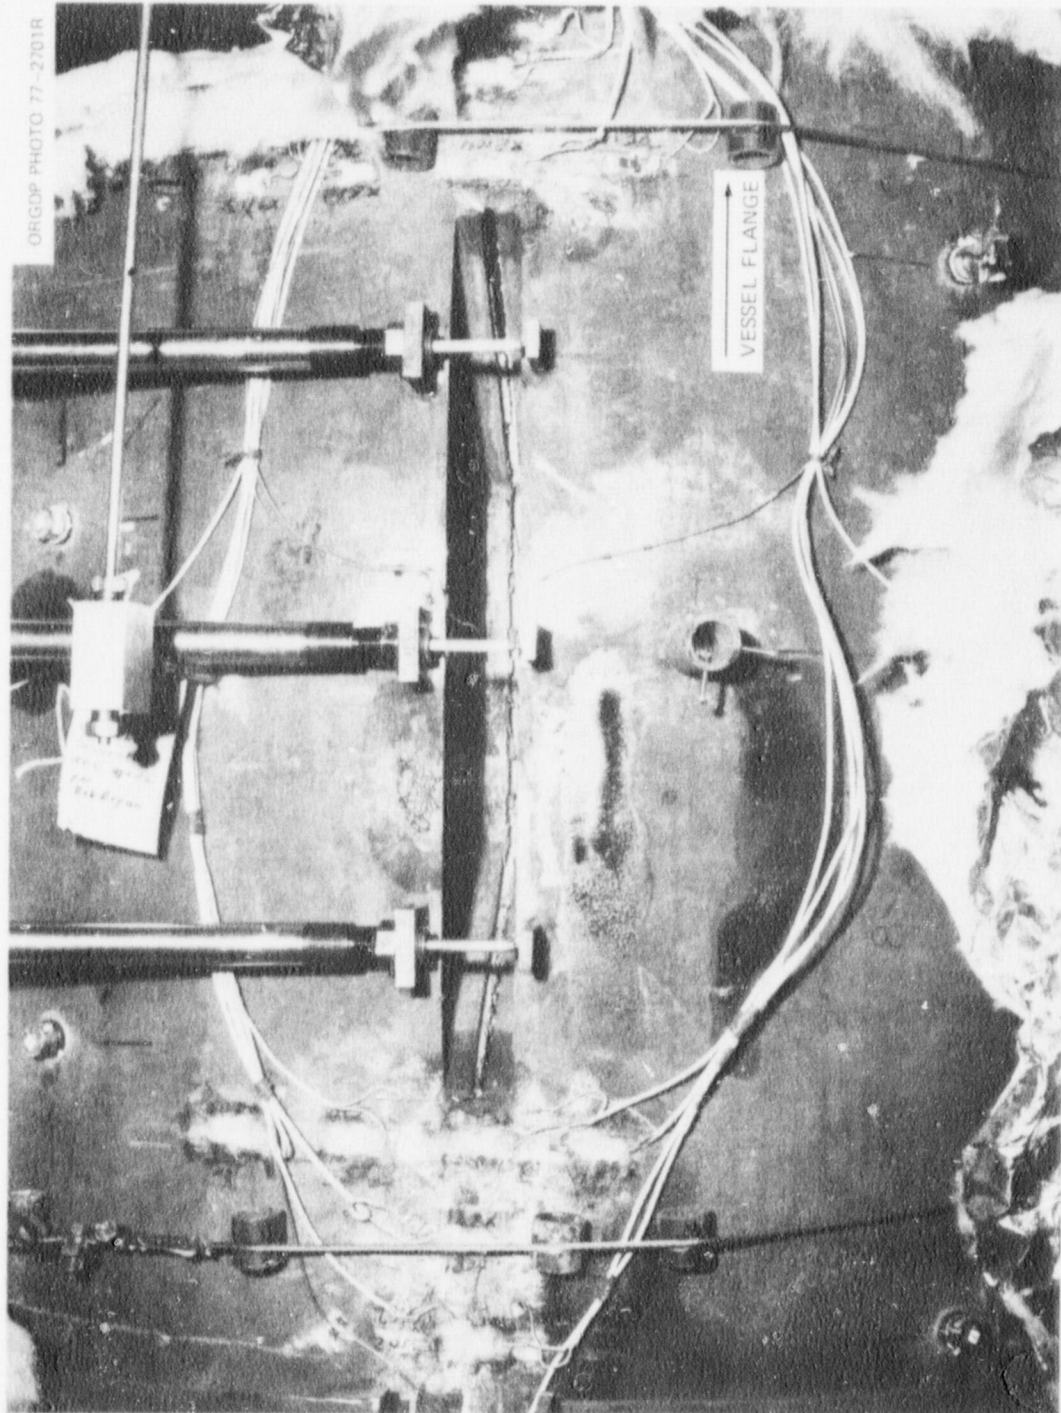
Fig. 4.22. Outside view of flaw in vessel V-7B after test. The initial EB weld crack surface that appears as a dark streak adjacent to light fracture surfaces was smooth to the expected depth of about 8 mm.

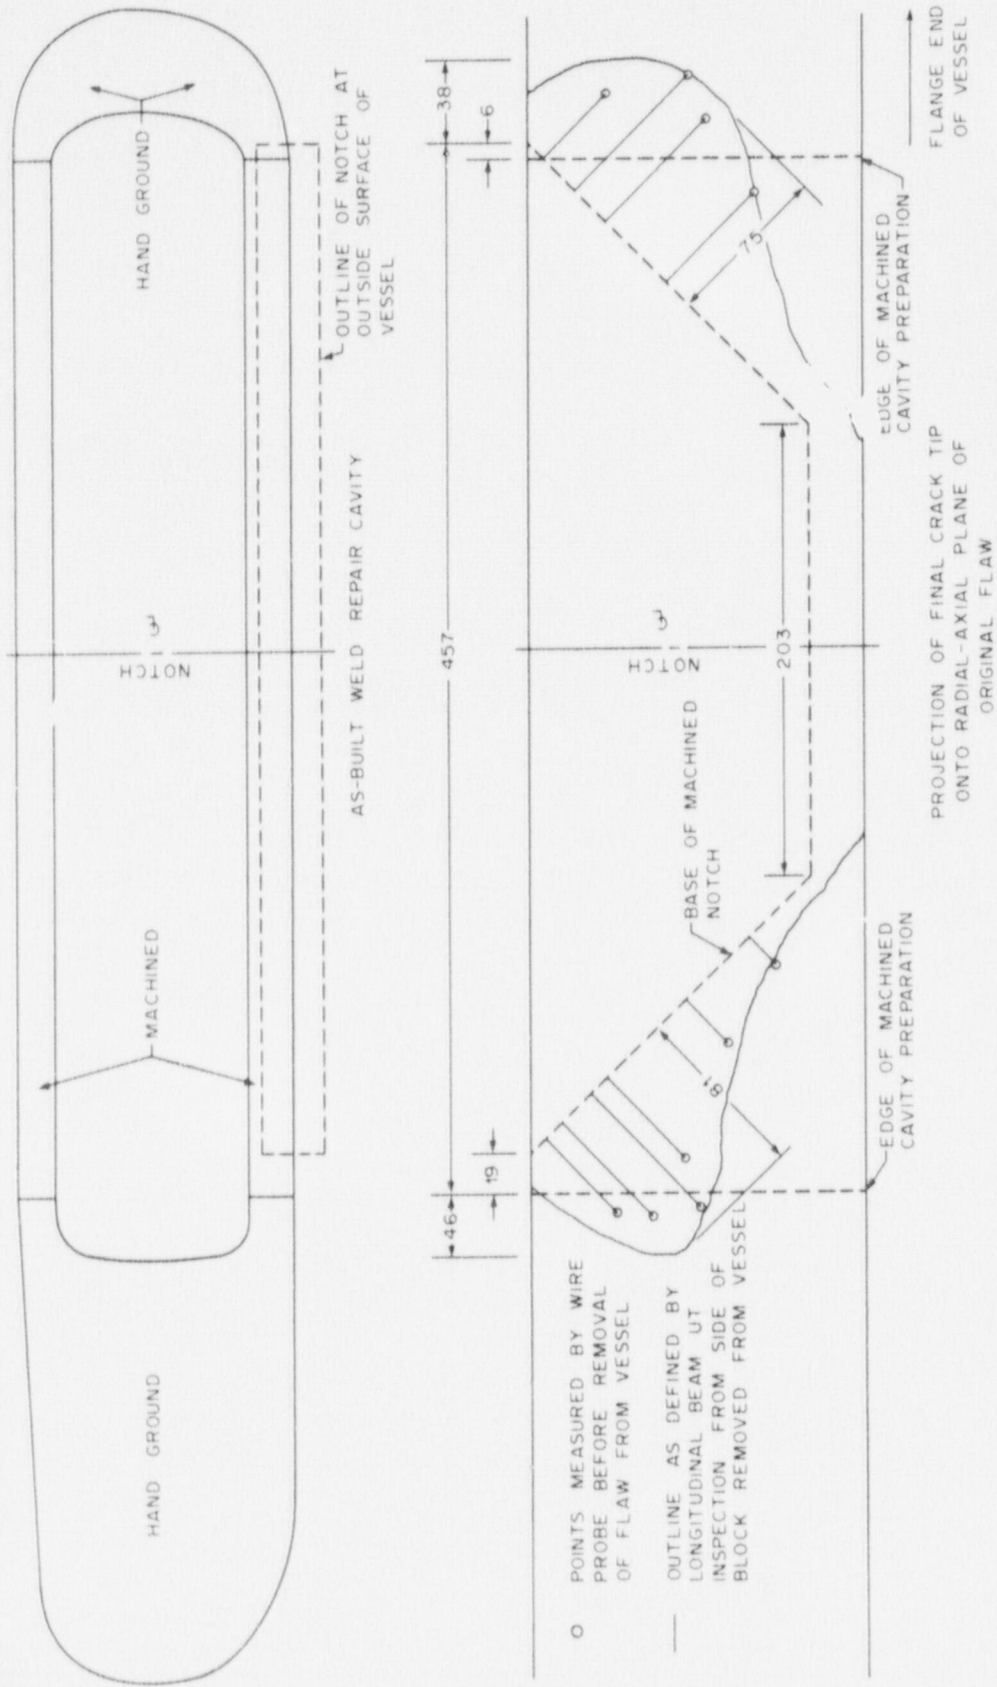
Fig. 4.23. Longitudinal section of V-7B flaw showing results of independent measurements of crack extension by wire probe and ultrasonic examination. The plan view shows the location of the crack relative to the weld.

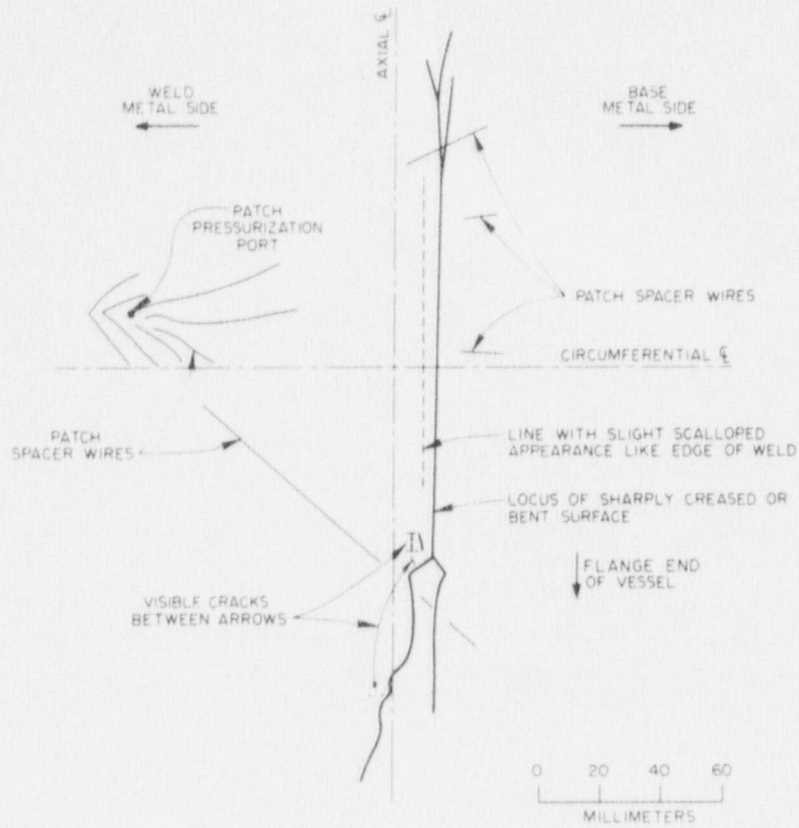
Fig. 4.24. Sketch of inside surface of vessel V-7B beneath the notch showing fissures and deformations developed during the test. Locations of features were determined by rubbed impressions on paper laid against the deformed surface.

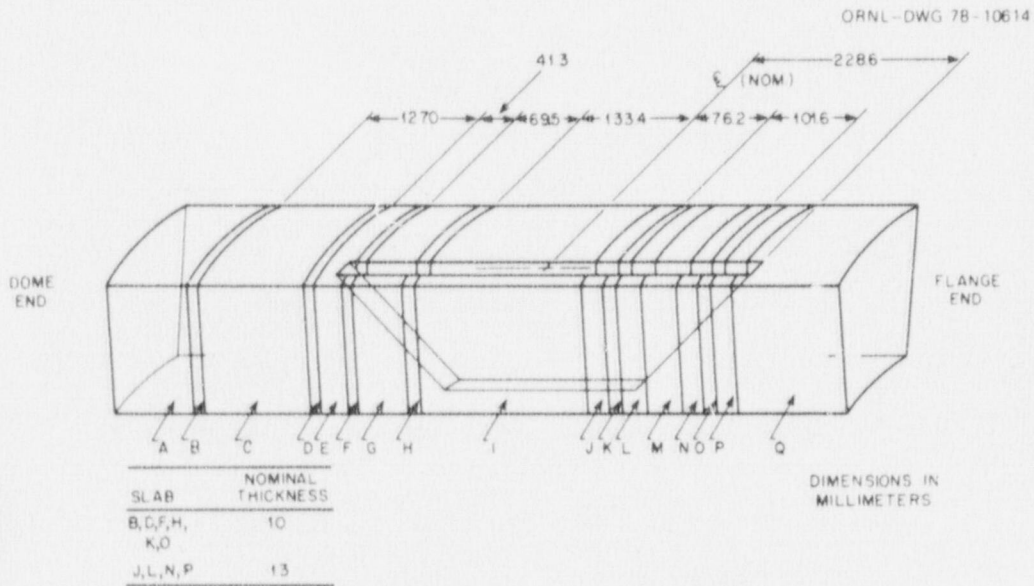
Fig. 4.25. Block cut from intermediate test vessel V-7B containing entire repair weld and fracture zone. Slabs A through Q were cut after all ultrasonic examinations were completed.

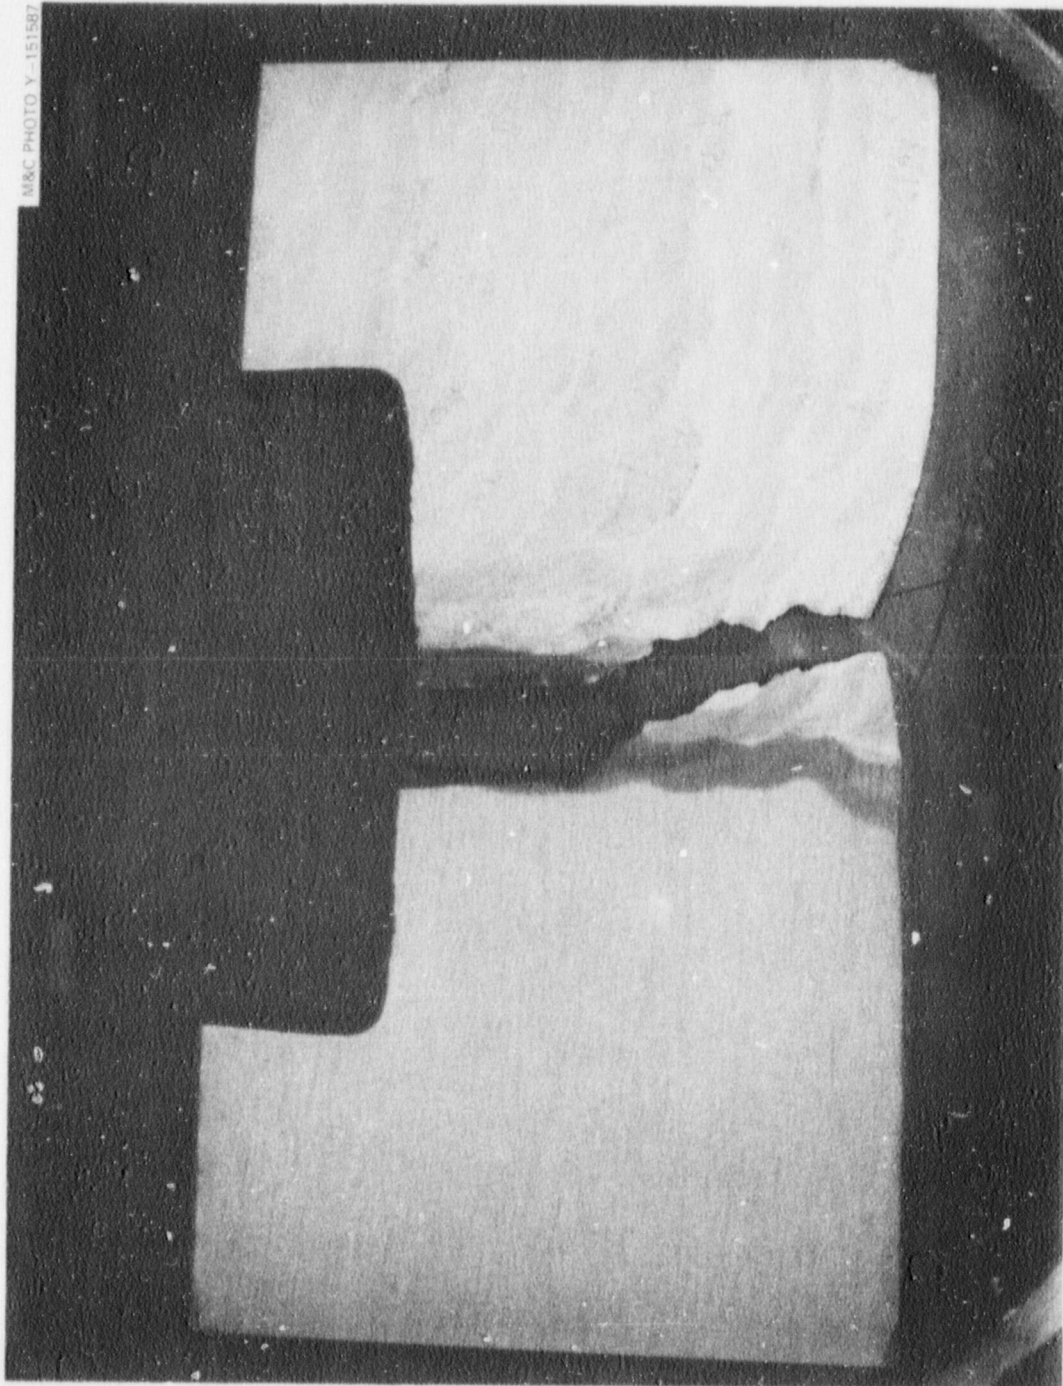
Fig. 4.26. Face K_f (the face of slab K nearest the flange end of the vessel) of cross section of V-7B fracture.

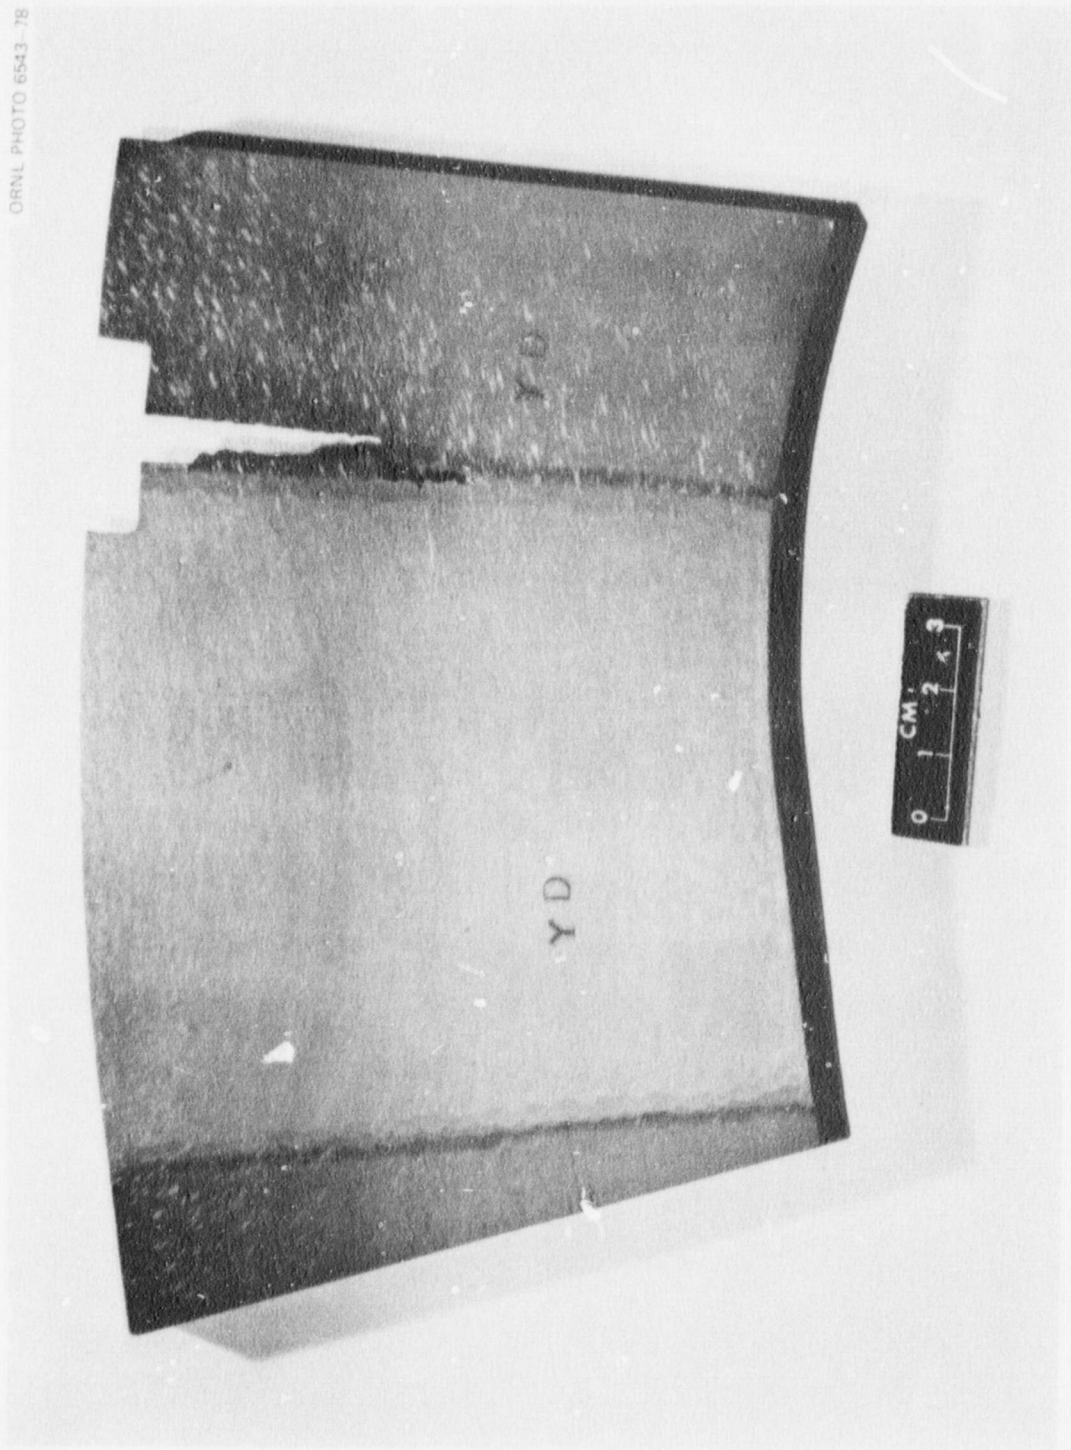
DRNL PHOTO 6543-78

Fig. 4.27. Etched face F_d (slab F, dome side) of cross section of the flaw near the dome end of the notch in V-7B. See Fig. 4.25 for definition of cross sections.

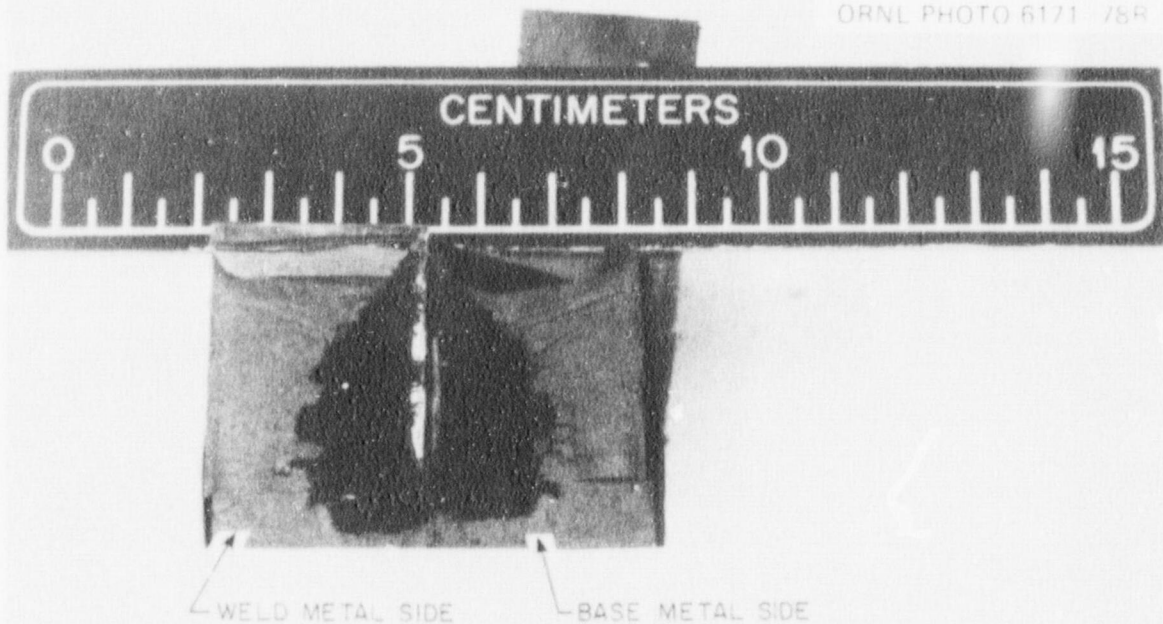
ORNL PHOTO 6171 78R

Fig. 4.29. V-7B fracture surfaces in slab C exposed by splitting the chilled slab.

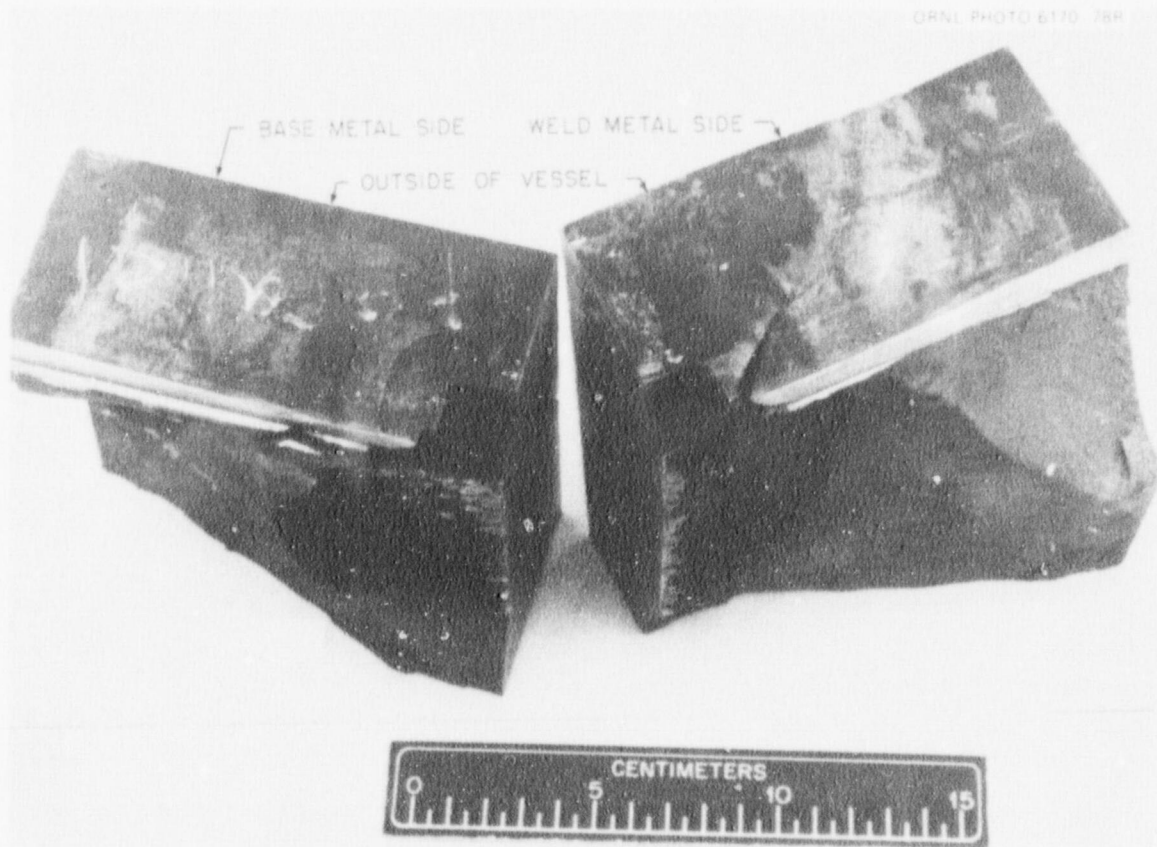
ORNL PHOTO 6170 78R

Fig. 4.30. V-7B fracture surfaces in slab Q exposed by splitting the chilled slab.
