The purpose of this letter is to forward to you part of a draft NUREG/CR report that documents work which was performed by PNNL staff at Seabrook Station Unit 2. In January 1996, Pacific Northwest National Laboratory (PNNL) staff, in conjunction with NRC Inspectors, participated in a field exercise aimed at evaluating a low frequency, long wavelength inspection technique for examining thick section, coarse grained stainless components. This field exercise allowed PNNL to acquire true field measurements of velocity and attenuation as a function of position on primary cast stainless steel piping under true field conditions and provided a basis for establishing a complete assessment of the utility and effectiveness of the low frequency/SAFT inspection technique. This exercise also greatly enhanced PNNL's database for cast stainless steel material thicker than 75mm.

Field Exercise: Seabrook Station Unit 2

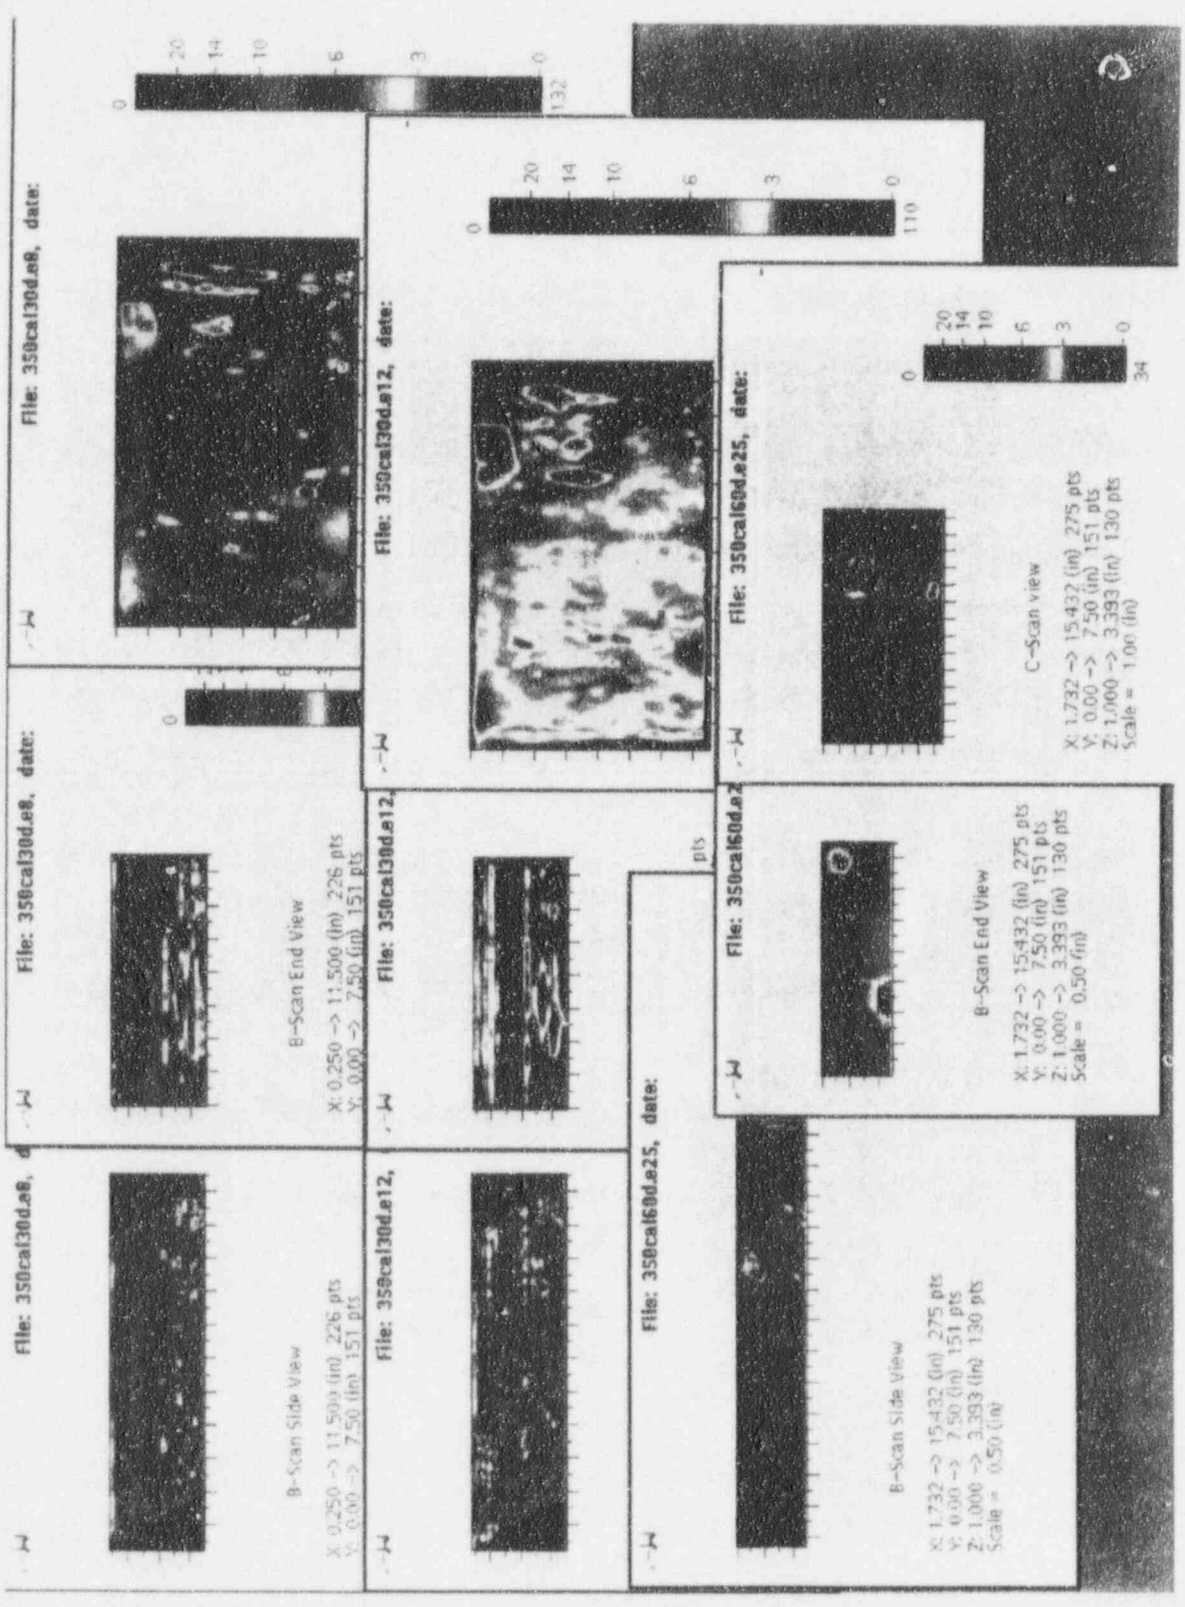
B.28 SAFT images from 30° and 60° incident signal responses

Image B.28 illustrates the 30° and 60° incident signal responses from the scans of the entire calibration block at Seabrook Station Unit 2, during the field exercise. The image consists of three rows of snapshots where the top two rows represent the 30° examination at 8° and 12° beam processing angles, respectively. The bottom row represents the signal responses from the 60° examination of the calibration block processed at a beam processing angle of 25° . The calibration block had large areas of the top surface that were bowed and rough. Even in water (immersion tank), this proved to be a problem as the signal response would tend to degrade (lower amplitude) over these areas. The noise conditions due to coherent backscatter of the material structure were high throughout the sample. The top row shows the three composite views where the tip of the axial notch is evident, the entire circumferential notch is evident, side drilled holes are evident, and the corner trap response is also evident. Although the corner trap response is not as continuous as expected, the experimental conditions and the surface discontinuities played an important role in degradation of the signal over large portions of the scans. Sizing information from this data set was quite accurate as the circumferential notch measured 10% deep and 2.54 cm. (1.0 in.) long. This corresponded exactly with the actual depth and length. The middle row represents the 12° beam processing angle of the same data set and shows a higher amplitude response from the side-drilled holes and the notch, but resolution is lost with regard to the corner trap and the axial notch tip. Sizing of the circumferential notch was also very accurate for this processing angle. The bottom row (60° exam) shows composite views that exhibit much lower noise conditions, but the dynamic range is also quite low. The side drilled holes running perpendicular to the direction of the scan (x-axis) are now no longer evident, however, the side-drilled holes that run parallel to the scan direction (x-axis) are evident. The tip of the axial notch can no longer be seen either, however, the circumferential notch and a high amplitude signal response from the corner trap are very evident. Sizing of the circumferential notch was also quite accurate with a 10% depth measurement and a 2.36 cm. (0.93 in.) length measurement.

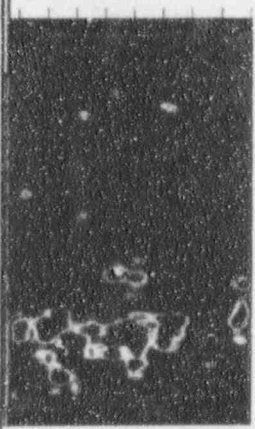
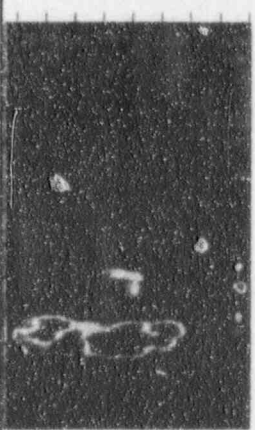
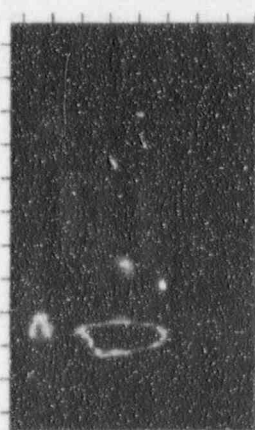
B.29 SAFT images from 45° incident signal responses

Image B.29 shows the 45° incident signal responses from the scans of the calibration taken at Seabrook Station Unit 2 during the field exercise. The image consists of three rows of snapshots where each row represents the same raw data set (taken at 45°) but processed at three different SAFT beam angles. The top row represents the 6° processing angle, the middle row represents the 12° processing angle, and the bottom row represents the 25° beam processing angle. The top row shows the capability for detection of the circumferential notch, the corner trap and the perpendicular side-drilled holes, as does the middle row. Noise conditions appear to be somewhat lower than the 30° and 60° data sets, however, coherent backscatter due to material structure is still evident here. The corner trap responses for these images are all fairly continuous and of high amplitude. The bottom row exhibits lower noise conditions and shows the tip of the axial notch as well as the perpendicular side-drilled holes, the circumferential notch, and the corner trap. The best sizing information was retrieved from the 6° and 12° processed files. The circumferential notch measured 10% in depth and 2.54 cm. (1.0 in.) matching exactly the actual dimensions of the notch.
