U. S. NUCLEAR REGULATORY COMMISSION
OFFICE OF NUCLEAR REACTOR REGULATION

Report No.: 50-302/87-22

Facility Name: Crystal River Nuclear Generating Plant, Unit 3

Inspection Conducted: August 24-September 4, 1987

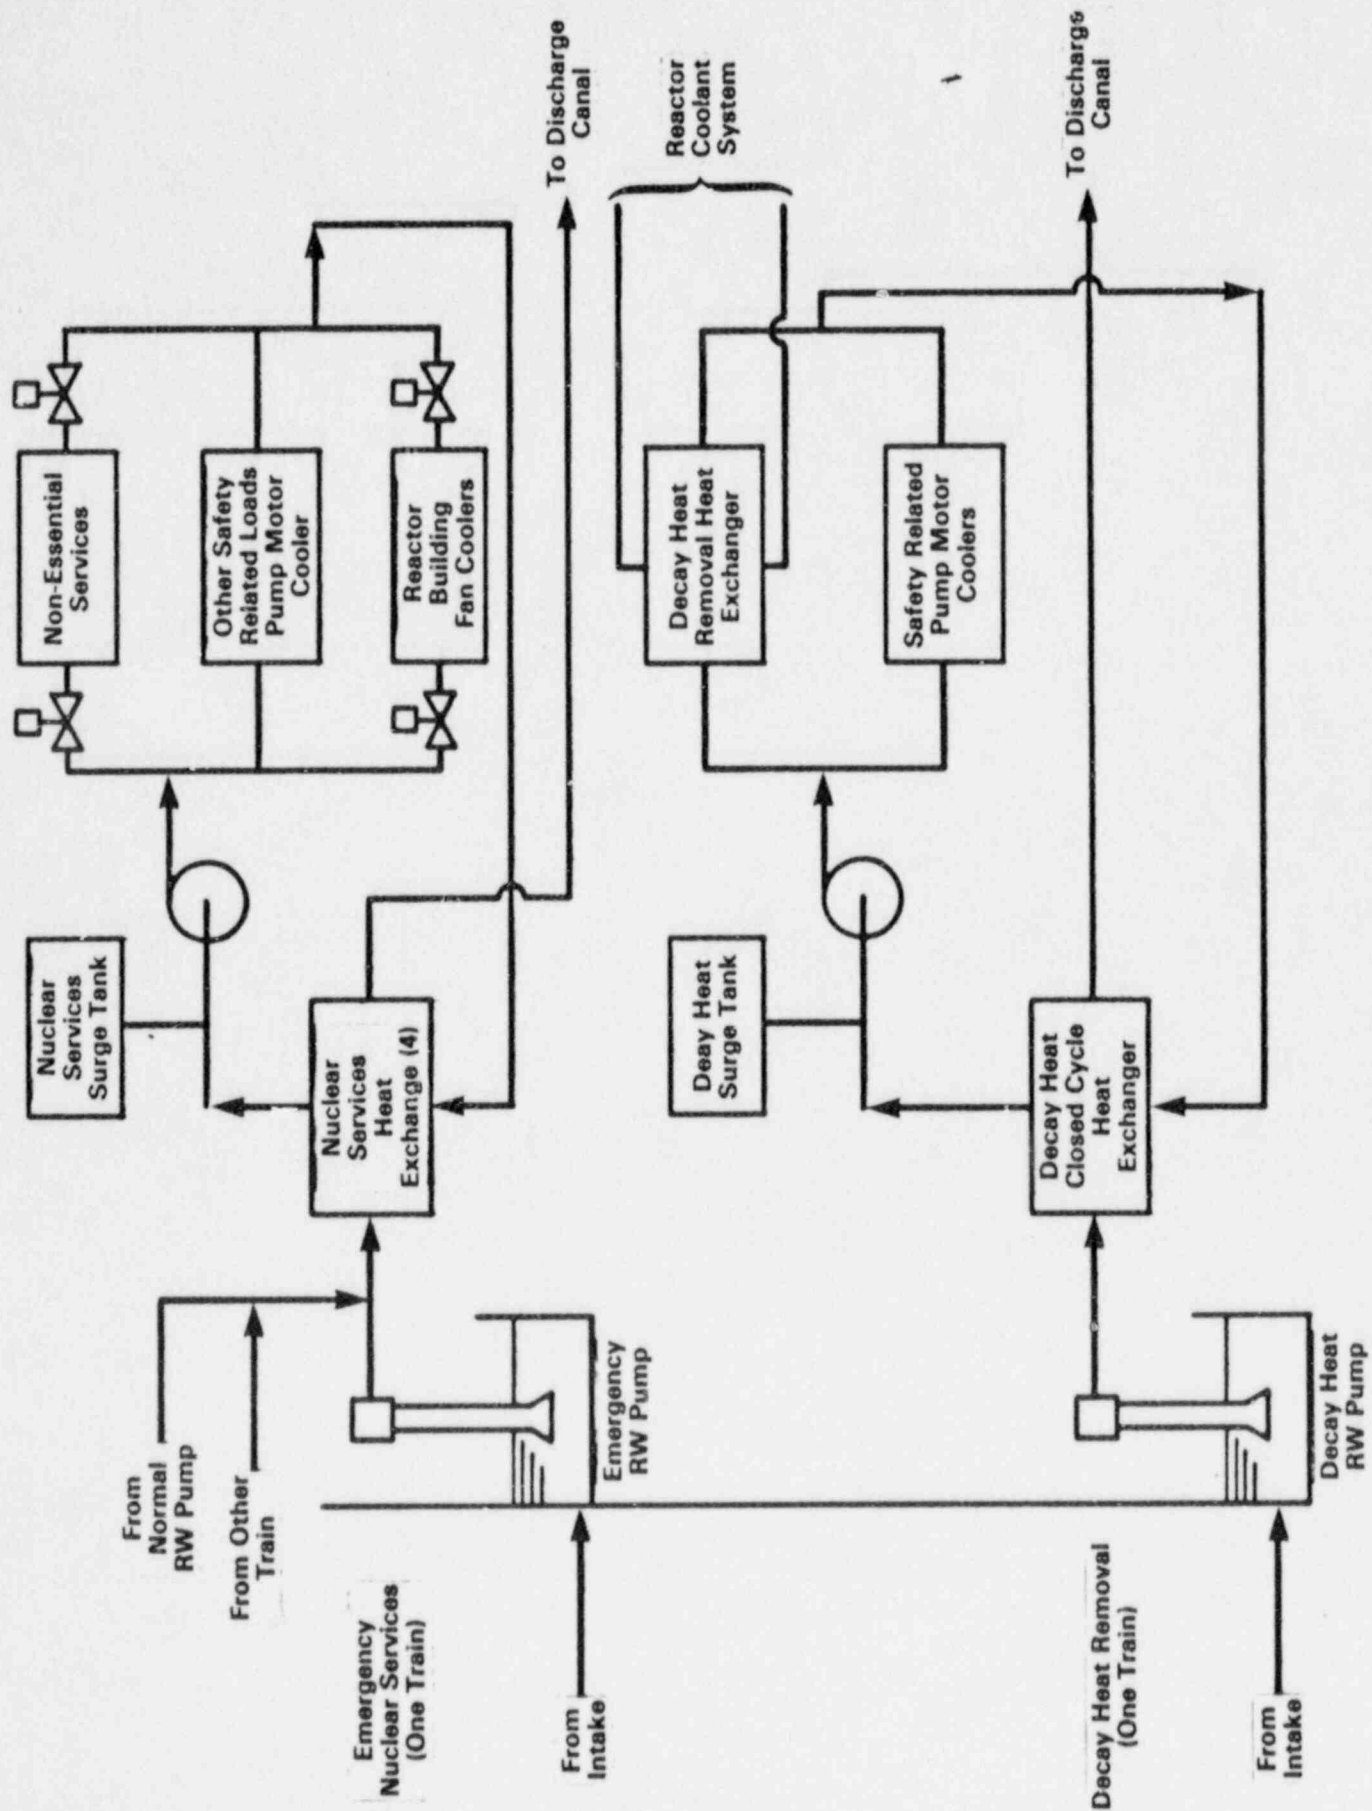
Figure 1 RAW WATER AND AUXILIARY COOLING WATER SYSTEMS

The decay heat closed cycle heat exchangers are cooled by the raw water system and supply cooling water to the decay heat removal heat exchangers and other safety-related equipment during a normal plant cooldown and during a postulated loss-of-coolant accident (LOCA). One decay heat removal heat exchanger cooled by one decay heat closed cycle heat exchanger constitutes a decay heat

removal train (Figure 1). During a normal plant cooldown, both decay heat removal trains are used to cool the plant to 140°F within 14 hours. However, in the event of a LOCA, only one of the redundant decay heat removal trains is required to accommodate the high accident heat loads during reactor building sump recirculation.
