Report Nos.: 50-259/87-43, 50-260/87-43, and 50-296/87-43

Facility Name: Browns Ferry 1, 2, and 3

Scope: This special announced inspection was conducted for the Browns Ferry Unit 2 drywell fire of November 2, 1987. This inspection was not intended to focus on regulatory enforcement issues. The inspection team was charged with investigation of the fire in order to identify and document all relevant and specific facts associated with the fire. Specifically the inspection team addressed: the sequence of events which portrayed the chronological activities prior to and during the fire, an assessment and evaluation of the fire impact on plant operations, the proximate root cause of the fire and licensee actions to cope with the fire. The licensee conducted concurrently a Serious Accident Investigation Team inspection to evaluate the root causes, program deficiencies, and lessons learned from the event. During the TVA inspection effort, it was noted that one of the potential root causes, consistent with test results, would

4. Summary of Browns Ferry Unit 2 Fire - November 2, 1987

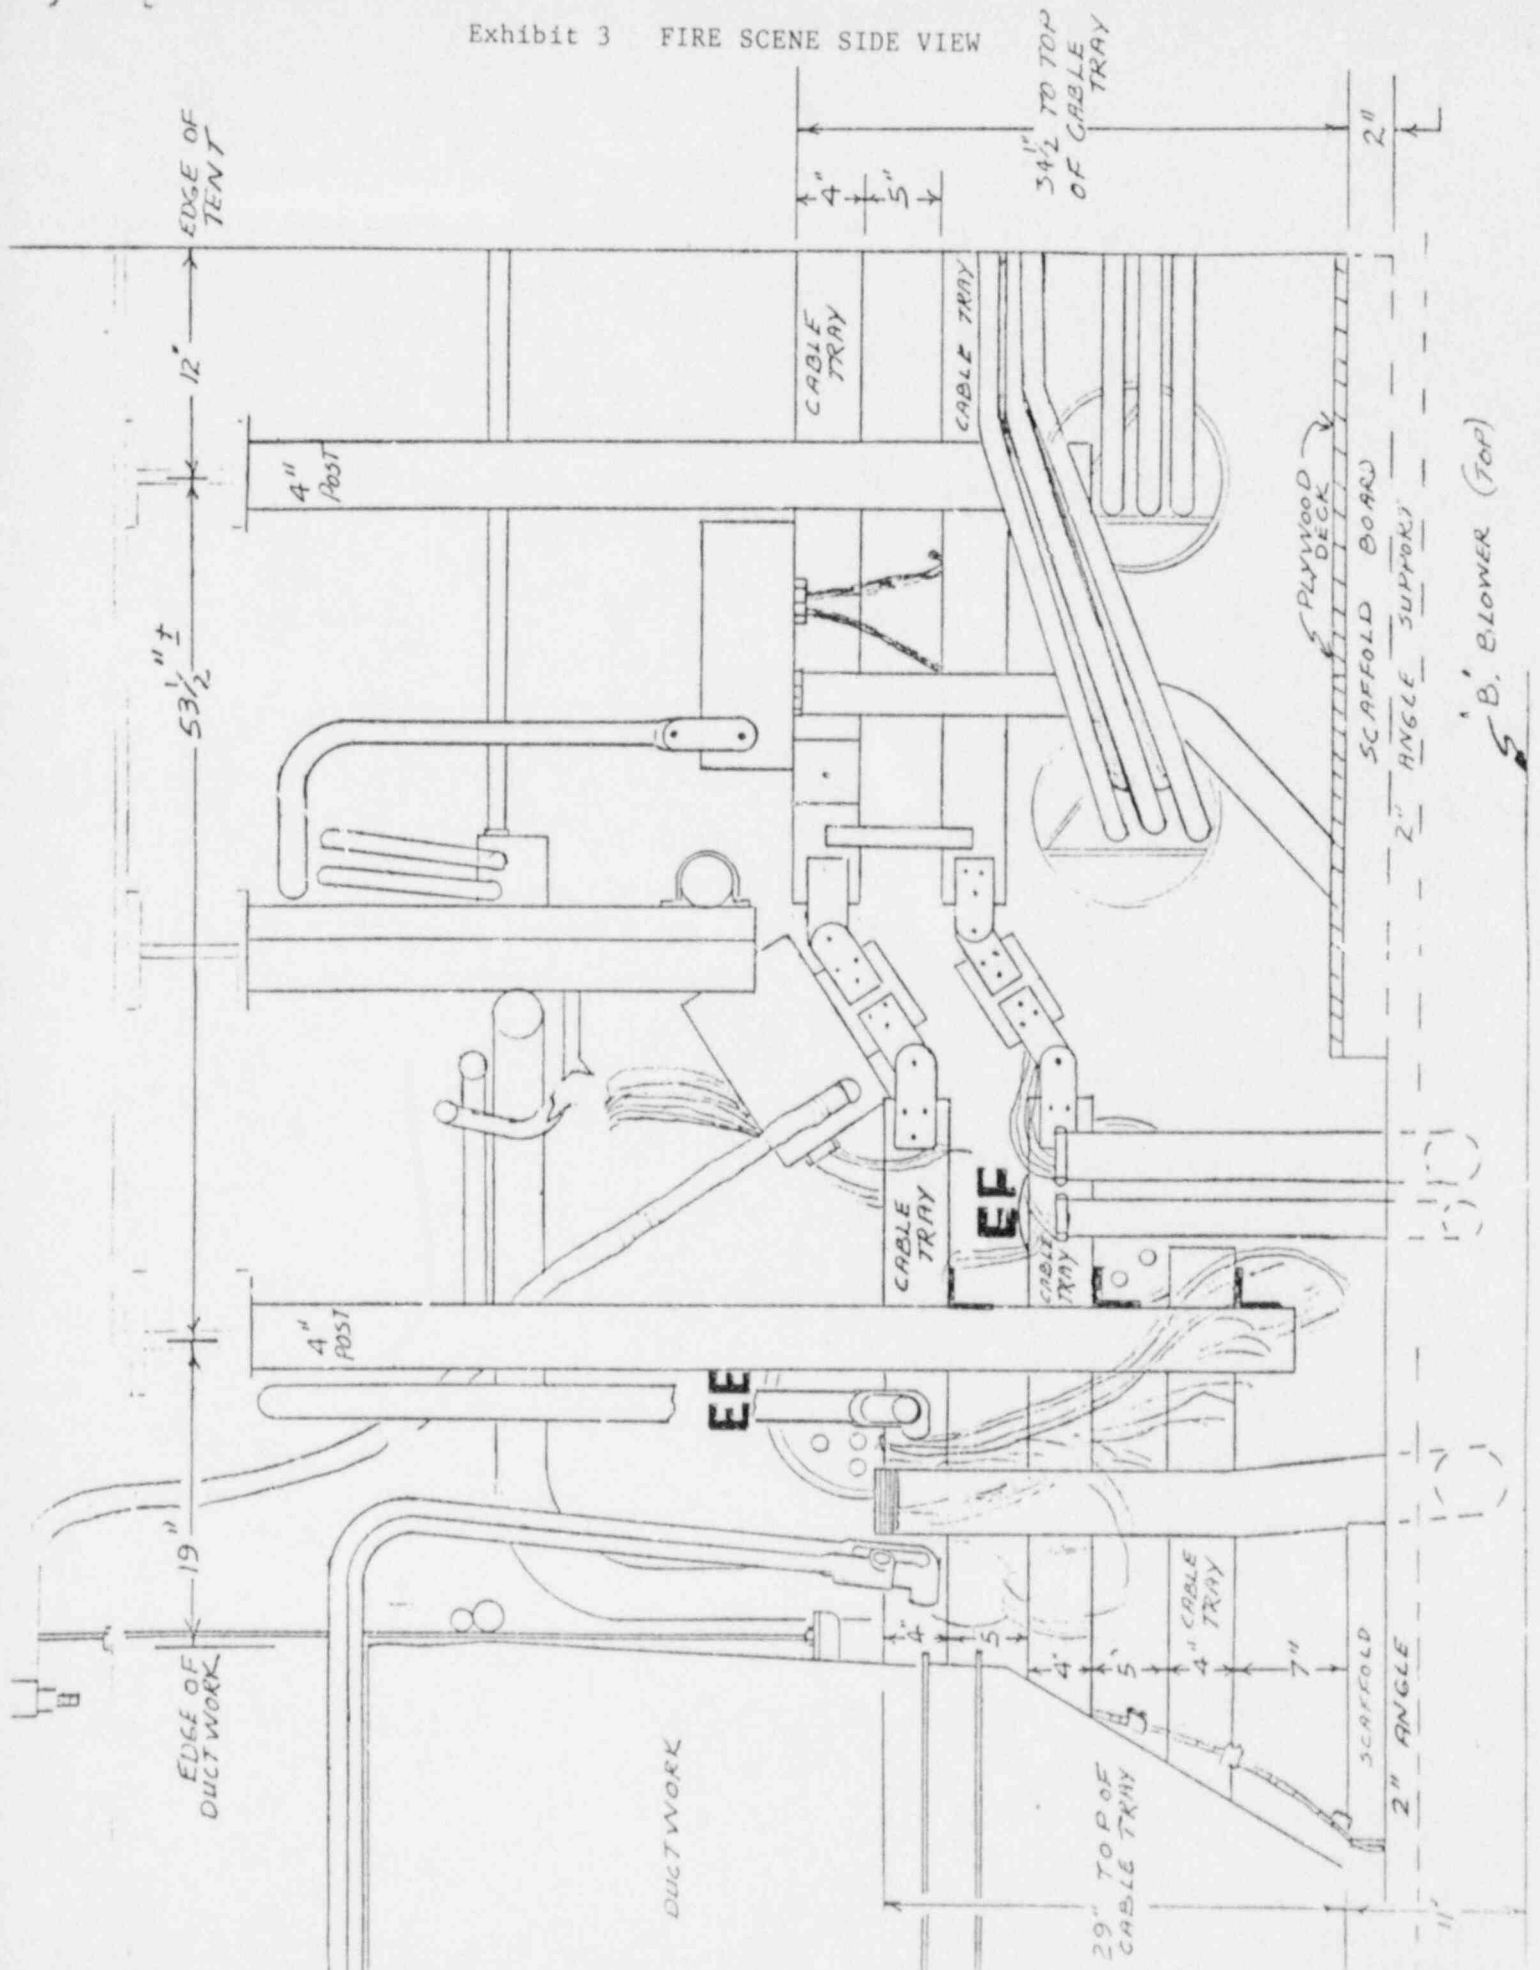
Exhibit 3 FIRE SCENE SIDE VIEW

The fire resulted in destruction of the cables in the affected section of the cable trays, the melting of two aluminum conduits above a penetration splice box, and the discoloration of the galvanized steel junction boxes, cable trays and conduits in the area. A section of the splice box was discolored white, from the heat of the fire inside the box. No melting or structural failure of steel components was noted. Charred remnants of the flame retardant blanket were found on top of the cable trays. The flame resistant plywood underneath and directly beneath the fire origin was charred.
