LICENSEE EVENT REPORT (LER)

FACILITY NAME (1) Fort St. Vrain, Unit No. 1 DOCKET NUMBER (2) 050002677 PAGE (3) 1 OF 06

TITLE (4) REACTOR SCRAM ACTUATION ON NEUTRON FLUX RATE OF CHANGE HIGH

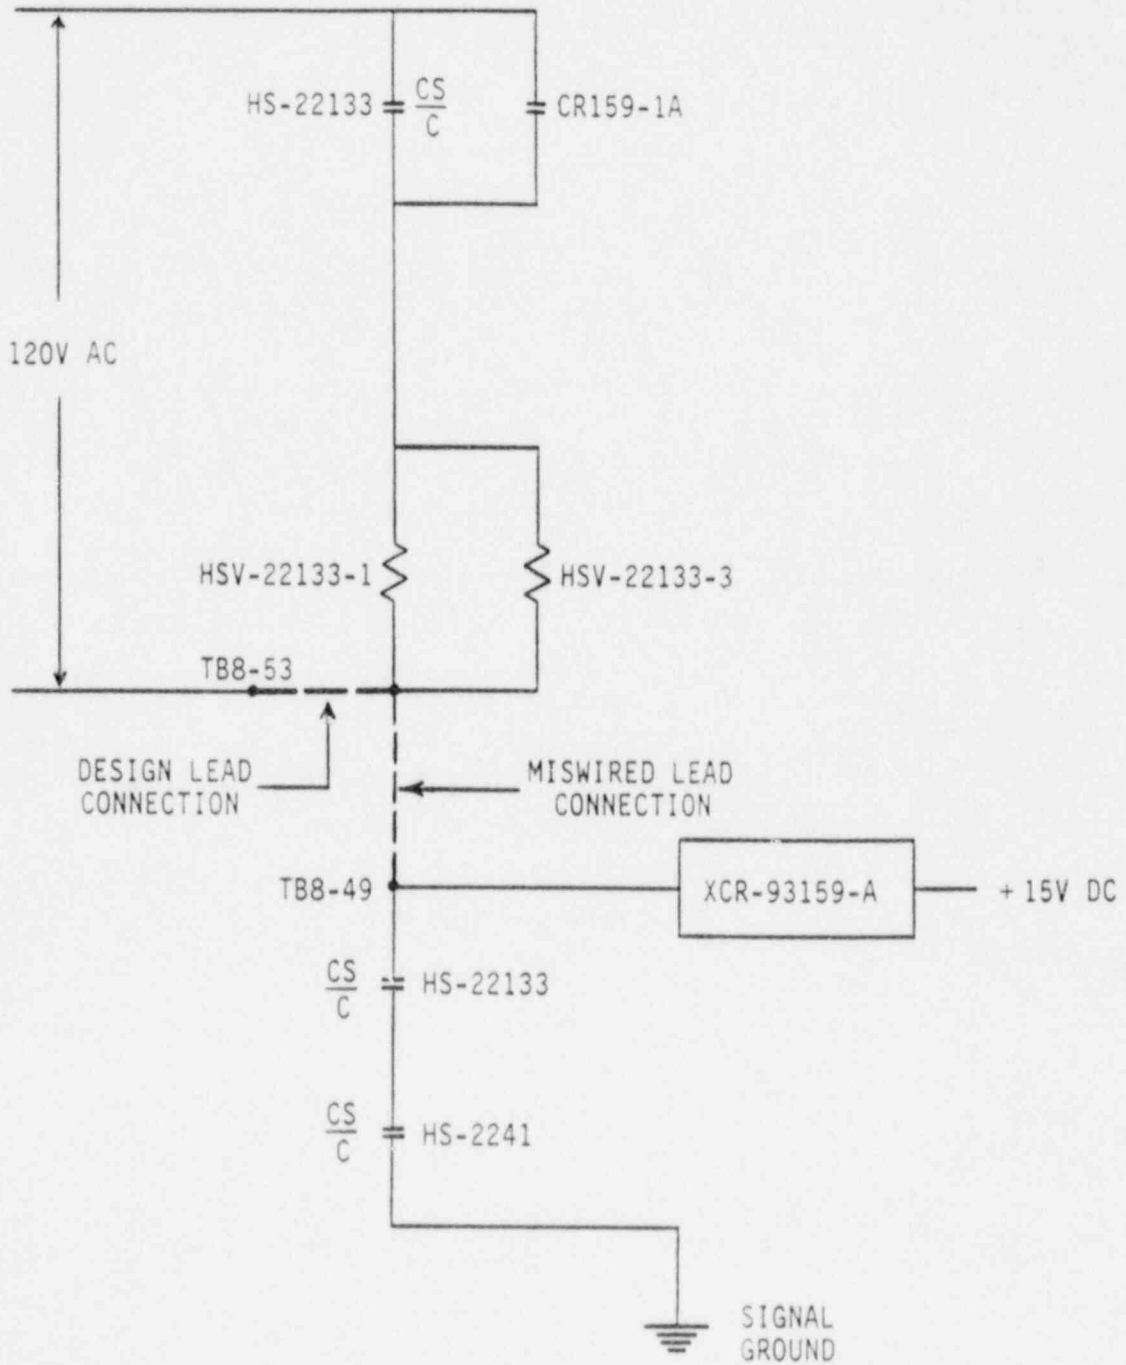
FIGURE 1

On October 4, 1987, cable 7487 (*CBL) was cleared out for repair of damage caused by the hydraulic oil fire of October 3, 1987, reported in Licensee Event Report 50-267/87-023. This cable provides for control of the Loop I Feedwater Attenuator valve HV-22133 (*TCV). The control section of the circuit was isolated by lifting leads 46, 47, 48, and 53 from TB8 in panel I-05 (*PNL). On December 1, 1987, following work performed under Change Notice CN-2701, cable 7487 was returned to service. During the reconnection of the cable 7487 leads to TB8 in I-05, the ground return wire for solenoids HSV-22133-1 and HSV-22133-3 (*SOL) was inadvertently connected to the reset circuit of relay XCR-92159-A (*RLY) at TB8-49 instead of the proper location at TB8-53 (Refer to Figure 1). Subsequent independent verification and Functional Test failed to detect the mispositioned lead.

The root cause of the incorrect location of the cable 7487 wire at TB8-49 was inattentiveness on the part of both the electrician and the independent reviewer.

The subsequent Functional Test of cable 7487 failed to detect the incorrect wire position due to circuit design and operation. With hand switch HS-22133 open, 120V AC is not applied to solenoids HSV-22133-1 and HSV-22133-3, and therefore not to relay XCR-93159-A. With hand switches HS-2241 and HS-22133 both closed, the reset circuit of relay XCR-93159-A is held at signal ground, thereby allowing current from solenoids HSV-22133-1 and HSV-22133-3 to pass to signal ground without affecting relay XCR-93159-A. This is the condition that allowed the Functional Test for cable 7487 to be satisfactorily completed. Under the plant conditions existing at the time, only the operation of hand switch HS-2241 to the open position with hand switch HS-22133 in the closed position could have created a condition whereby the mislocated wire would be detected. Since hand switch HS-2241 is not a design part of the circuit which was tested, its operation was not part of the Functional Test performed for cable 7487. The subsequent operation of hand switch HS-2241 during testing prior to reactor startup eventually led to the discovery and correction of the mislocated wire.

The ground return lead for solenoids HSV-22133-1 and HSV-22133-3 from cable 7487 was relocated to the proper position at TB8-53 in panel I-05. Relay XCR-93159-A and logic module CT-1AL1 (*CPU) which were damaged by high voltage were replaced.
