LICENSEE EVENT REPORT (LER)

FACILITY NAME (1) Peach Bottom Atomic Power Station - Unit 3	DOCKET NUMBER (2) 0 5 0 0 0 2 7 8	PAGE (3) 1 OF 0 5
---	--------------------------------------	----------------------

TITLE (4) Reactor Water Cleanup System Isolation Signal During Piping Decontamination Process  
Due To Procedural Deficiency

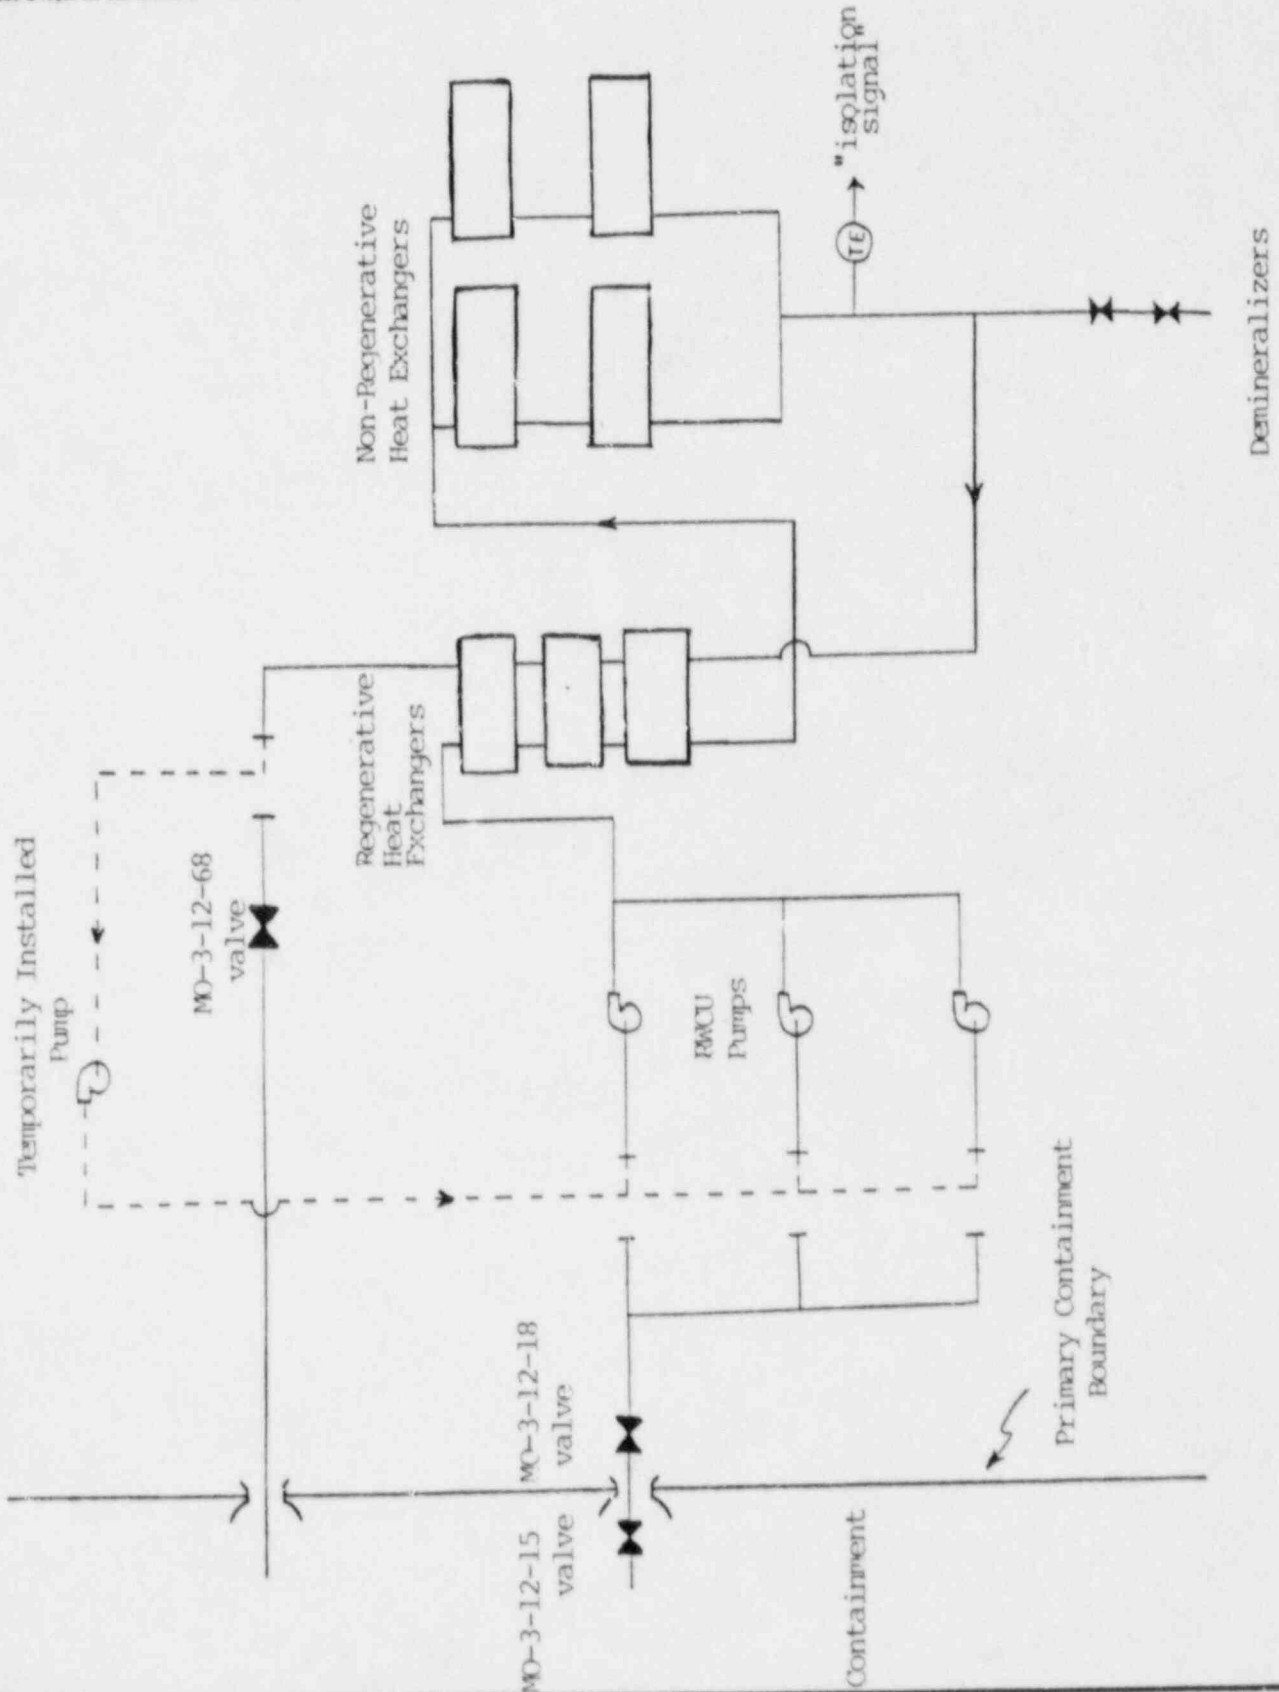
The RWCU System was in a unique condition when the isolation occurred. A special piping decontamination process was in progress to minimize personnel radiation exposures during upcoming modifications to the RWCU System piping. The RWCU System inlet and outlet containment isolation valves, MO-3-12-15, MO-3-12-18 (inlet) and MO-3-12-68 (outlet), were blocked in the closed position. These are the only valves that received isolation signals. The RWCU pumps were uncoupled from their motors and the process flow was established by a temporary pump which was installed and in service specifically for the decontamination process (see attached diagram).
