Millstone Nuclear Power Station, Unit No. 2

Independent Review Team Report

September 1993

### 5.1 LETDOWN VALVE 2-CH-442

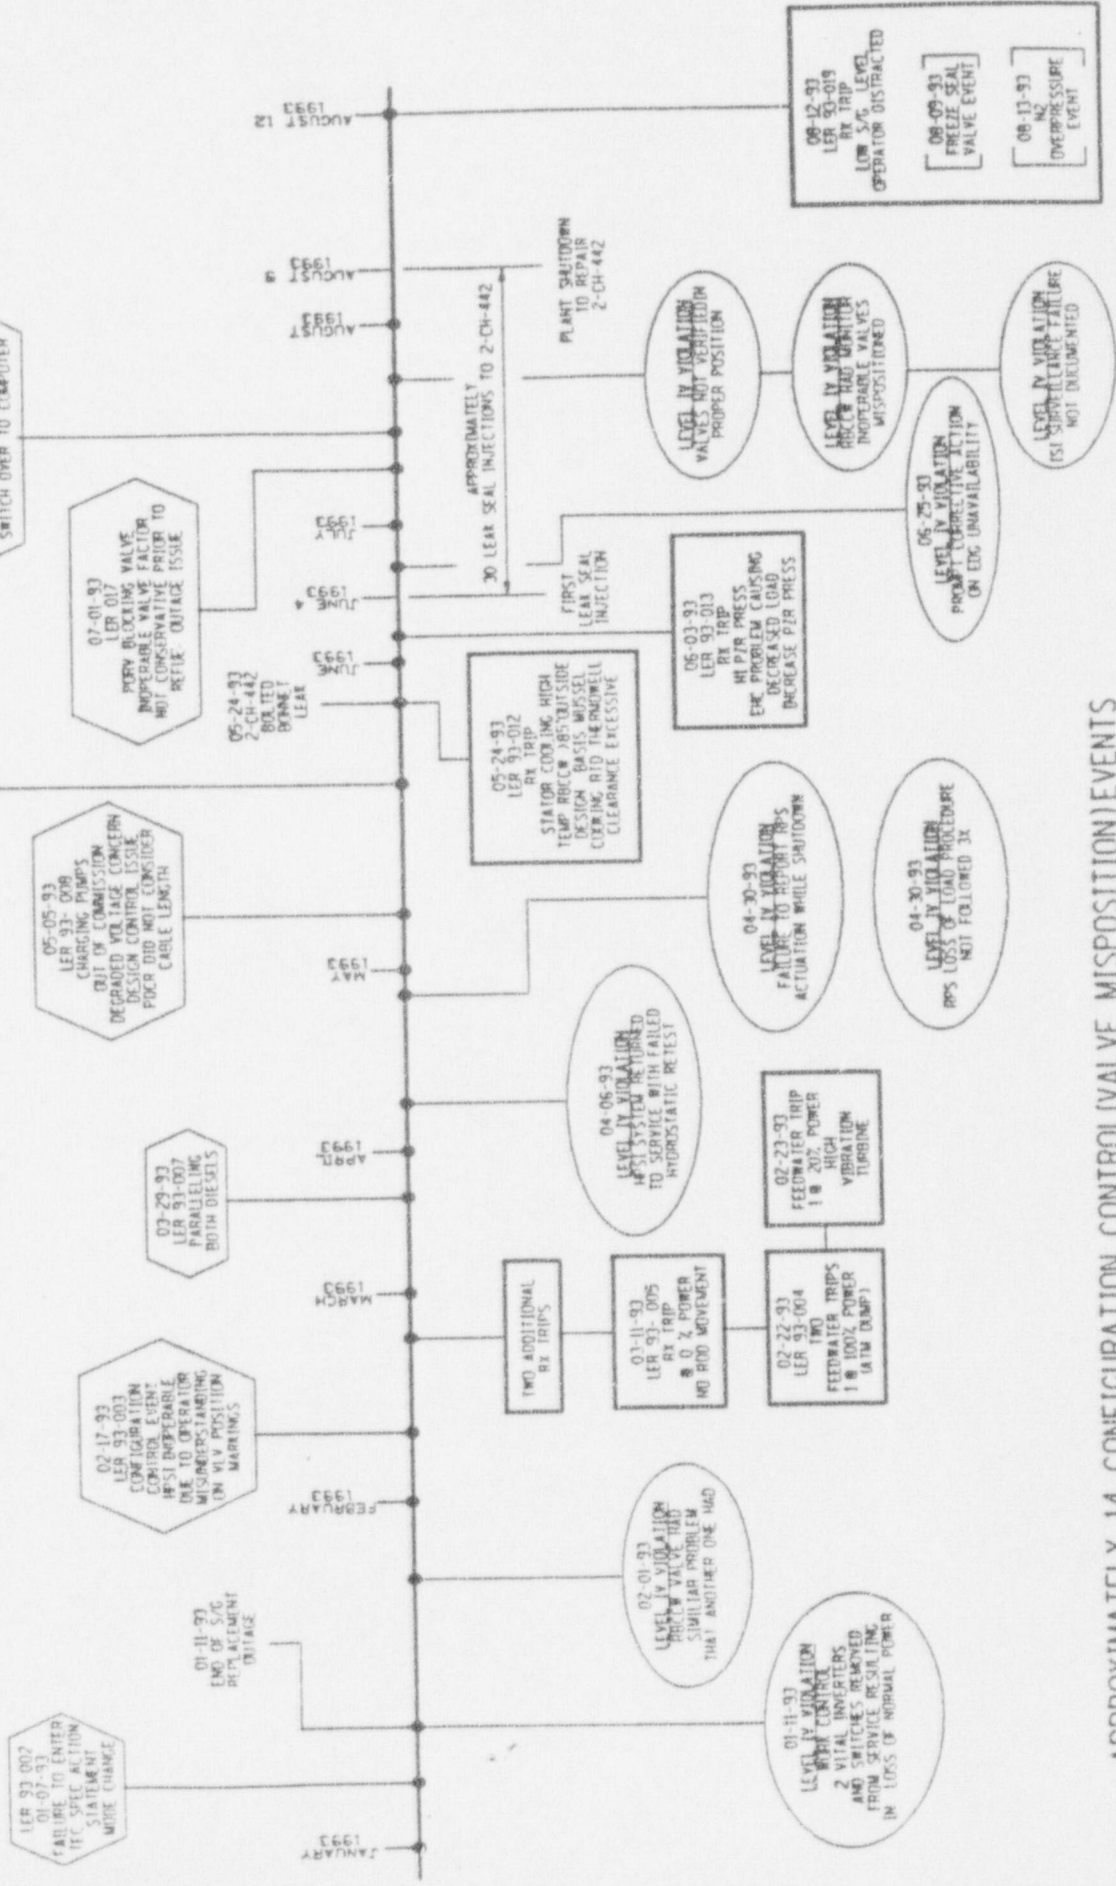
# TIME LINE FOR VALVE 2-CH-442 & OTHER EVENTS FROM JAN. 93 THRU AUG. 93

APPROXIMATELY 14 CONFIGURATION CONTROL (VALVE MISPOSITION) EVENTS
