RADIOLOGIC AND ENGINEERING ASSESSMENT

DOE ID NO.: GJ-97002-OT - PHASE II  
ADDRESS: THE 300 BLOCK OF MAIN STREET  
(BOTH SIDES FROM THIRD TO FOURTH STREETS)

JUNE 1989

SUPPLEMENTAL  
STANDARDS

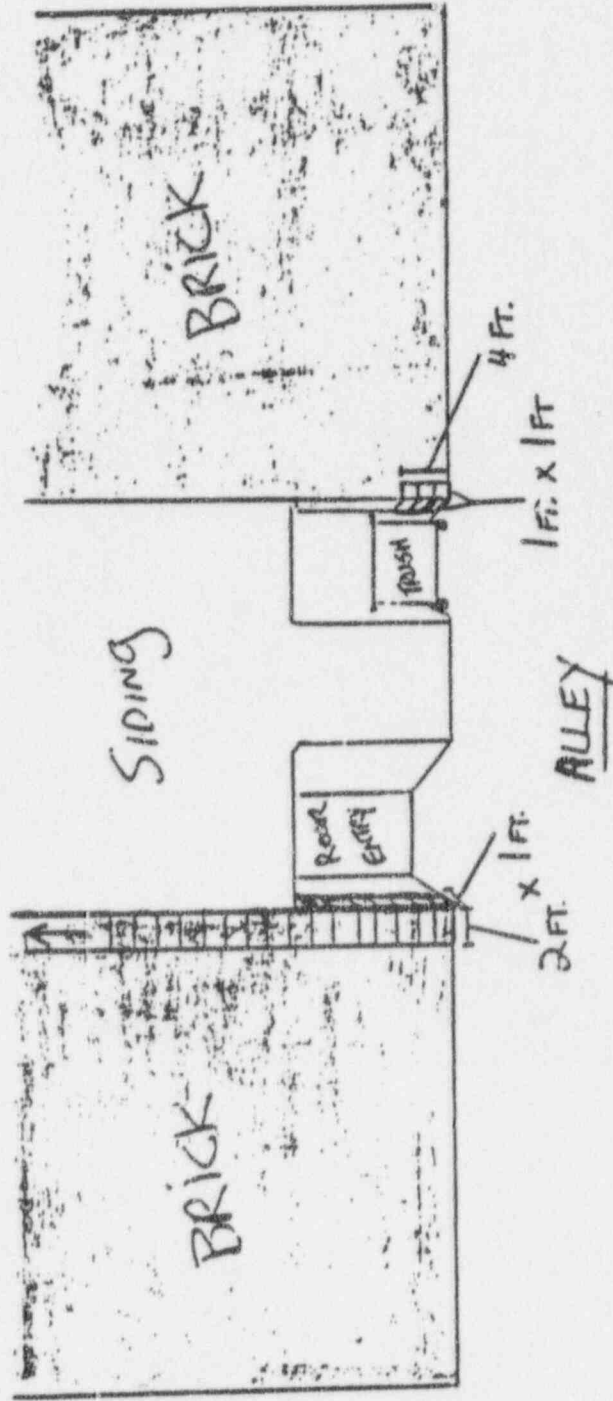
EXTERIOR  
NORTH FACE OF BUILDING

CONTAMINATED BRICK AREA
