UNITED STATES
NUCLEAR REGULATORY COMMISSION

SUBJECT: GENERIC IMPLICATIONS OF THE SALEM 2 LOSS OF OVERHEAD
ANNUNCIATORS

ATTACHMENT 2
SUMMARY OF ROOT CAUSE ANALYSIS AND SAFETY SIGNIFICANCE

EVALUATION OF UNIT 1 AND 2
POWER OPERATED RELIEF VALVE (PORV) ACCEPTABILITY

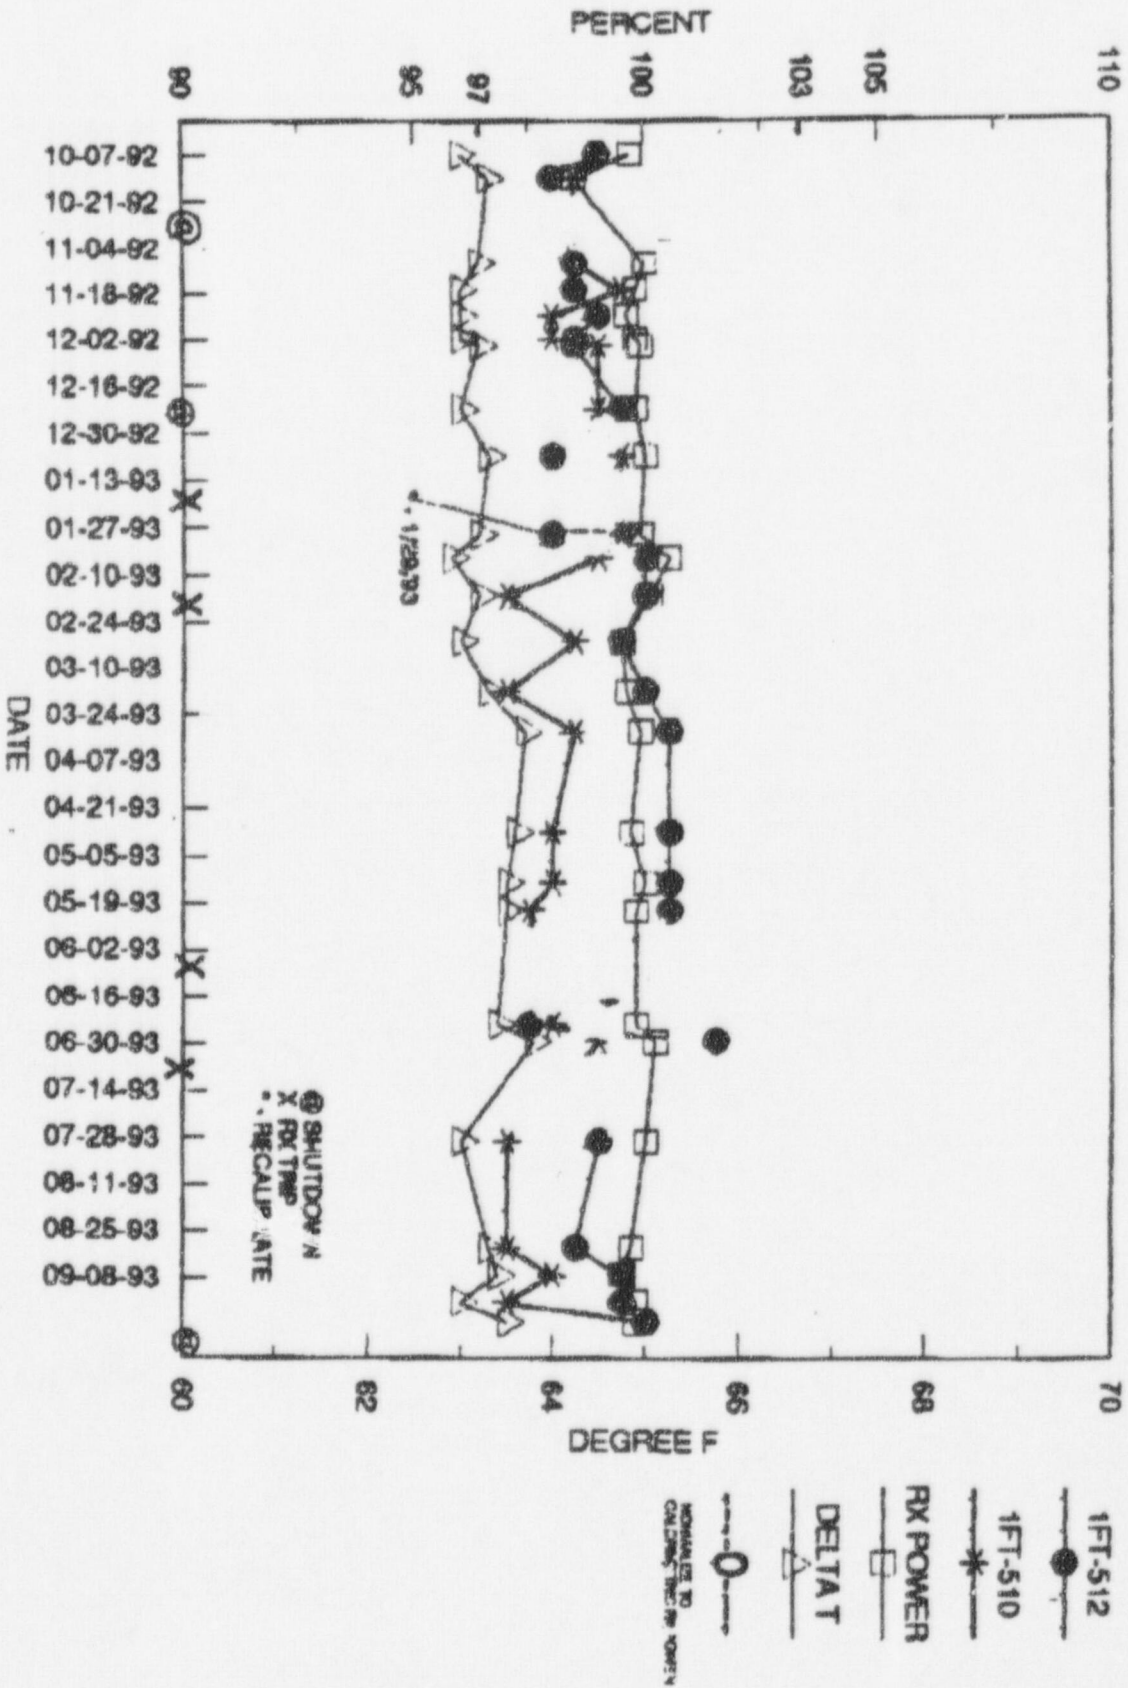
UNIT 1 STEAM FLOW - CYCLE 11, LOOP 11 - CH 1
8/15/92 - 10/1/93

Decreases in indicated steam flow have been observed after reactor trips or plant shutdown because of gas entrainment in the sensor instrument tubing on either the high or low side of the sensor/transmitter (see the attached Unit 1 Steam Flow - Cycle 11 graphs). With changes in pressure in the steam lines, non-condensable gases will either go into or out of solution. Horizontal or negative slopes in the sensing line can result in the collection of these entrained gases and add to sensor differential pressure error.

The main steam flow drift evaluation has determined that the most probable cause of the drift is instrument line configuration, as opposed to transmitter or sensor drift. Electrical noise associated with the steam flow signal is not considered to be a contributor to the cycling concern. Positive steam flow drift of 3% to 5% coupled with sensed process noise, not electrical noise, allows the instrument loop comparator to exceed the setpoint. It is the process noise that causes the multiple trip and reset comparator functions. The reset value for the setpoint is 1% steam flow, 40 mvdc, of the four volt loop span. The administrative limit of $\pm 3\%$ discussed above has minimized this cycling concern.

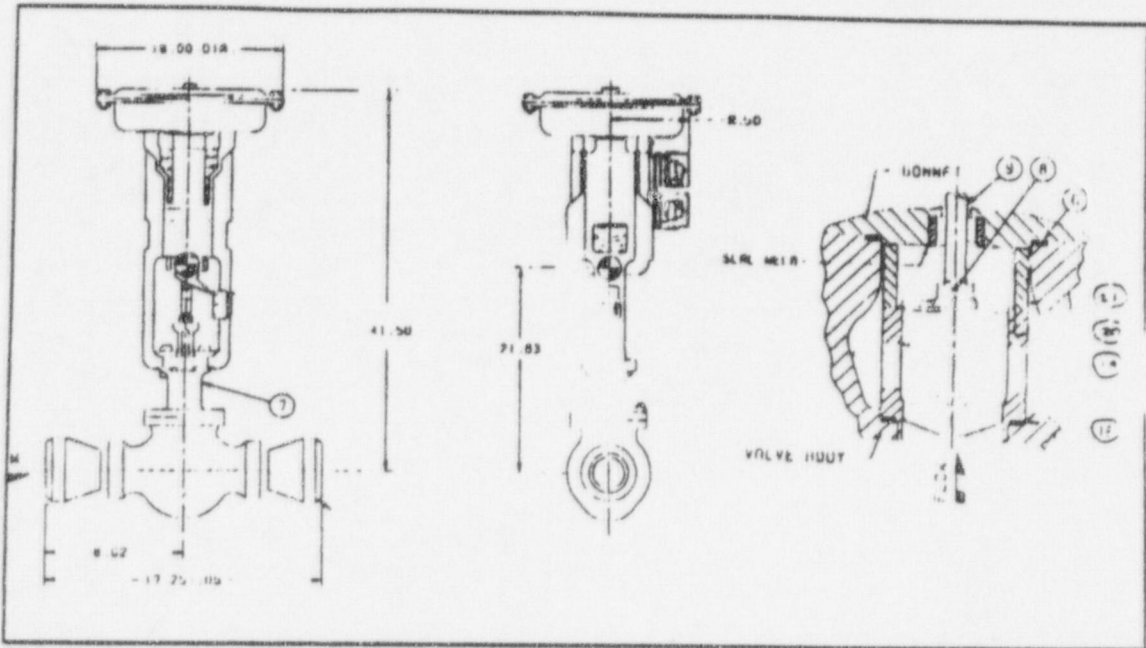
Figure 1. Pressure Operated Relief Valve

Although the PORVs functioned as designed during the April 7, 1994 event, they were subsequently disassembled and inspected. Following disassembly three concerns were identified with the PORVs. Both 1PR1 and 1PR2 exhibited cracking on the pinning boss which contained the anti-rotational pin. 1PR2 had galling at the stem and both valves had scuffing in the plug and cage area. A detailed root cause analysis was initiated to address all concerns with the PORVs.

The cracks in the pinning boss were determined through metallographic examination to be intergranular stress corrosion cracking (IGSCC). The extent of cracking was similar in 1PR1 and 1PR2, extending from the top of the pinning boss, above the anti-rotation pinhole and continuing down to just below the top of the plug. The crack in 1PR2 was about 1/16 inch shorter than 1PR1.

We have concluded that the existing configured 420 stainless steel trim assemblies will be removed from 1PR1 and 1PR2. We have initiated a design change package to re-install trim assemblies similar to the materials utilized prior to 420 stainless steel (316 stainless steel stellite plug with a 17-4 stainless steel cage).
