ULNRC-3045

**DOCKET NUMBER 50-483
CALLAWAY PLANT UNIT 1
FACILITY OPERATING LICENSE NPF-30
LICENSEE EVENT REPORT 94-002-00
TECH SPEC 3.5.2 VIOLATION AND SUBSEQUENT ENTRY INTO
TECH SPEC 3.0.3 DUE TO LEAKING BORON
INJECTION TANK RELIEF VALVE EM8852**

TITLE (4) **Tech Spec 3.5.2 Violation and Subsequent Entry Into Tech Spec 3.0.3 Due to Leaking Boron Injection Tank Relief Valve EM8852**

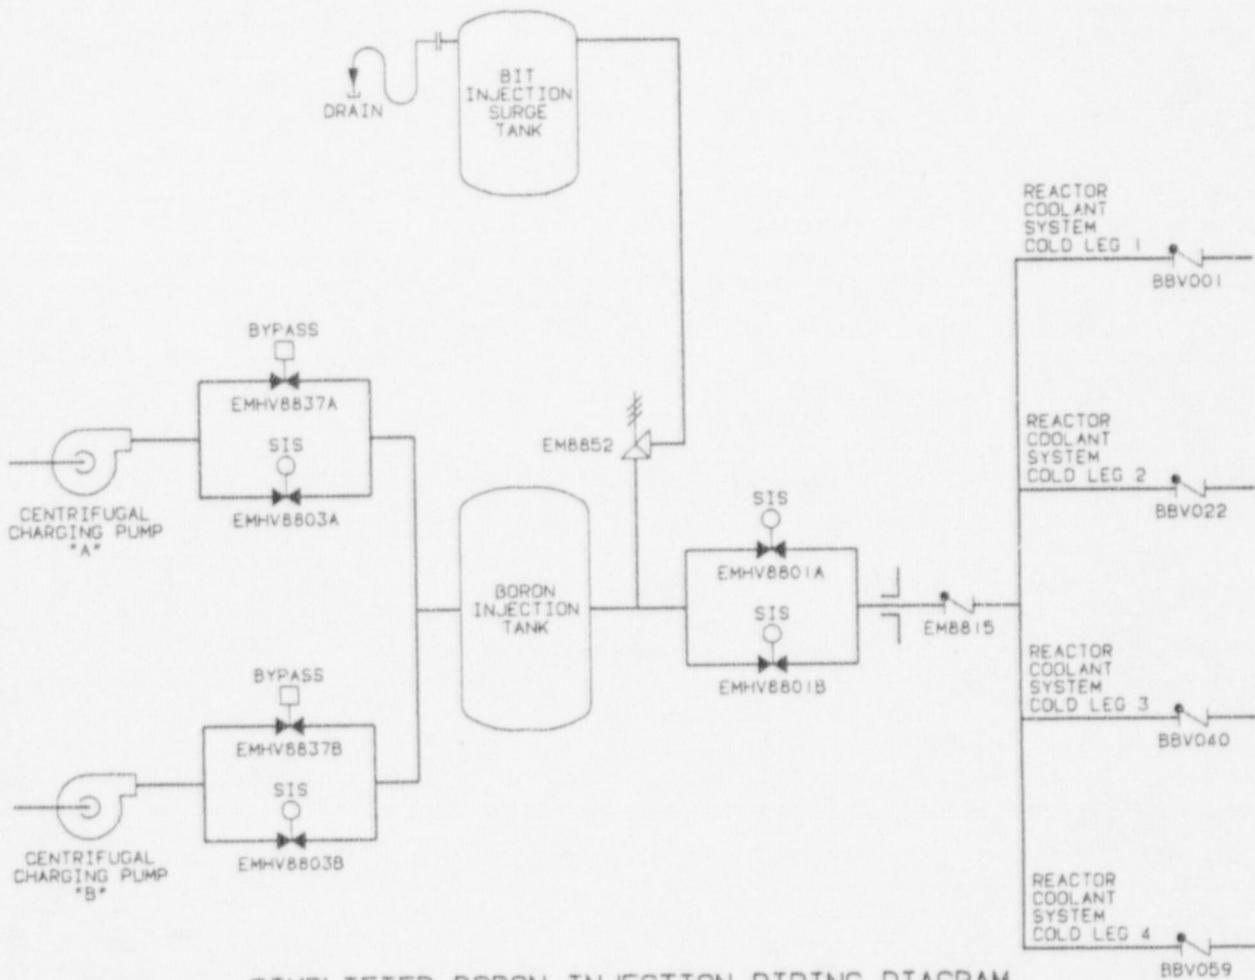
Figure 1

On 4/22/94 during routine rounds, a utility equipment operator discovered a small trickle of water running from a tygon hose which was routed from the BIT surge tank to a floor drain in the BIT room. Investigation by utility engineers determined the source of this water was seat leakage past BIT relief valve EM8852. During times when the Centrifugal Charging Pumps (CCP) were in operation, water was leaking past the seats on BIT supply bypass isolation valves EMHV8837A and EMHV8837B⁽³⁾, entering the BIT, leaking through EM8852 to the BIT surge tank and out the tygon hose referenced above. (See Figure 1)

The root cause of this event was seat leakage past BIT relief valve EM8852 of approximately 0.69 gpm. Entry into T/S 3.0.3 was made to avoid a shutdown and cooldown transient that would be imposed on the plant by an unnecessary shutdown to Mode 4 conditions and to maintain containment bypass leakage into the Auxiliary Building within the 2 gpm FSAR accident assumption. The replacement of EM8852 with a blank flange was necessary to eliminate the 0.69 gpm of containment bypass leakage.

SIMPLIFIED BORON INJECTION PIPING DIAGRAM

Utility engineers determined relief valve EM8852 is no longer required since a high concentration of boric acid in the BIT has not been required and the associated heat tracing system has been disabled. EM8852 was therefore removed and replaced with a blank flange.
