LICENSEE EVENT REPORT (LER)

Facility Name (1) LaSalle County Station Unit 2 Docket Number (2) 0 | 5 | 0 | 0 | 0 | 3 | 7 | 4 Page (3) 1 | of | 0 | 5

Title (4) Defective Low Pressure Core Spray Minimum Flow Switch

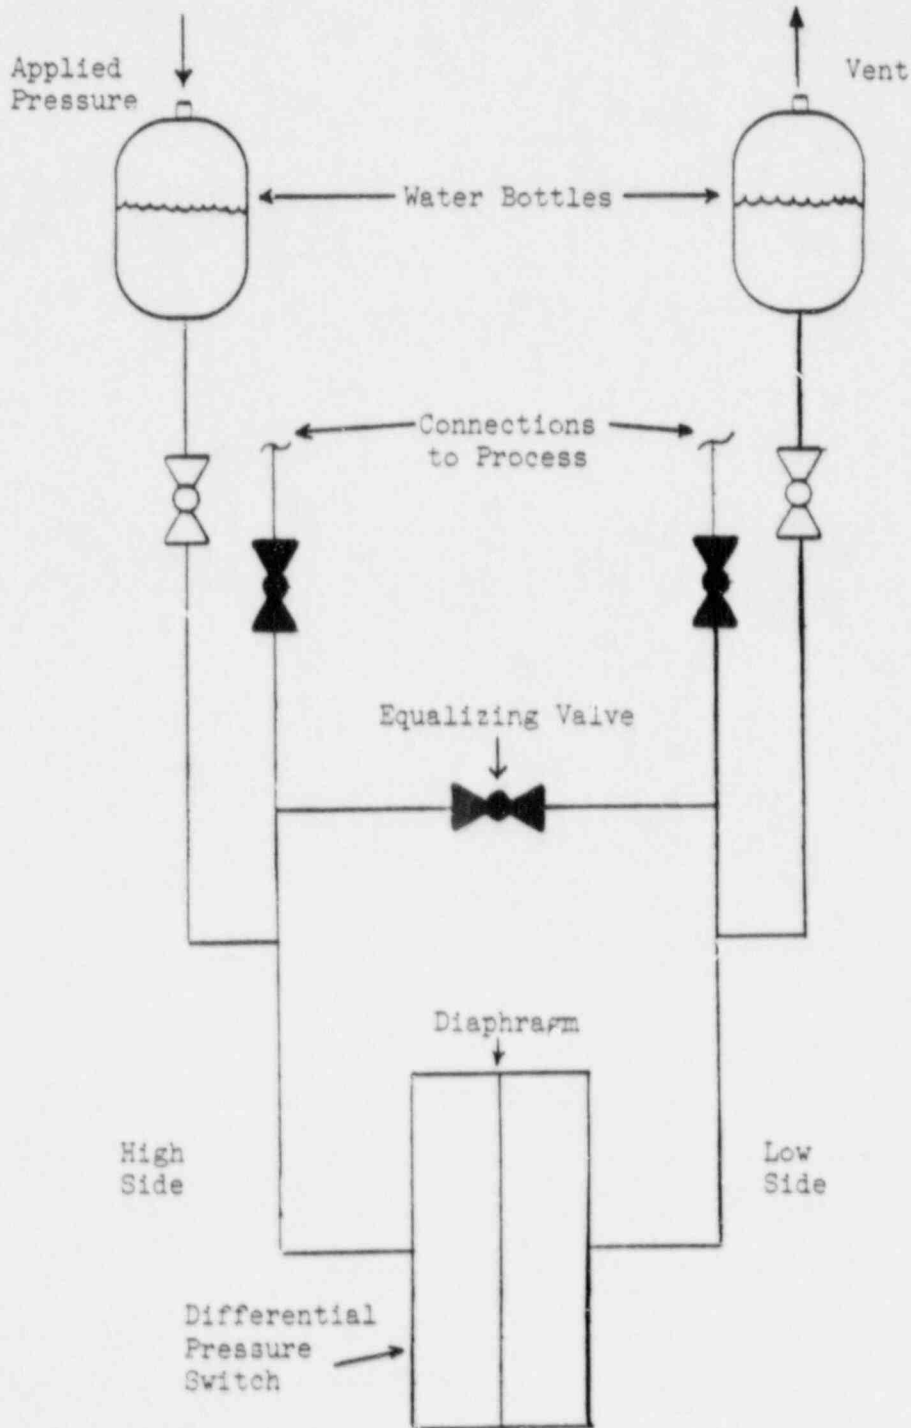
FIGURE 1

The calibration procedure calls for checking the leakage integrity of the switch by maintaining a differential pressure approximately equal to the switch setpoint (23 inches of water column) between the high and low pressure sides of the switch. The test configuration for this leakage integrity check is shown in Figure 1. When this leakage check was performed, the water level in the high side bottle was observed to slowly decrease while the water level in the low side bottle was observed to slowly increase. It was thought that this may have been due to a leaking equalizing valve, so the technician connected the water bottles directly to the instrument ports and checked for leakage again. The same behavior was observed, indicating leakage through the switch's internal components. Further testing was done to qualify the nature of the leak. The water bottles were left installed with approximately 1 inch of water column ("WC) differential pressure applied. After one hour, no change in water levels was observed. The differential pressure was then raised to approximately 27 "WC and a slow leakage was observed. No leakage was observed for an equal differential pressure applied in the reverse direction (i.e., from the low side to the high side of the switch).

CONFIGURATION OF TEST EQUIPMENT FOR LEAKAGE INTEGRITY CHECK
