Serving The Best Location in the Nation
PERRY NUCLEAR POWER PLANT

February 12, 1988
PY-CEI/OIE-0303 L

Perry Nuclear Power Plant
Docket No. 50-440
MSIV Solenoid Testing Update

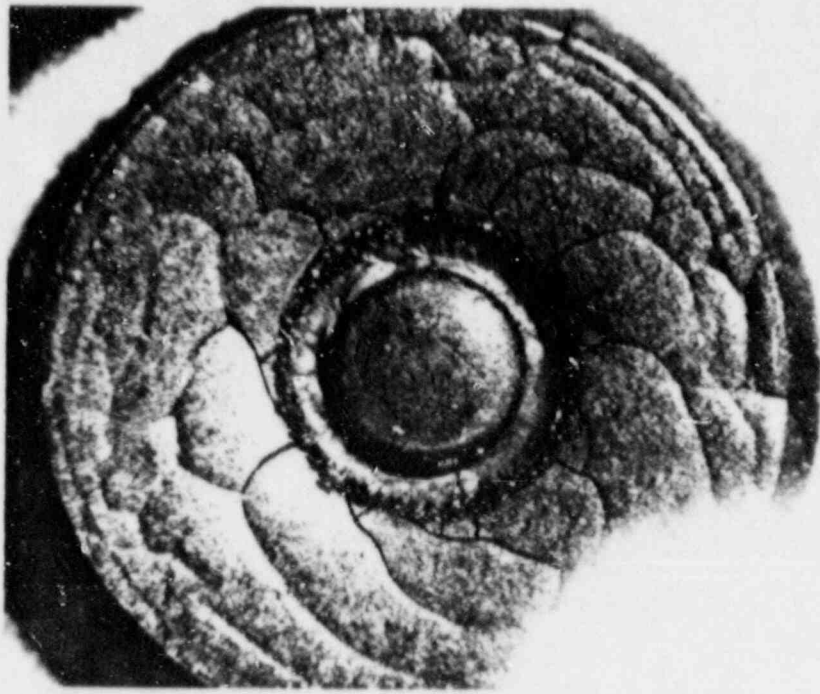
DISC HOLDER SEAT
"B" SIDE

The radiographs from test specimen 7 ("A" coil was energized and "B" coil de-energized) indicated sticking or binding had occurred on the core to the solenoid base sub-assembly. Visual inspection during disassembly was conducted at Ricerca utilizing the troubleshooting work order previously developed and microscopic photos indicates that sticking may have occurred on the disc holder seat to the "B" side port hole of the solenoid body (See attached photos of the solenoid internals). Further evaluation/analysis is planned for the solenoid elastomers and results will be included in a future update or the final report.
