NUREG-0040
Vol. 21, No. 1

Licensee Contractor and Vendor Inspection Status Report

Quarterly Report
January-March 1997

U.S. Nuclear Regulatory Commission
Office of Nuclear Reactor Regulation

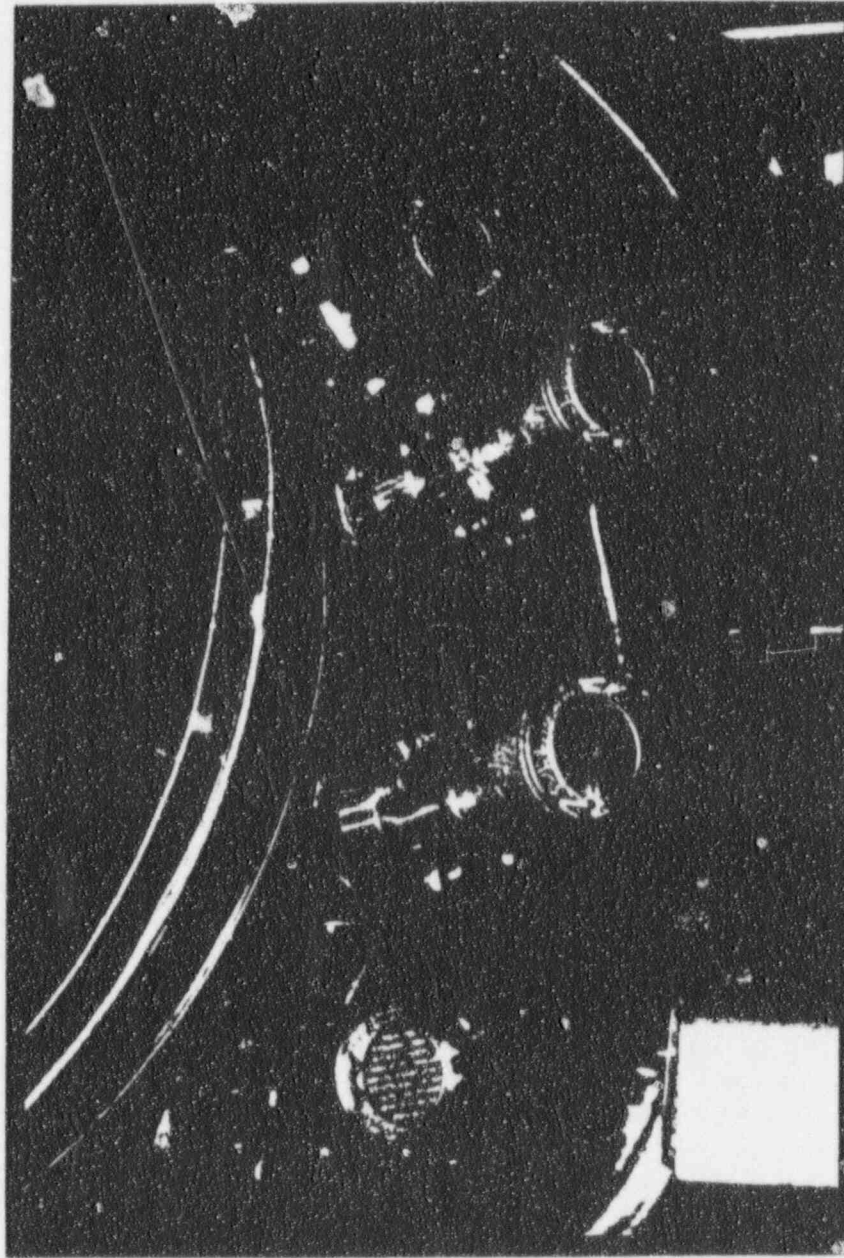
Figure 1

transducers for the leading edge flow meter (LIFM) Model 601 or Model 8300 mounted on spool piece welded to feedwater pipe.

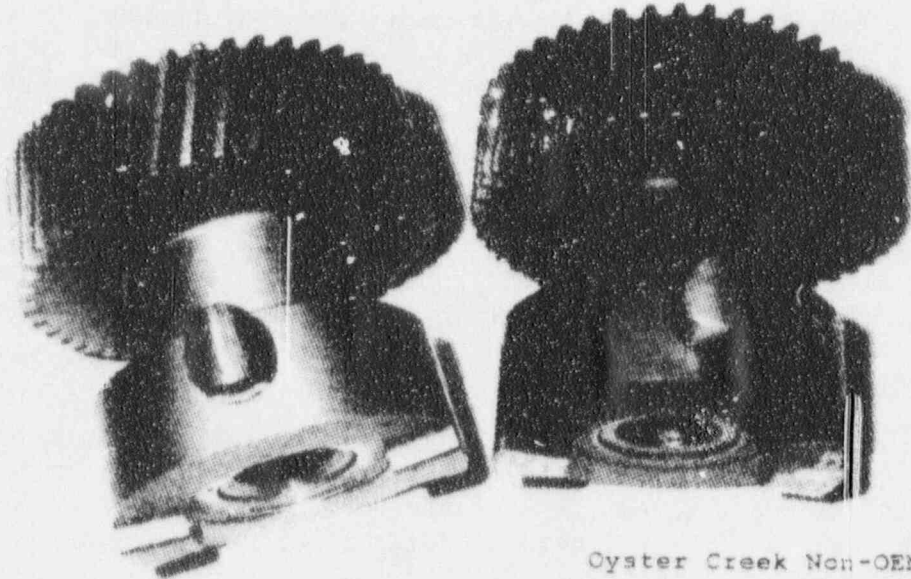
Figure 1 - Worm Shaft Clutch Gear (Plan View)

Limatorque Original Part

Oyster Creek Non-OEM Gear
