NUREG/CR-4674  
ORNL/NOAC-232  
Vol. 20

# Precursors to Potential Severe Core Damage Accidents: 1993 A Status Report

Appendices E and F

Oak Ridge National Laboratory

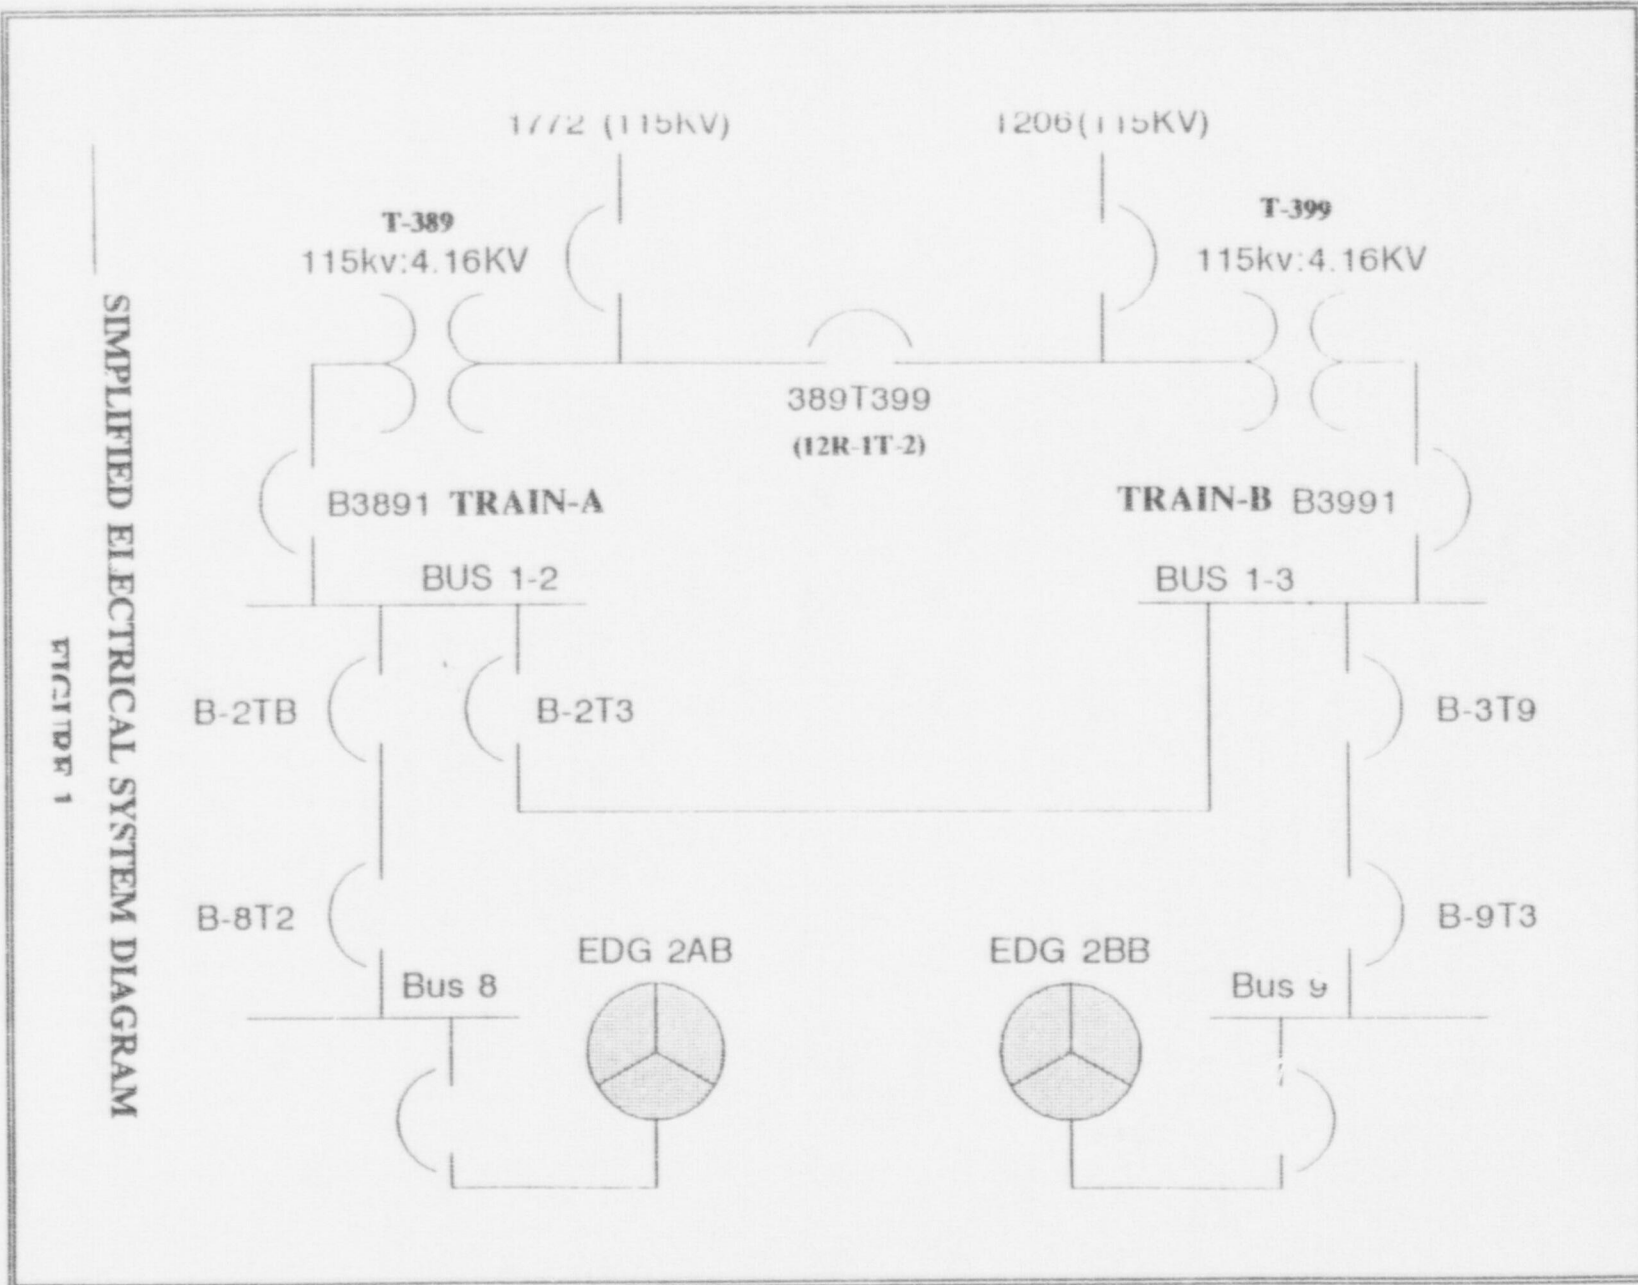
FIGURE 1

SIMPLIFIED ELECTRICAL SYSTEM DIAGRAM

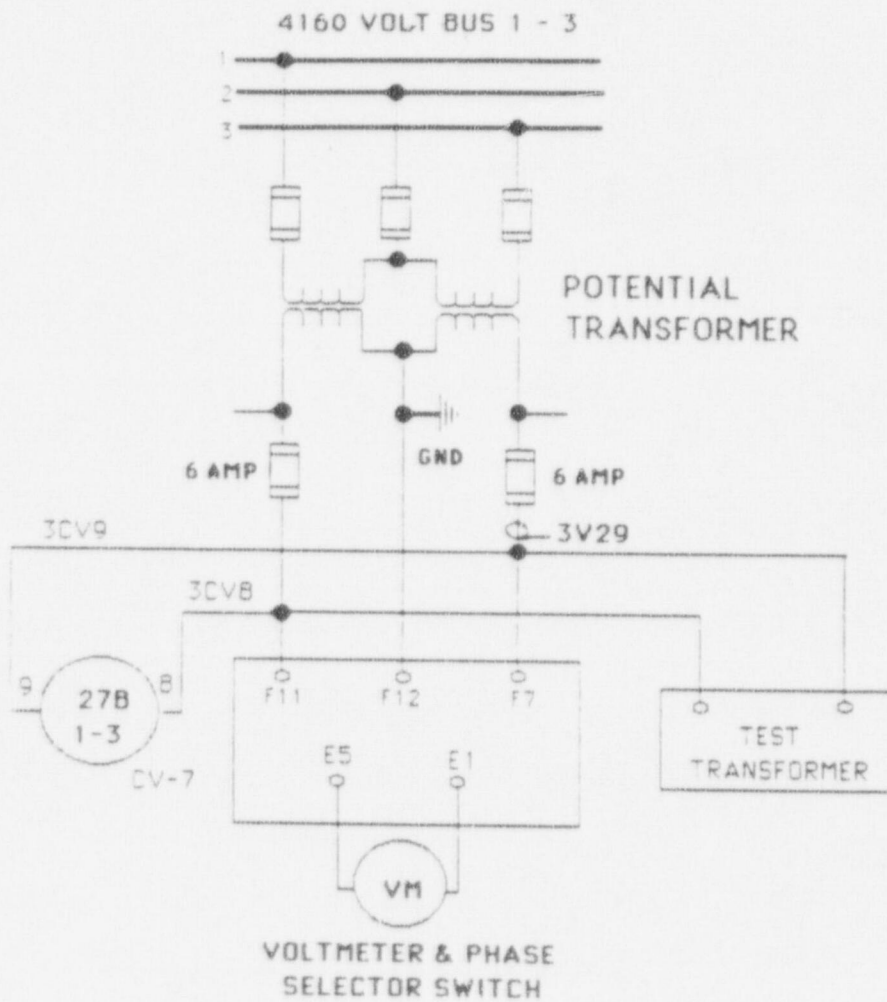
FIGURE 2

### BUS 1-3 PT CIRCUIT & UNDERVOLTAGE TRIP SCHEME

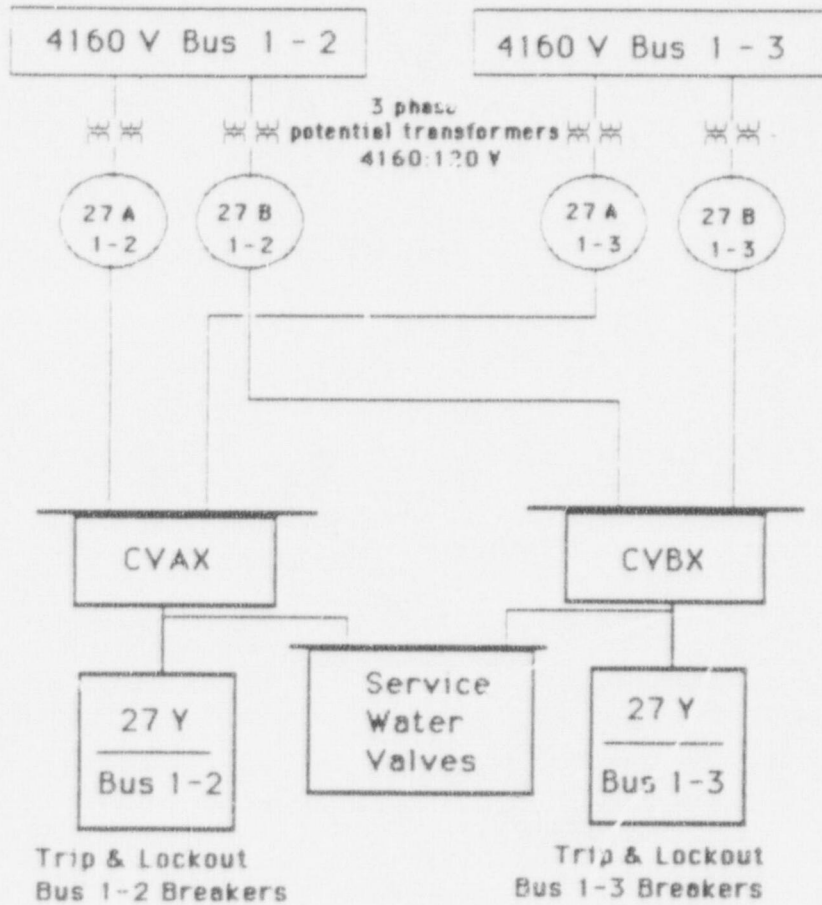
FIGURE 3

BUS 1-2/1-3 UNDERVOLTAGE LOGIC

JUNE 26 LOSS OF POWER EVENT

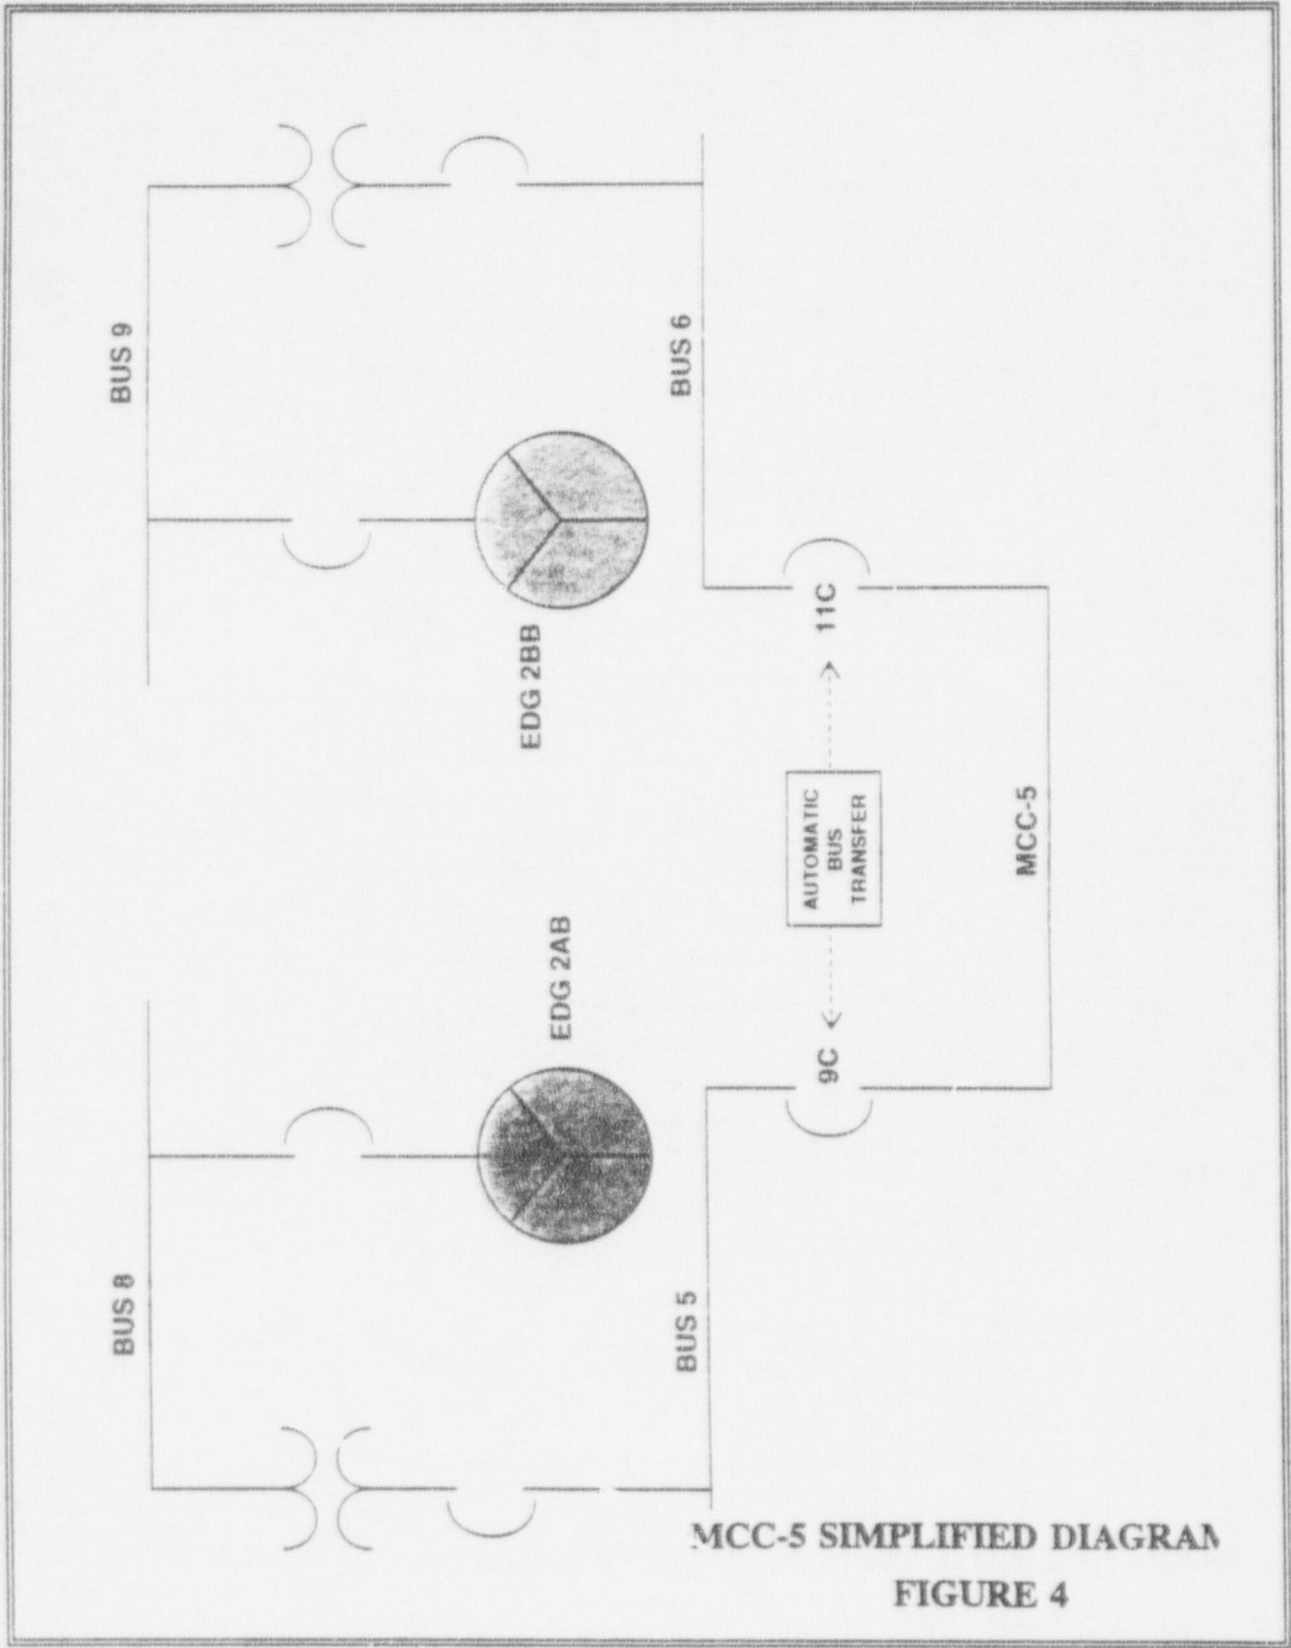
- THE FUNCTION OF MCC-5 IS VERY SIGNIFICANT TO OVERALL PLANT SAFETY.
- TEAM INDEPENDENTLY VERIFIED MOST LIKELY CAUSE OF FAILURE.
- THE EVENT CLASSIFICATION ERROR WAS AN INDIVIDUAL PERFORMANCE ISSUE.
- TROUBLE-SHOOTING AND TESTING CONDUCTED WAS APPROPRIATE.
- ACTIONS TAKEN TO RESTORE MCC-5 WERE APPROPRIATE.
- THE FORMAL ROOT CAUSE EVALUATION WAS THOROUGH.
- SHORT TERM CORRECTIVE ACTIONS TAKEN WERE APPROPRIATE.
- COMPENSATORY MEASURES ARE APPROPRIATE.
- ENGINEERING EVALUATION OF DESIGN.

MCC-5 SIMPLIFIED DIAGRAM  
FIGURE 4

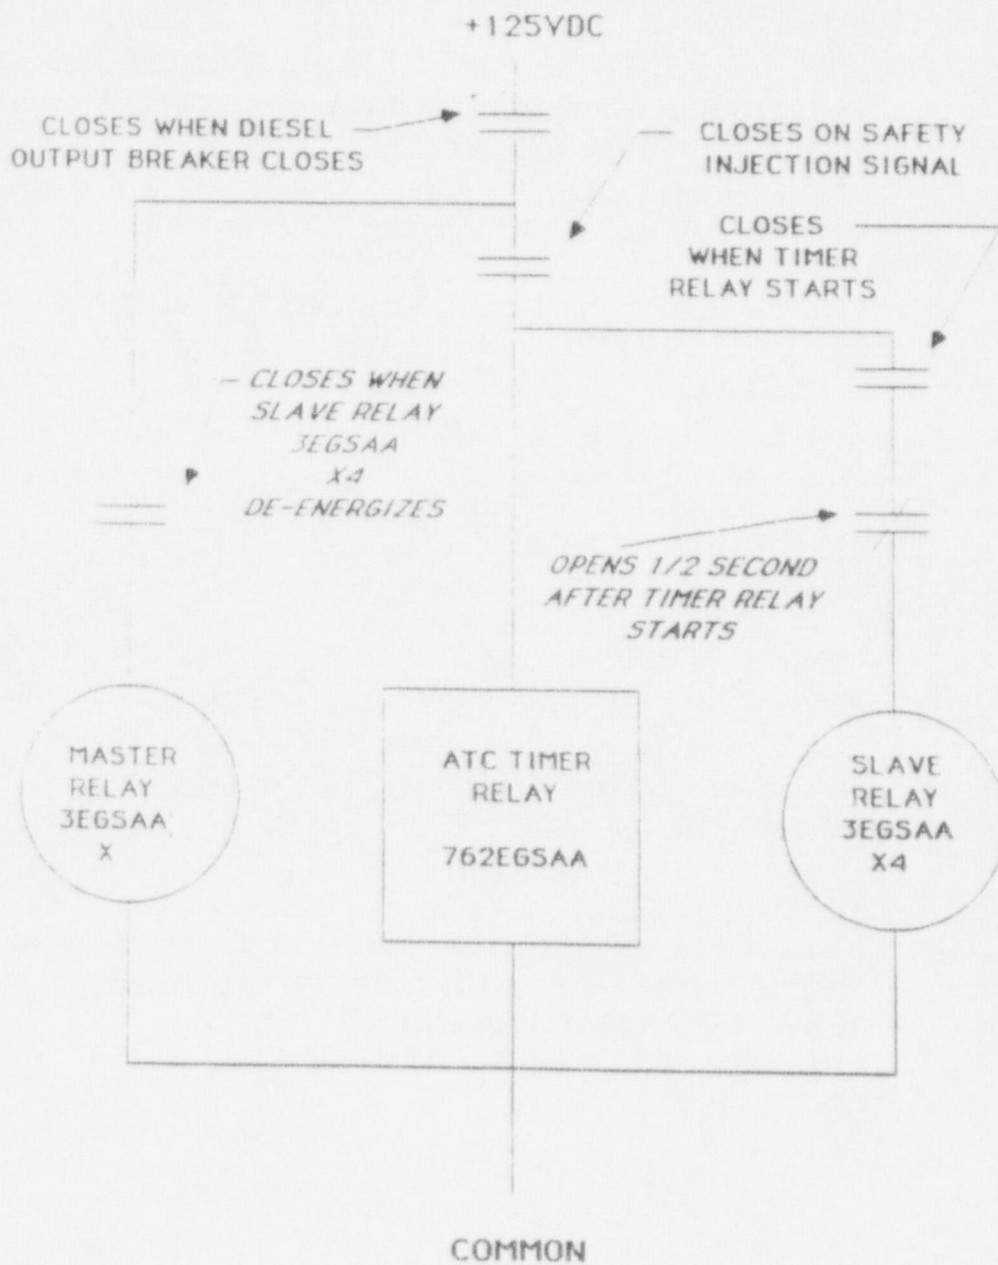
- THE TEAM DETERMINED THAT THE SAFETY SIGNIFICANCE OF THIS EVENT WAS HIGH BECAUSE A COMMON CAUSE FAILED REDUNDANT TRAINS OF SAFETY-RELATED EQUIPMENT.

DIESEL GENERATOR SEQUENCER LOGIC

- A NUMBER OF BENCH AND INSITU TESTS WERE PERFORMED TO DETERMINE THE CAUSES OF THE EQUIPMENT FAILURE.
- DIODES WERE INSTALLED AROUND THE SLAVE RELAYS TO REDUCED THE MAGNITUDE OF THE VOLTAGE SPIKES CAUSED BY THE DROPOUT OF THESE RELAYS.
- THREE ATC TIMER\RELAYS IN THE SEQUENCER WERE REPLACED WITH NEW TIMER/RELAYS.
- POST MODIFICATION TESTING IDENTIFIED A PROBLEM WITH THE AUXILIARY FEEDWATER PUMP STARTING LOGIC.
- ADDITIONAL SEQUENCER AND PUMP STARTING LOGIC DESIGN CHANGES WERE REQUIRED TO ELIMINATE THE AUXILIARY FEEDWATER PUMP LOGIC PROBLEM.
- EXTENSIVE POST MODIFICATION TESTING OF THE LOAD SEQUENCERS WAS CONDUCTED TO DEMONSTRATE OPERABILITY AND RELIABILITY.

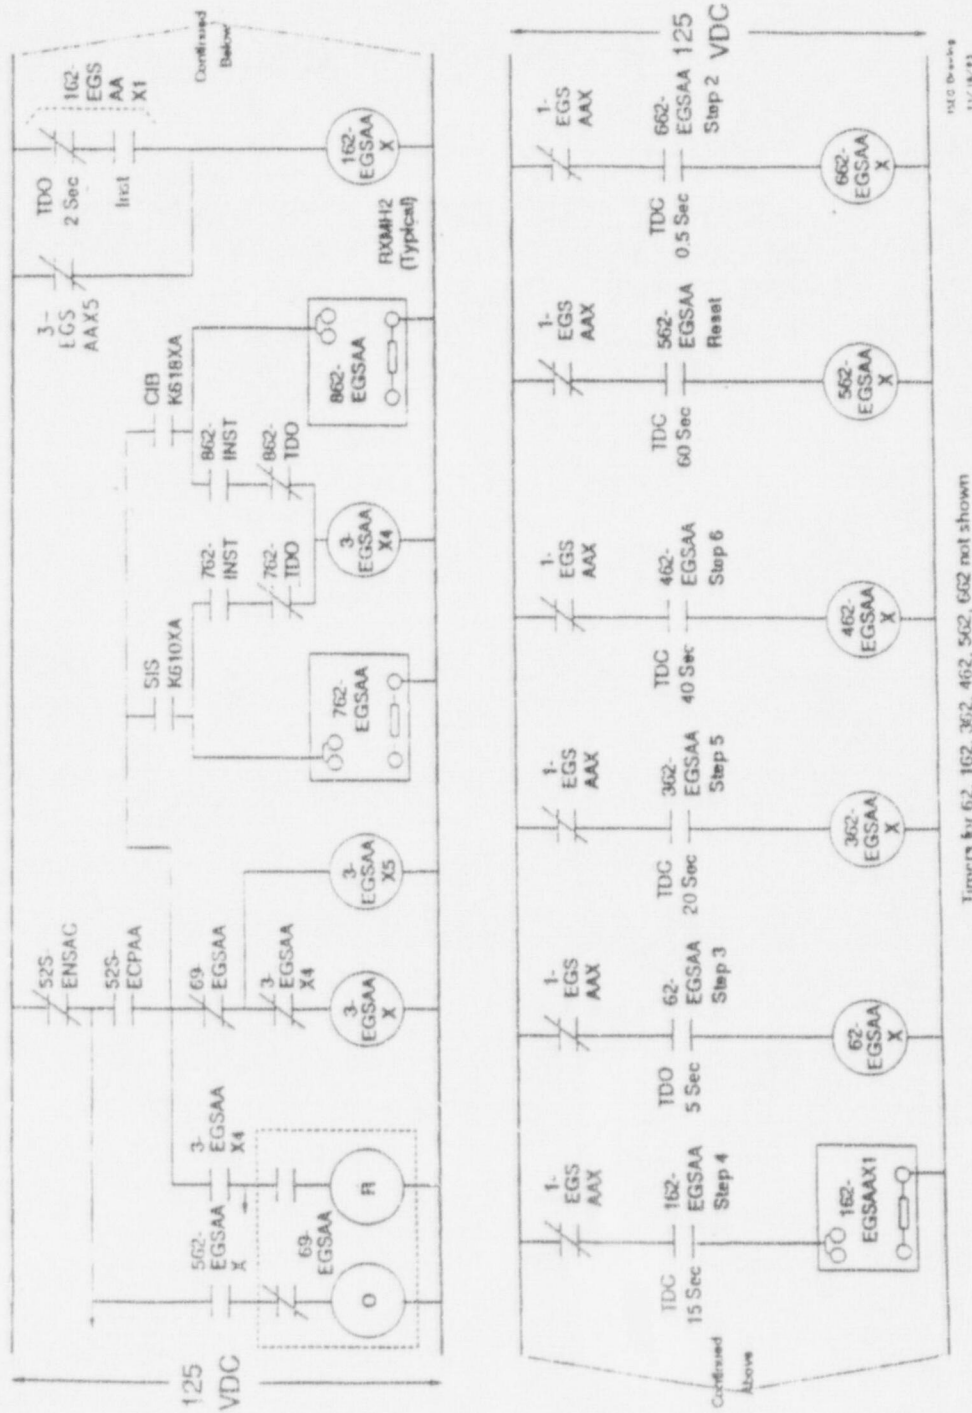
**Figure 1**  
**12241-E-12A Sh.1 (Simplified) - Before Modification**

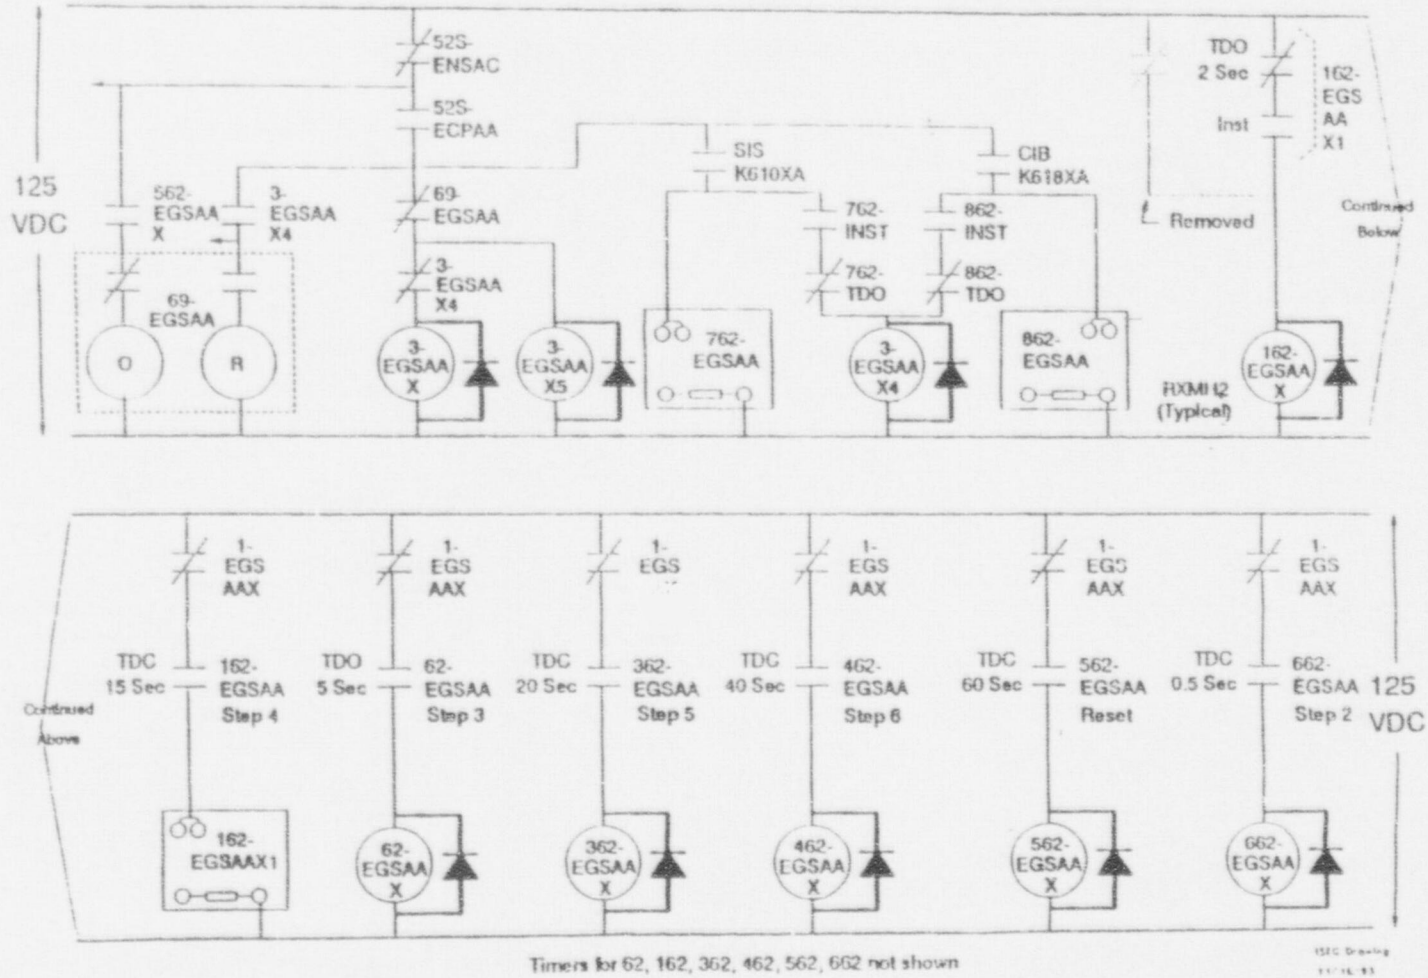
Figure 2

12241-E-12A Sh.1 (Simplified) - After Modification

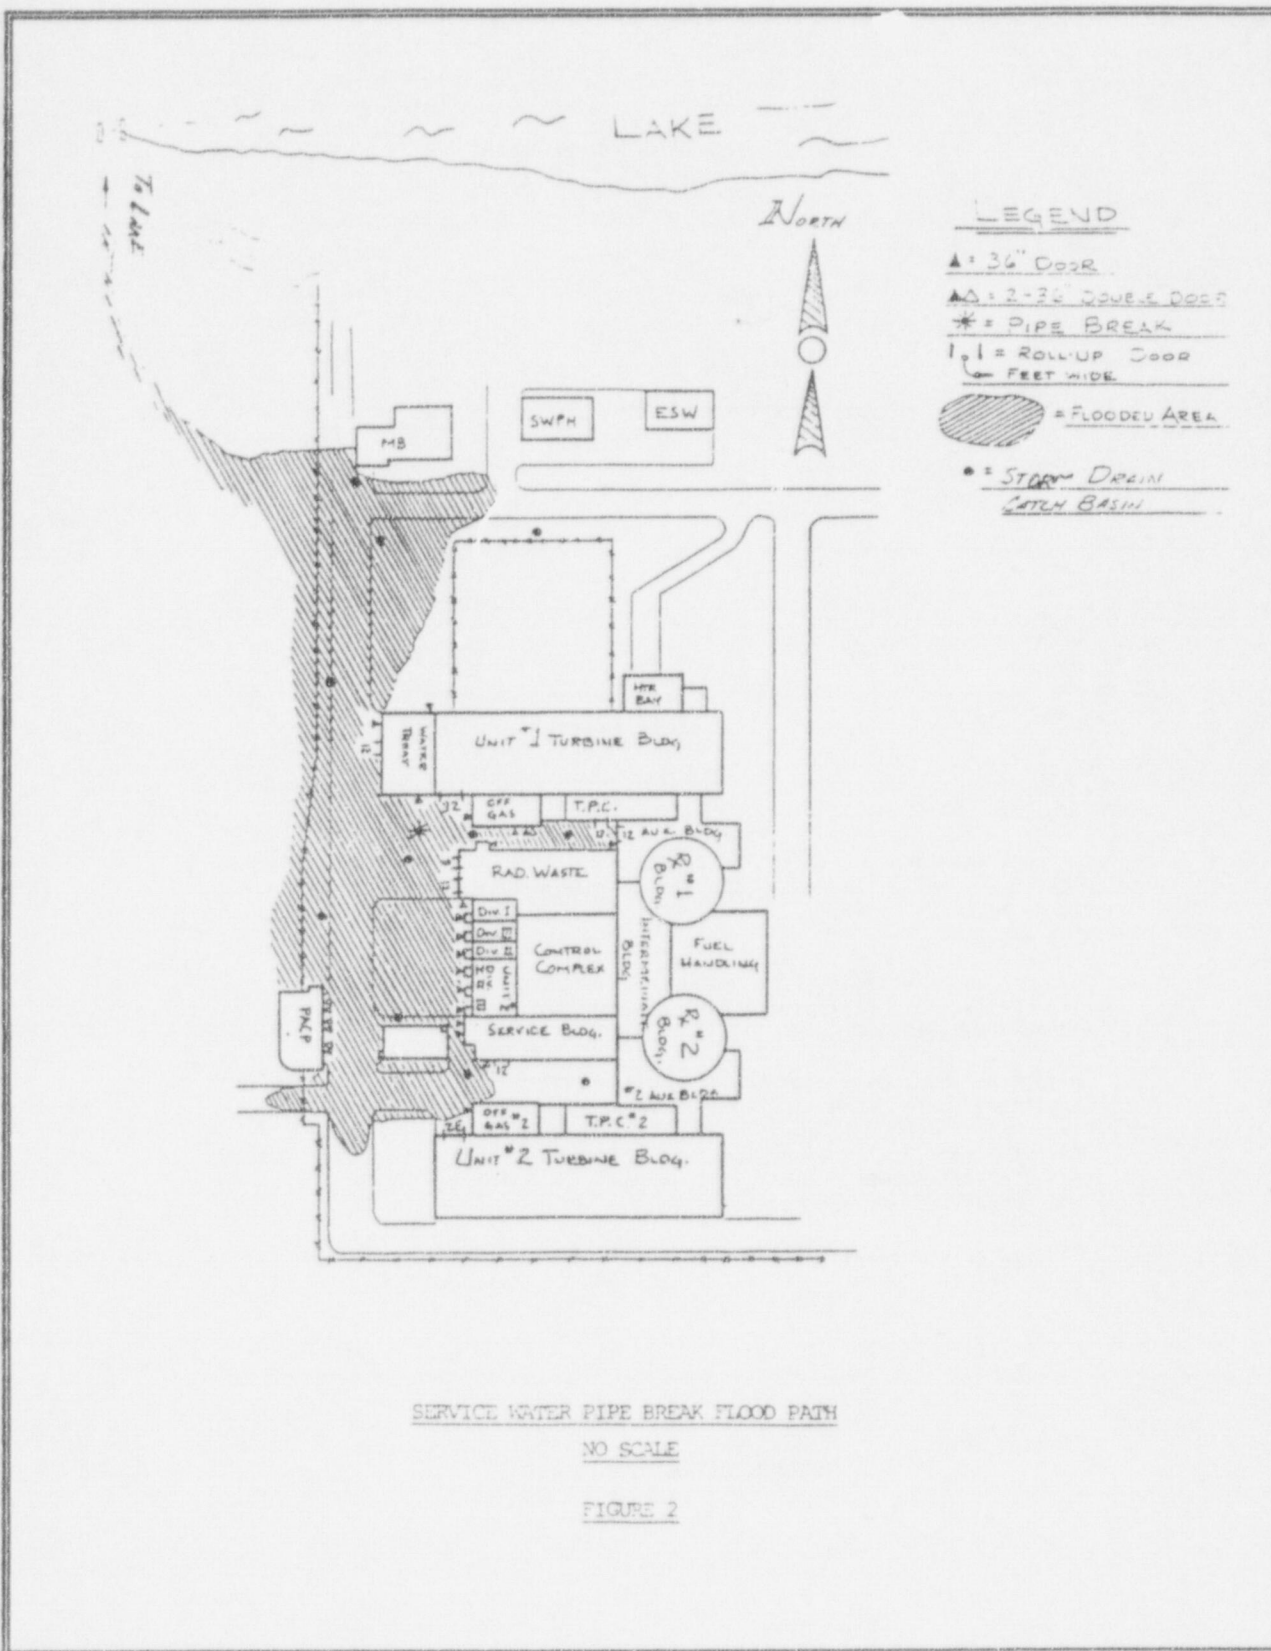
SERVICE WATER PIPE BREAK FLOOD PATH
