**Nuclear Design Information Transmittal**

Calculation No.: 5.2.2-BRW-97-0667	Page No.: 1
<input checked="" type="checkbox"/> Safety Related <input type="checkbox"/> Regulatory Related <input type="checkbox"/> Non-Safety Related	
Calculation Title: Evaluate Tendon H&ED For Broken/Unseated Wires	
Station/Unit: 2	System Abbreviation: RB
Equipment No. (if appl.):	Project No. (if appl.) 905U-63
Rev.: 0 Status: Approved QA Serial No. or Chron No.	Date:
Prepared by: R. Nampuramali <i>R. Nampuramali</i>	Date: 7/9/97
Revision Summary: Original Issue Added pages 1 thru 8 Attachment A, pages A1 thru A9 Attachment B, pages B1 and B2 Attachment C, pages C1 and C2	
Electronic Calculation Data Files Revised: (Name ext/size/date/hour: min/verification method/remarks)	
Do any assumptions in this calculation require later verification? <input type="checkbox"/> Yes <input checked="" type="checkbox"/> No	
Reviewed by: M. Valathuri <i>M. Valathuri</i>	Date: 7/9/97

PROJECT NO. 9050-63		
CALCULATION NO. 5.2.2-BRW-97-0667	REV. NO. 0	PAGE NO. 3
DESCRIPTION Unit 2 Tendon H4ED Broken Wires	PAGE NO.	SUB-PAGE N
TITLE PAGE	1	
REVISION SUMMARY	2	
TABLE OF CONTENTS	3	
PURPOSE/OBJECTIVE	4	
METHODOLOGY/ACCEPTANC

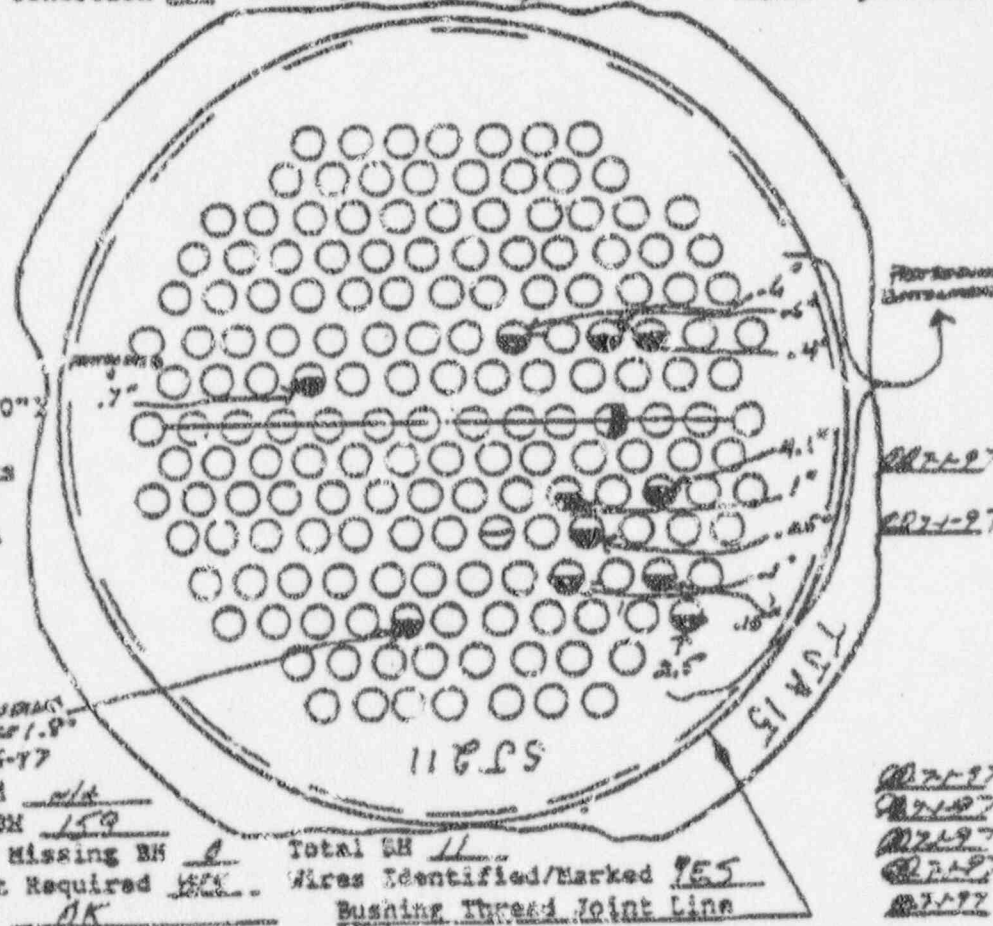
TENDON NO. H4 ED TENDON END/BUTTRESS NO. SHOP 10 UNIT 2

(8.3.7.2) Buttonheads Found all  
 (8.3.7.3) Total Effective BH 159  
 (8.6.1) Protruding BH 11 Missing BH 0 Total BH 11  
 (8.4.1.2.1) Continuity Test Required NONE Wires Identified/Marked YES  
 (8.5.1) SHIM GAPS: AS FOUND OK Bushing Thread Joint Line OK

(9.0) Reporting:  Accept  Unacceptable  Engineer Notified. NCR NO. BR97/11-001 02-1-97

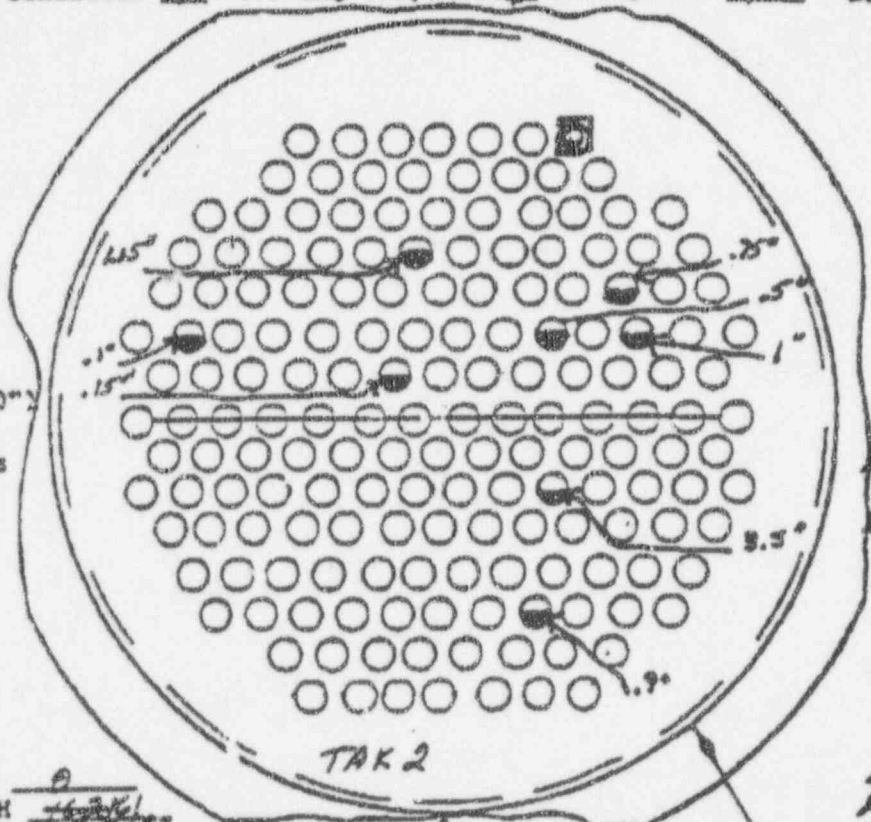
PROJECT BRAIDWOOD WATER INSPECTION SURVEILLANCE NO. 1997 YEAR 97  
 TENDON NO. H4ED TENDON END/BUTTRESS NO. FOUR/LEFT UNIT 2

(8.4.1) Protruding BH 8 Missing BH 1

(8.5.1) SHIM GAPS: AS FOUND 1/8
