THE MEMORANDUM RELATING TO SHIPROCK (KEER-MOGEE) MILL INCIDENT

SUBJECT: Detailed Report of Data Regarding  
Shiprock Accident.

INVESTIGATION OF THE HOLDING POND RUPTURE AT THE KERR-McGEE OIL  
INDUSTRIES, INC., URANIUM MILL, SHIPROCK, NEW MEXICO - LICENSE  
R-157, AMENDMENT 2

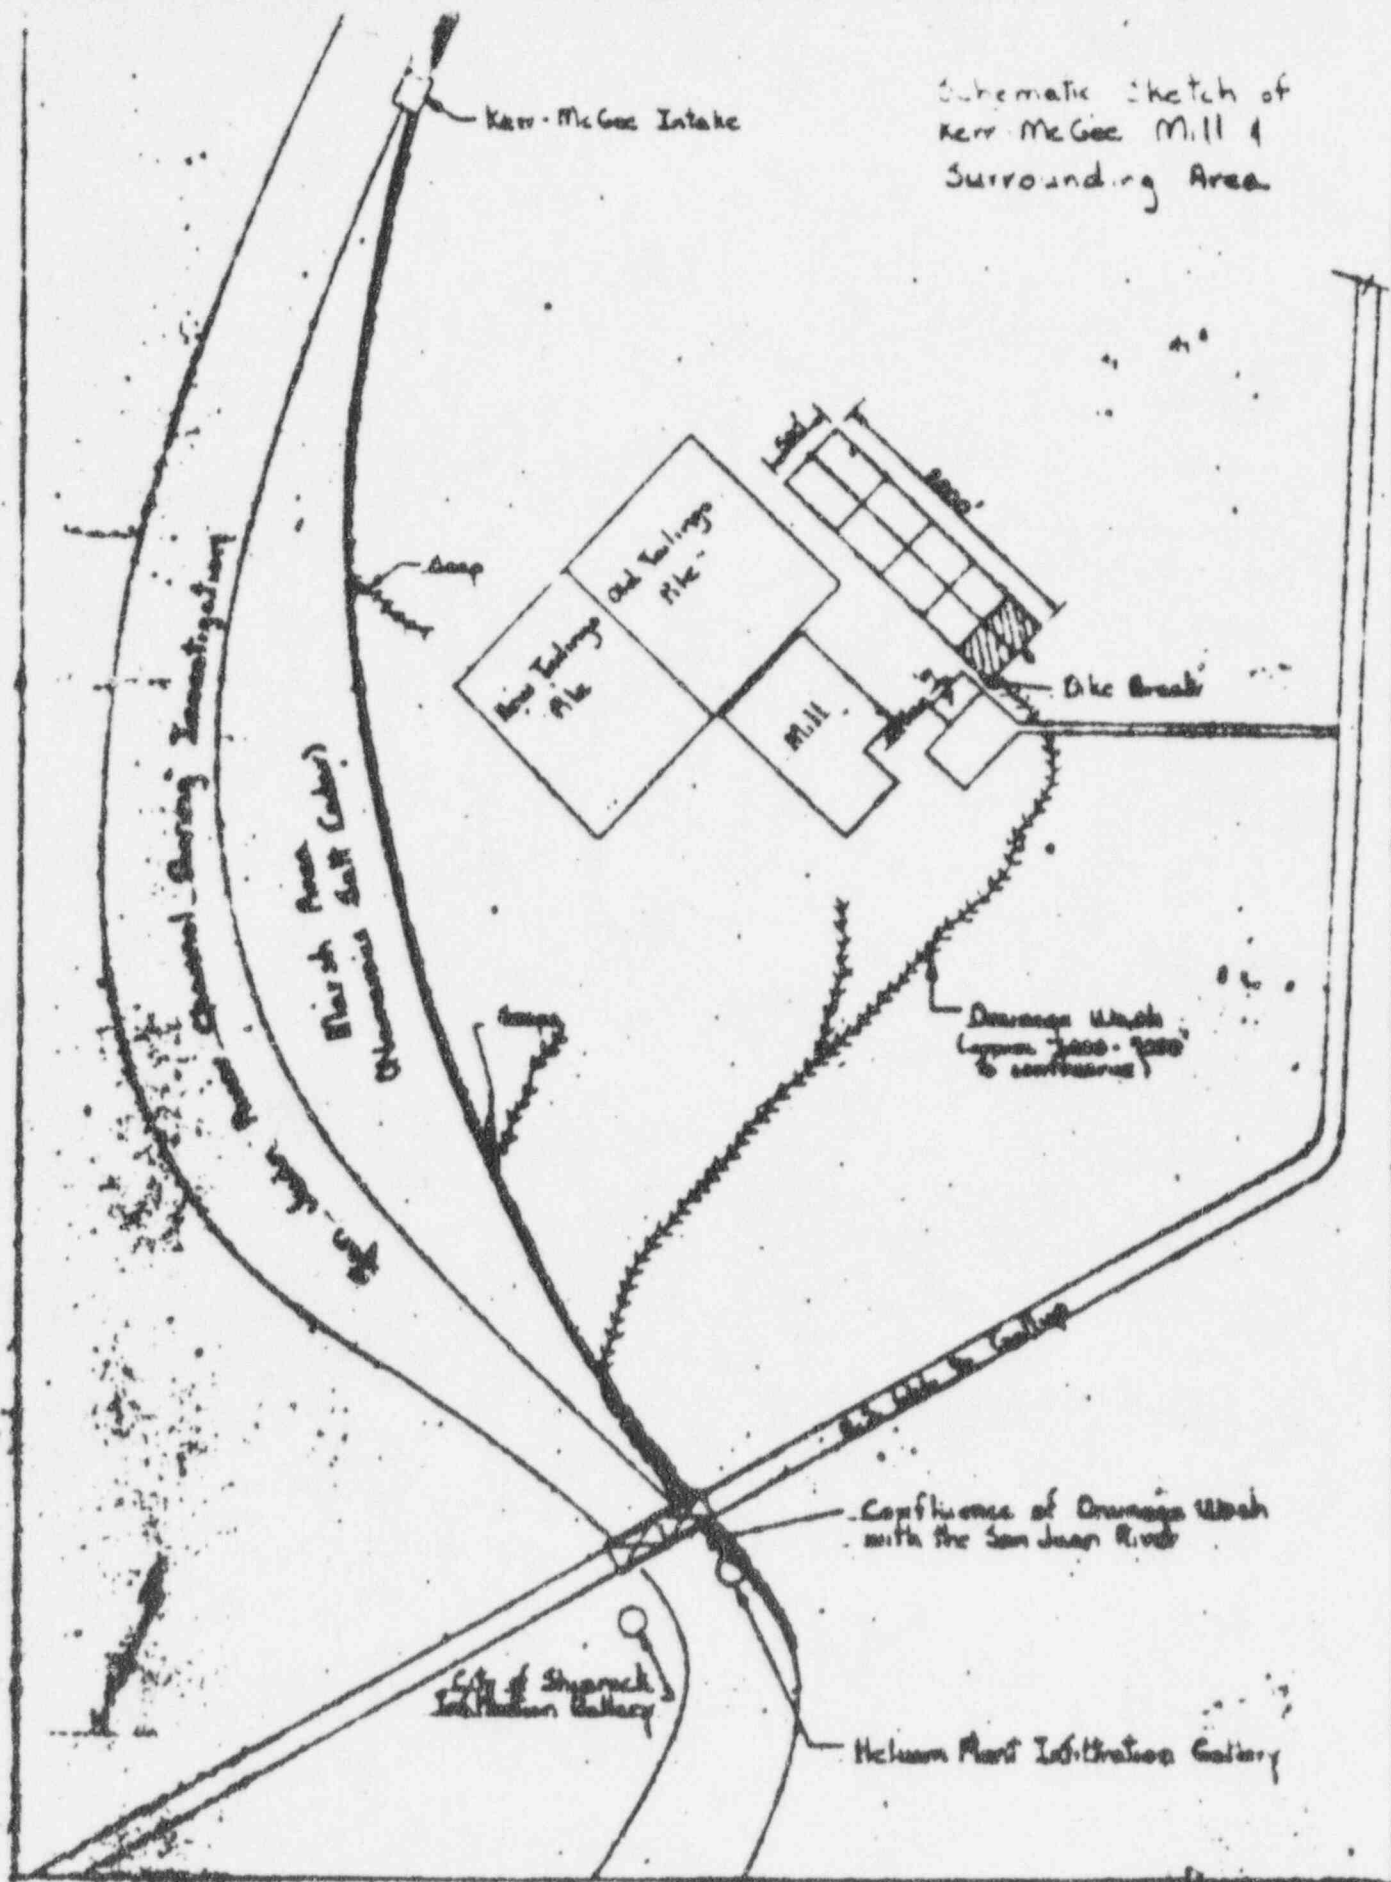
Schematic sketch of  
Kerr-McGee Mill &  
Surrounding Area

Quality and Quantity of Waste Released. Initial estimates were that some 200,000 gallons of waste were released; later estimates place the figure at about 250,000 gallons. These are the figures supplied by mill personnel and later estimated by P.H.S. and A.E.C. observers. The attached sketch map indicates the general area and route of the released material.

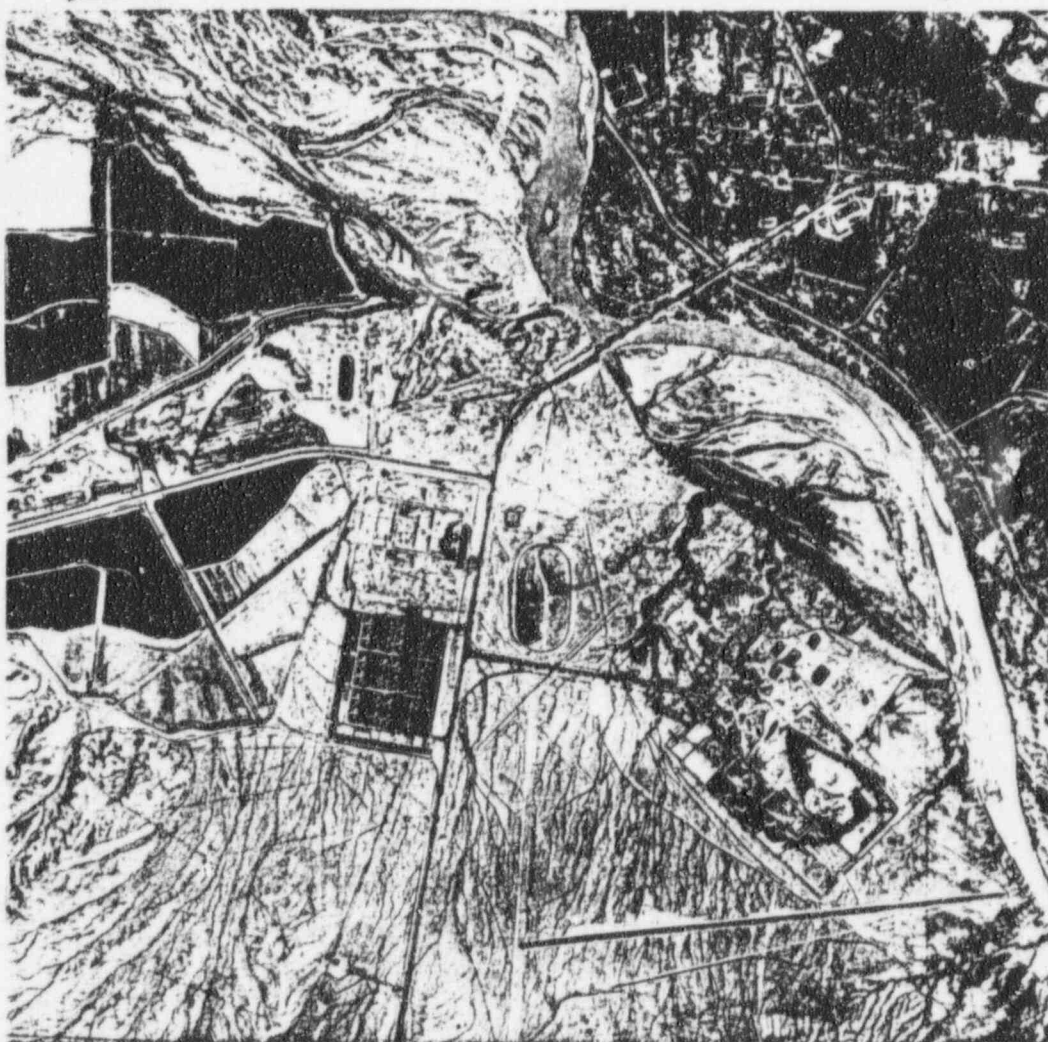
1. Aerial photograph of the mill and surrounding area. Taken in 1958. Compare with Exhibits E and F for identification.

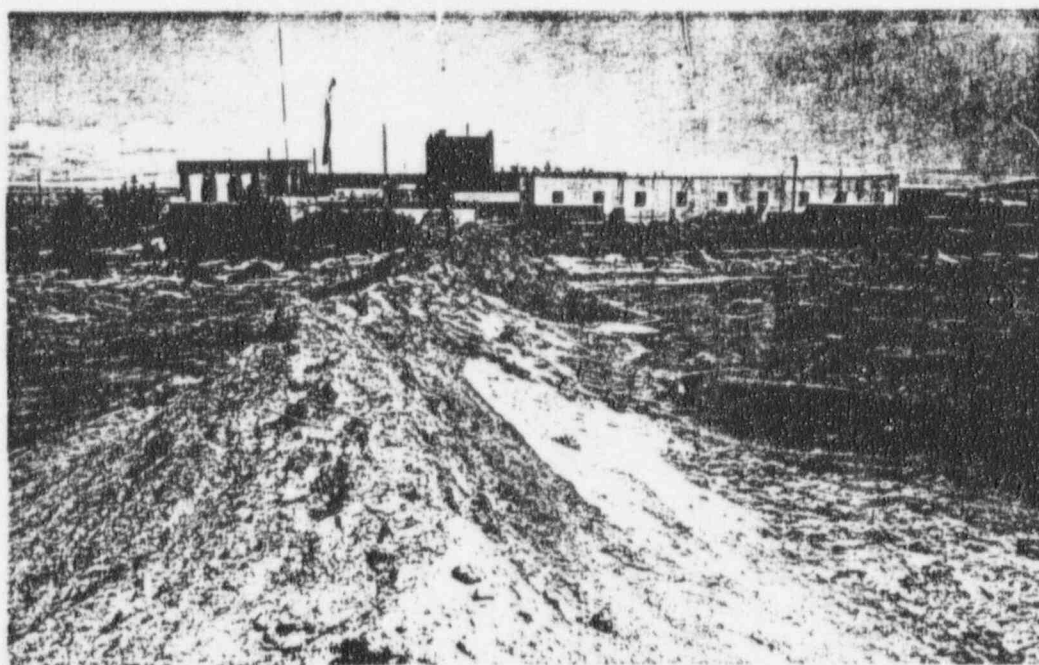
3. Retaining wall of holding Pond #1 - note repaired area in upper corner of pond - note the water line marked by the arrow.

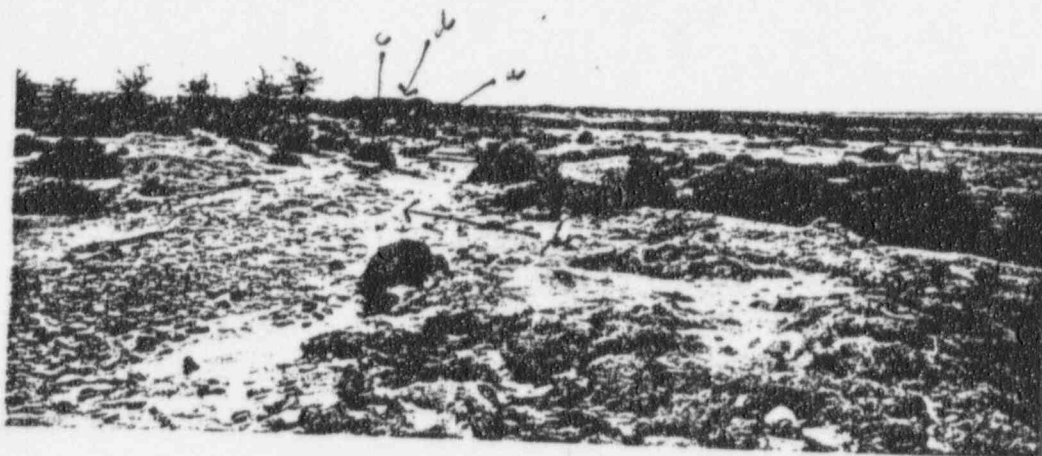
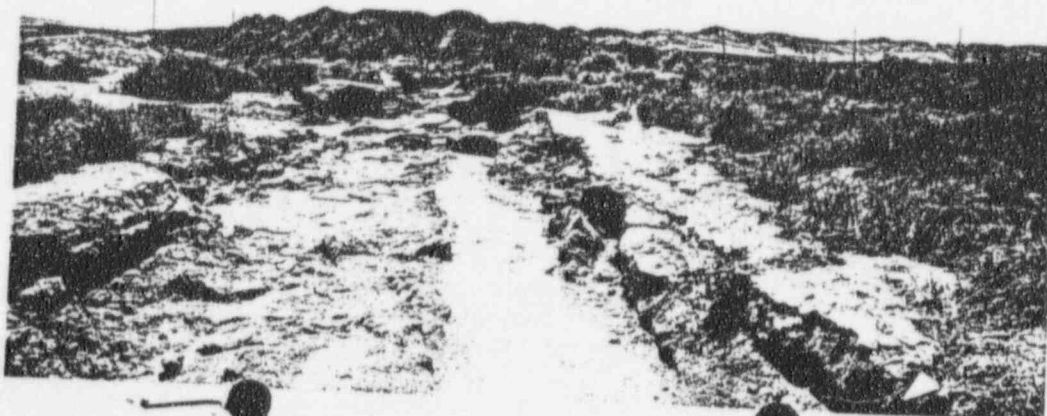
4. Photograph taken from road showing:
- (a) the eroded stream bed down which the raffinate probably flowed
  - (b) the cooling water stream
  - (c) the probable point of confluence of the cooling water and the raffinate
  - (d) the repaired area of the holding pond retaining wall
5. The eroded area through which the raffinate probably flowed. Note the retaining wall and the size of the eroded area.

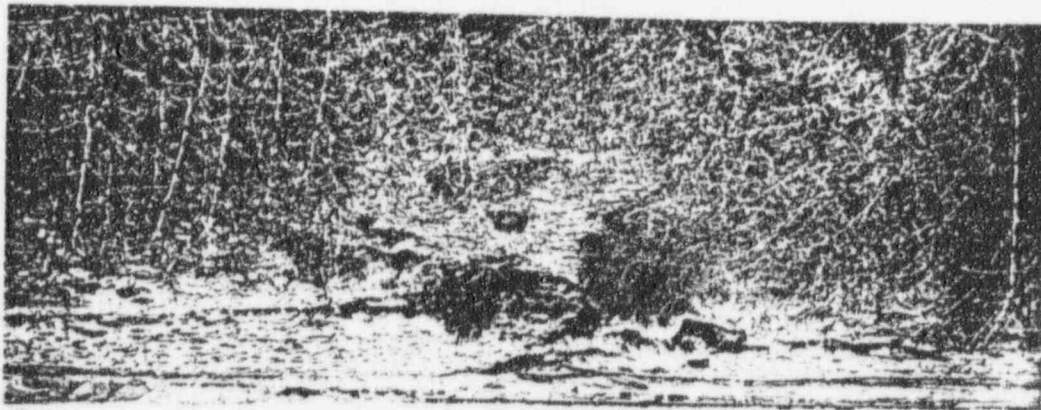
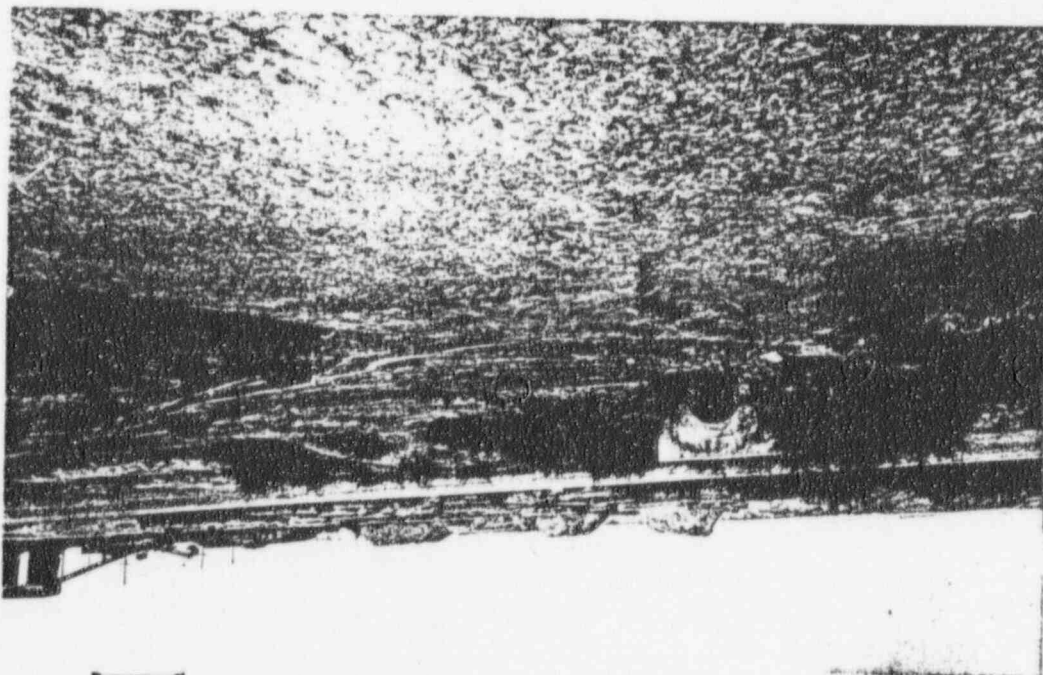
6. Culvert through which karst water had to flow to reach river - note the height and dam like qualities of the road bed.
7. Photograph taken from the road showing the cooling water stream after it passes through the culvert.

We recommend that the Division of Licensing and Regulation seriously consider that the licensee be required to install a flood gate on the culvert or a secondary retaining dike to prevent a recurrence of this incident with respect to the same or other ponds. If a flood gate is installed on the culvert, the licensee should be required to keep it closed except when local rains necessitate the use of the arroyo for drainage; at these times, a close watch should be kept on the holding pond retaining walls.

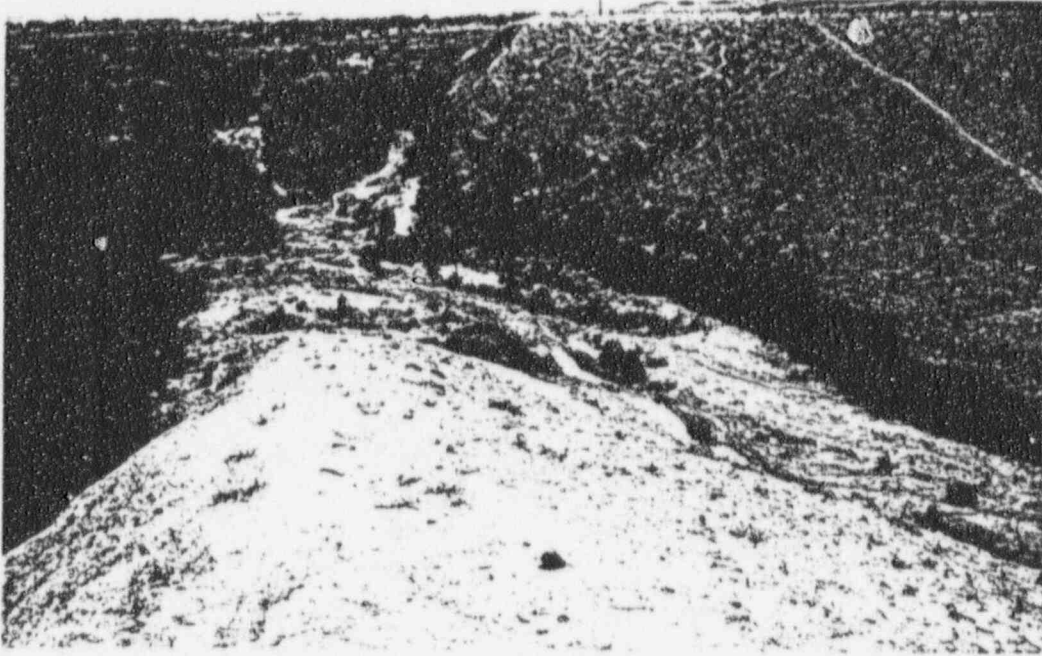
8. Area where the cooling water stream enters the dry river bed.

9. Cooling water stream as it flows along the river bottom.

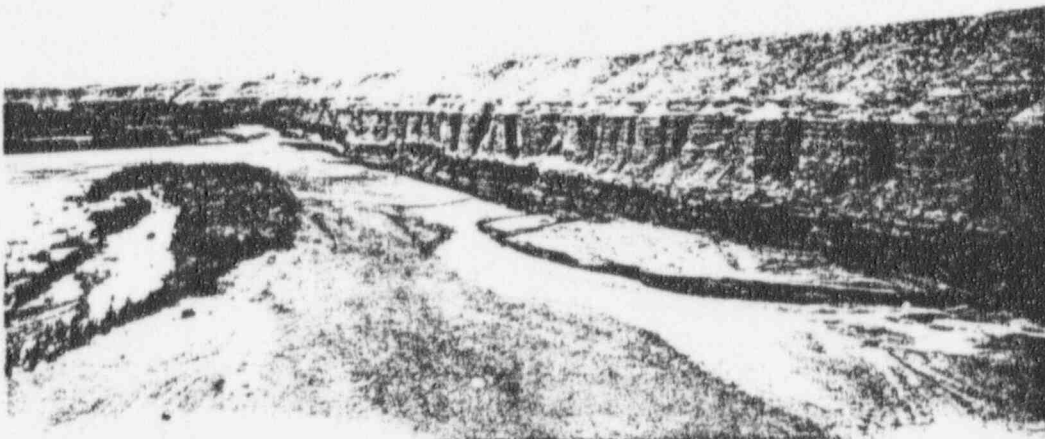
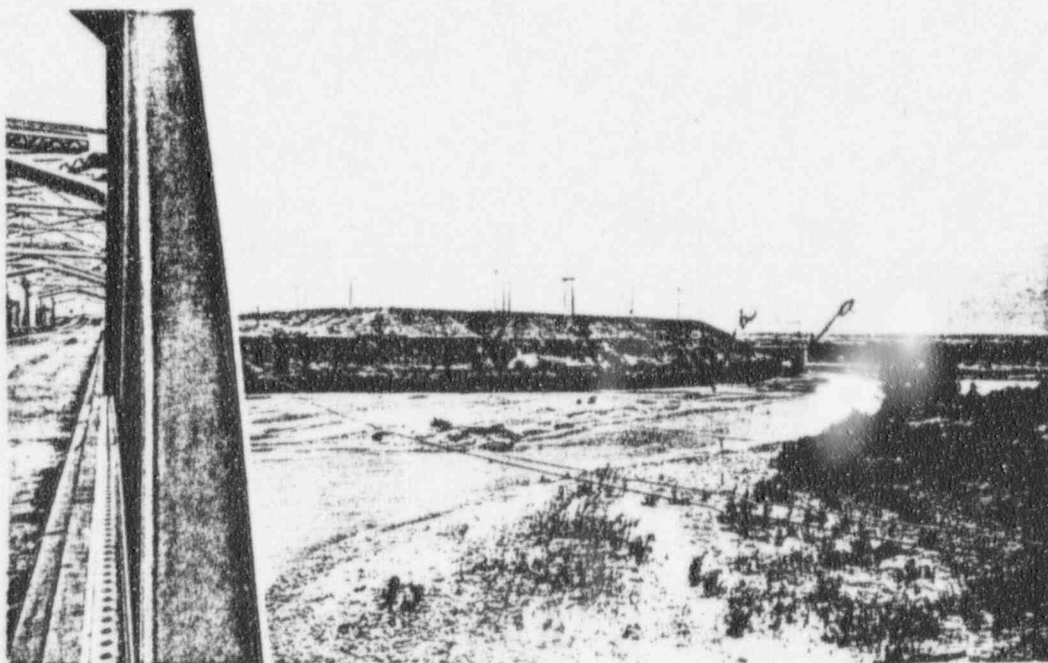
10. Area where the cooling water stream enters the San Juan River.  
    (a) helium plant water collection gallery  
    (b) cooling water stream

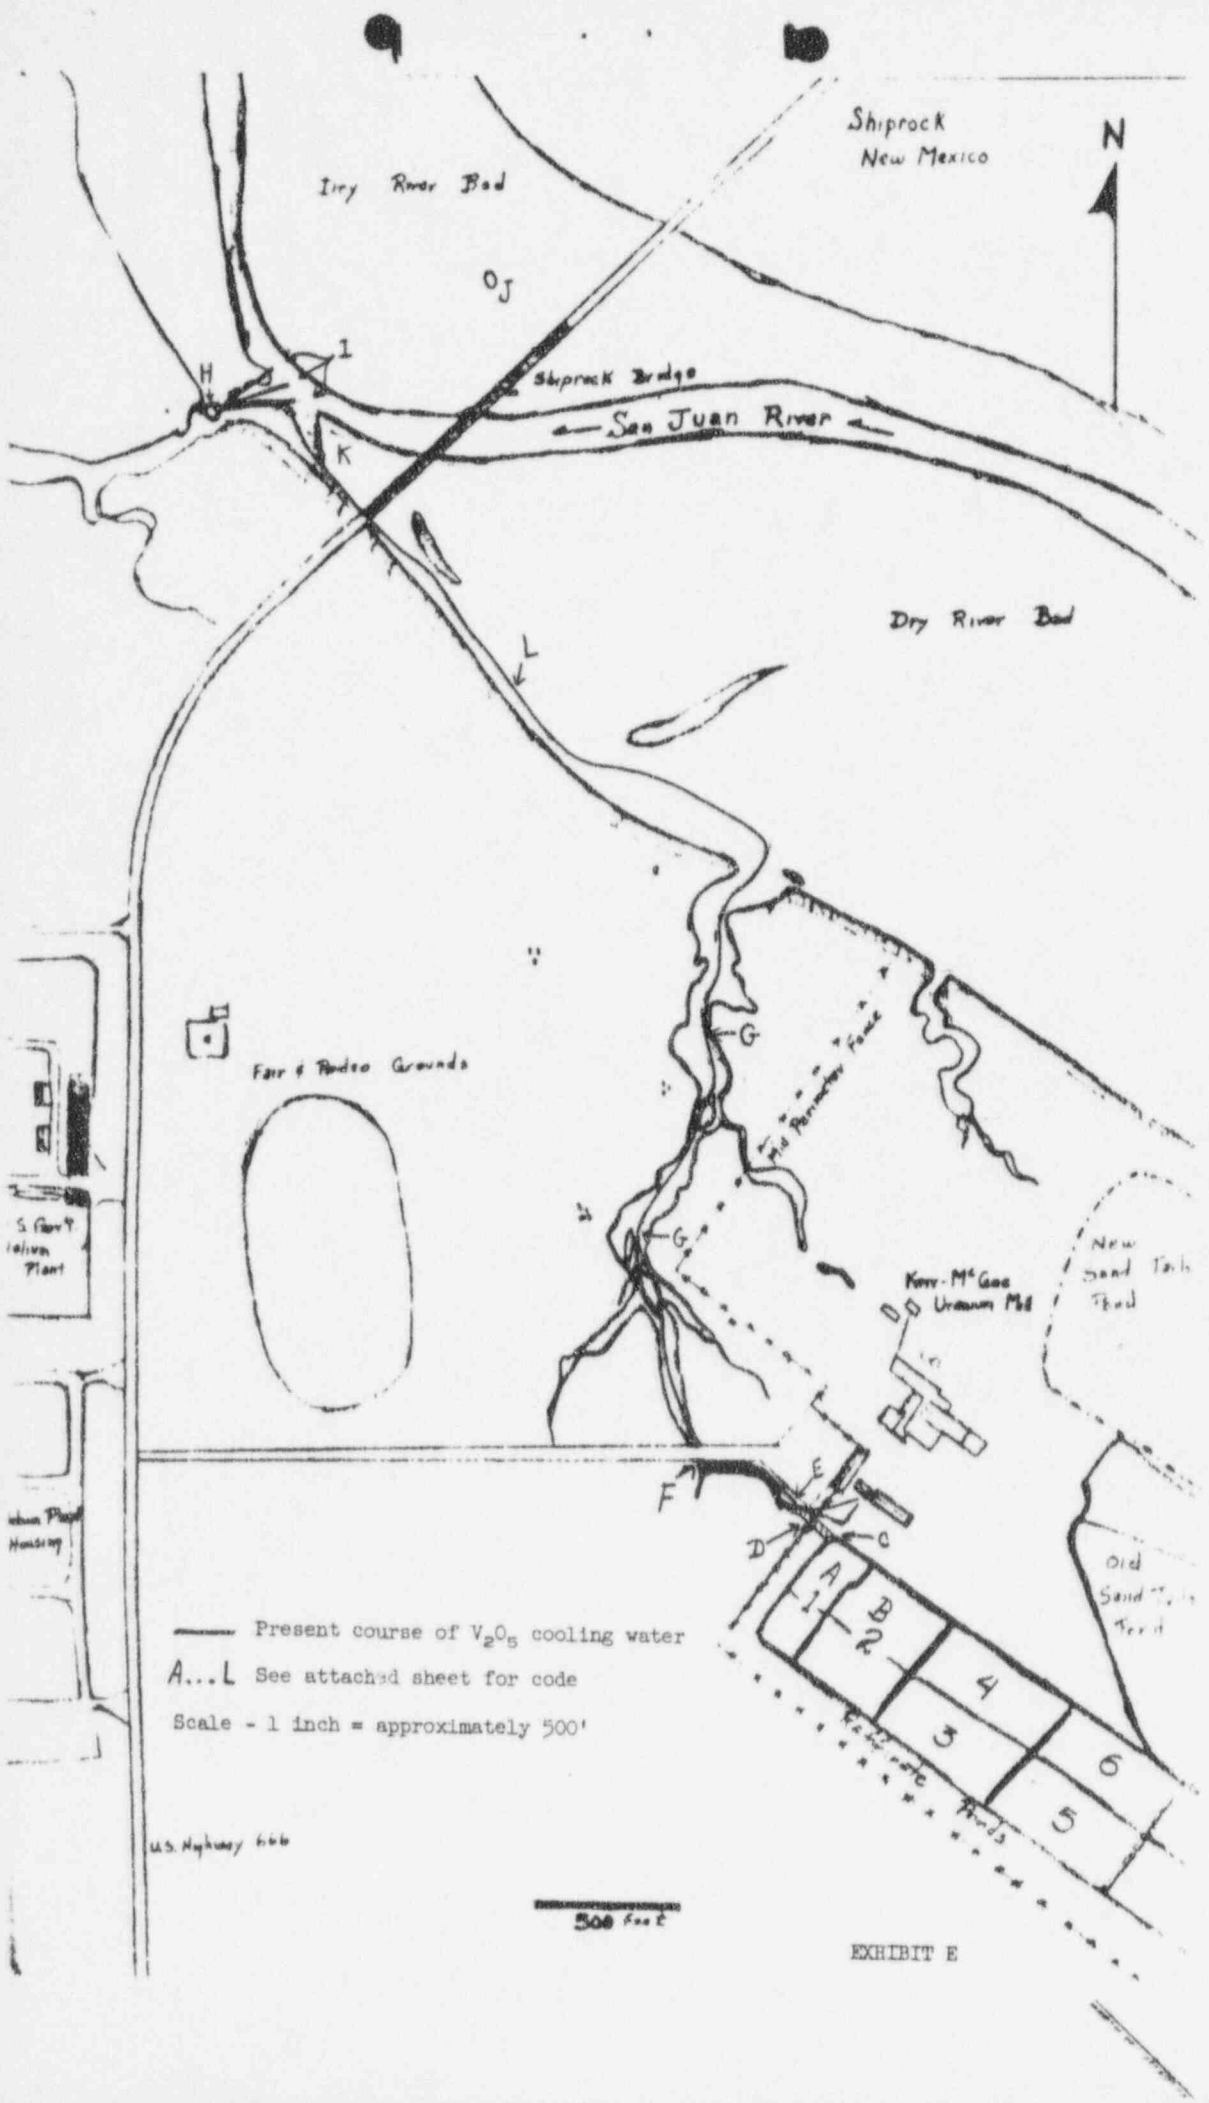
— Present course of  $V_2O_5$  cooling water  
A...L See attached sheet for code  
Scale - 1 inch = approximately 500'

<u>Code</u>	<u>Description</u>
A	Holding pond - retaining wall broke releasing contents
B	Holding pond - filled simultaneously with Pond A
C	Approximate area on retaining wall that has been repaired
D	Eroded dry stream bed, down which the raffinate probably flowed
E	Confluence of cooling water stream and possible flood stream
F	Culvert through which the raffinate had to flow
G	Arroyo, down which the raffinate probably flowed
H	Helium plant water collection gallery
I	Approximate location of h. p. water collection pipes (approximately 3 feet under the sand)
J	Approximate location of one of the BIA wells
K	Confluence of cooling water stream and San Juan River
L	Approximate course of cooling water stream in the river bottom
