Subject: Transmittal of written report regarding reportable occurrence at Idaho State University AGN-201 reactor.

# REPORT TO THE U.S. NUCLEAR REGULATORY COMMISSION REGARDING THE CONTROL ELEMENT CLADDING FAILURE AT THE IDAHO STATE UNIVERSITY AGN-201 NUCLEAR REACTOR

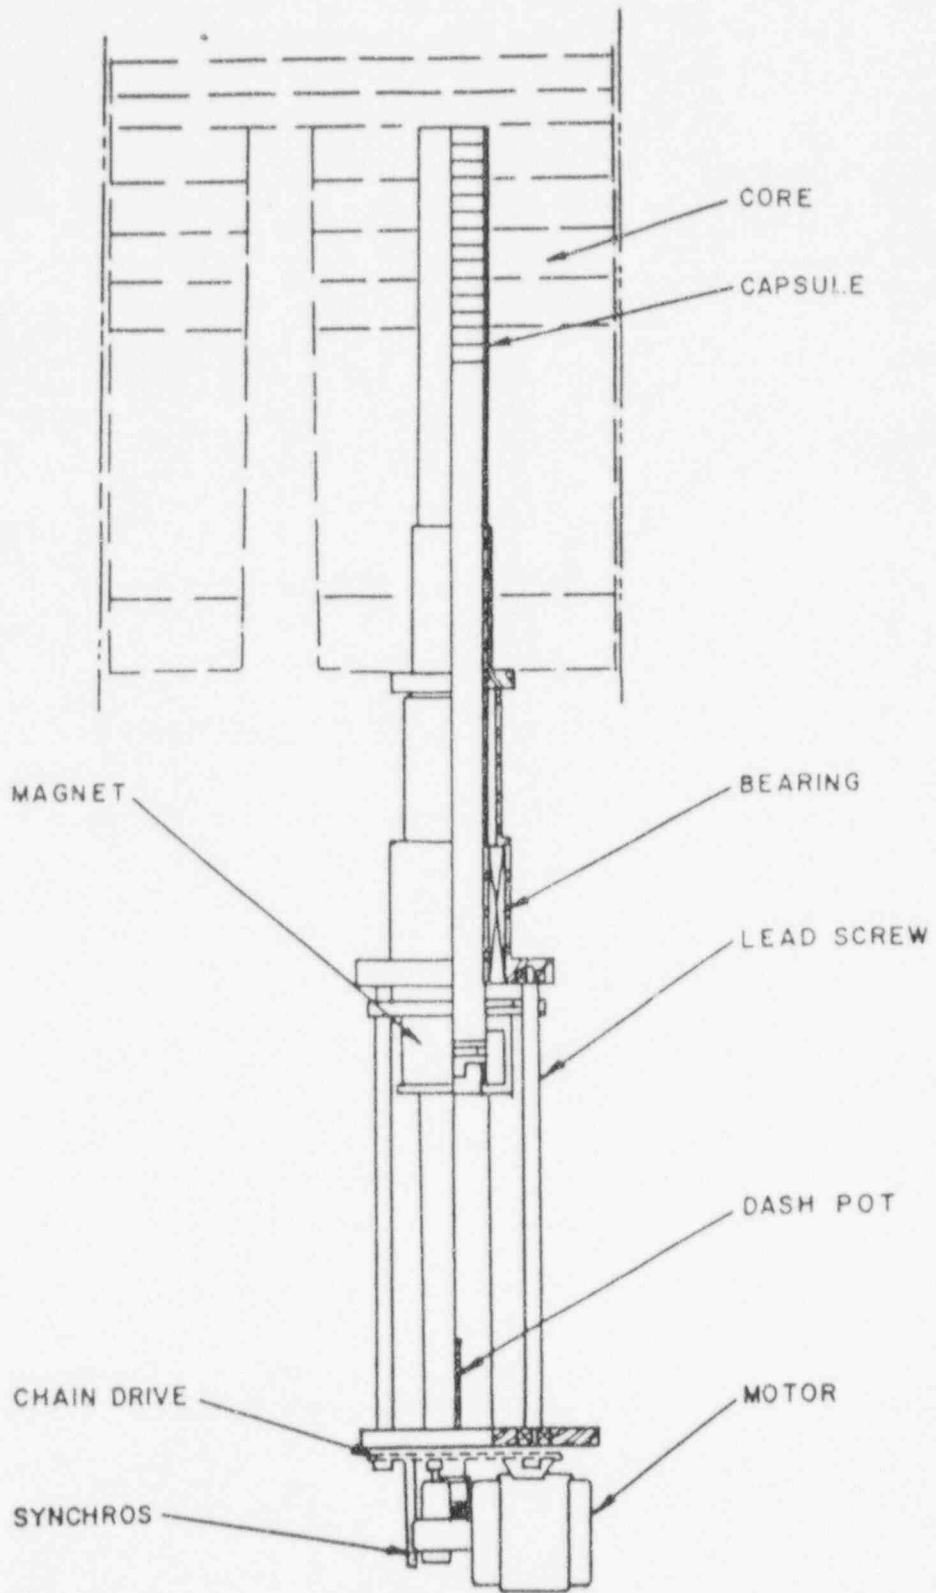
Figure 2. AGN-201 control element and drive mechanism.

A control element assembly is comprised of the capsule, which provides the primary fission-product barrier, four fuel disks, one graphite reflector disk at the bottom, a ferrous compression spring, and the extension tube or shaft. The capsule appears to be fabricated from 0.065-inch-thick aluminum (6061T6) tubing by welding a flat end cap to the capsule tubing. The welded joint was then mechanically ground to make a smooth and slightly rounded cylindrical surface. The capsule is loaded with the four fuel disks followed by the graphite disk and compression spring. The open end of the capsule is threaded and screws onto the

extension shaft. An o-ring allows the capsule to be hermetically sealed when the capsule is tightly screwed onto the extension shaft. Within the capsule, fuel is held against the distal end cap under spring loading. The control rod assembly is connected to the armature plate by means of a threaded joint thus forming the complete control rod drive assembly, as shown in Figure 2. This latter assembly is suspended from the reactor tank by threaded studs below the sealed core can and is covered by the control element access cover which serves as a secondary barrier against the release of fission products.

However, the dashpot was not shipped by the date as promised and the facility administration became concerned that the dashpot might not be installed in time for the NRC examination. On Thursday, July 3rd, in preparation for installing the new dashpot, the SR-2 assembly was removed from the drive assembly for inspection to ensure that the element was not damaged when the dashpot failed. When the element was transferred from the pedestal area to the Reactor Supervisor it became apparent that the end cap of the capsule had been punched through and the distal fuel disk was protruding about 2 cm out of the end of the capsule.

As a result of personal interviews with the reactor operating staff and inspection of the failed control element capsule, the Internal Incident Assessment Committee concluded that the capsule failure was caused directly by the failure of the dashpot. The impact of SR-2 at the end of travel, without benefit of the damping action of the dashpot, following ejection from its fully inserted position, was sufficient fracture the weld. The final break of the weld may not have occurred until the start of the next scram.

The following actions and measures will be taken in order to prevent recurrence of this type of failure of a primary fission-product barrier. First, the control element capsules will be examined more closely for signs of wear or degradation during the annual control element maintenance program. Second, all dashpots will be inspected carefully for evidence of degradation of the seal around the plunger rod which might indicate excessive wear and might contribute to the catastrophic failure of the damping piston. In addition, as a possible long-term remedy, the facility will investigate the practicality of modifying the control element drive

logic to allow both safety rods to be driven down manually rather than having to scram the rods to shut down the reactor. Such a modification would help to reduce impact frequency on both the control elements and the dashpots.
