PRECURSOR DESCRIPTION AND DATA

NSIC Accession Number: 163478

Title: HPCI and RCIC Fail to Inject Following Scram at Hatch 1

CATEGORIZATION OF ACCIDENT SEQUENCE PRECURSORS

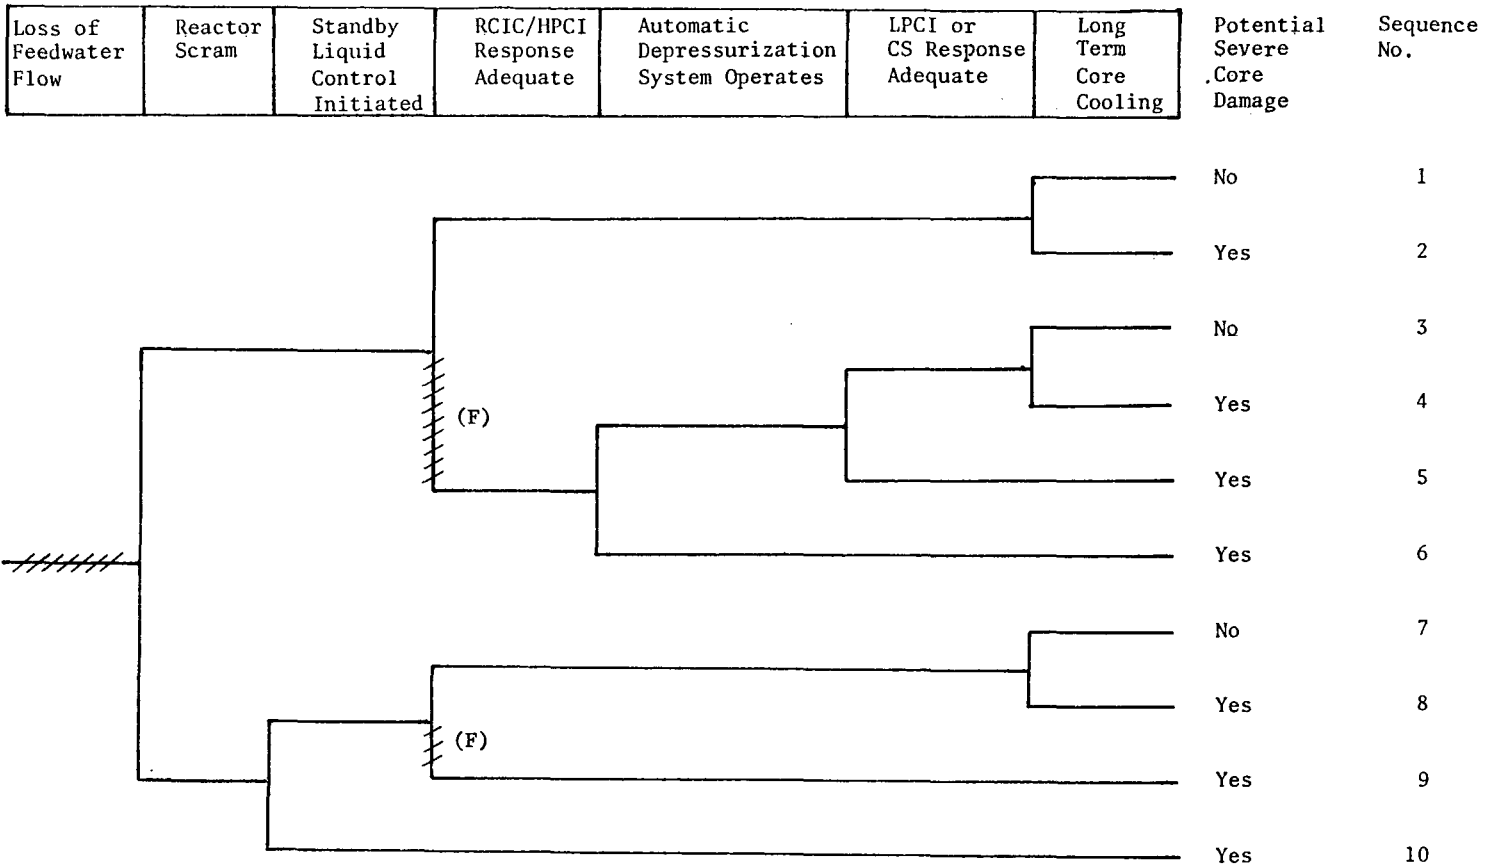
1. At 99.4% power, an erroneous reactor high water level signal initiated tripping of the feedwater pumps and the turbine/generator, which subsequently resulted in a reactor scram.
2. The reactor water level dropped to the low-low level set point.
3. The feedwater pump started but tripped since the MSIVs were closed.
4. On low low level the HPCI system received an auto-initiation signal but failed to inject water into the reactor due to automatic isolation of the HPCI turbine caused by the initial high steam pressure to the HPCI turbine.
5. RCIC was manually initiated during the event, but failed to start and remained inoperable throughout the event.
6. About 5 min after the event began, the operators cleared the HPCI steam supply isolation trip and HPCI auto-initiated successfully and injected water into the core.

NSIC 163478 - Sequence of Interest for RCIC and HPCI Failure to Inject Following Scram at Hatch 1

1. The HPCI isolation, due to steam line high pressure differential, was caused by the turbine speed controller being out of calibration. The system was recalibrated and HPCI tested satisfactorily.
2. The RCIC failure, determined to be due to a faulty limit switch and/or relay, was corrected by replacement of both components. The system was then tested satisfactorily.
3. Calibration surveillance and test procedures were being revised to include cold quickstarts of both HPCI and RCIC.
