B.43 LER No. 366/83-042, -055, and -056

Event Description: Reactor Trip with RCIC and RHR Loop A Unavailable

Date of Event: July 14, 1983

Plant: Hatch 2

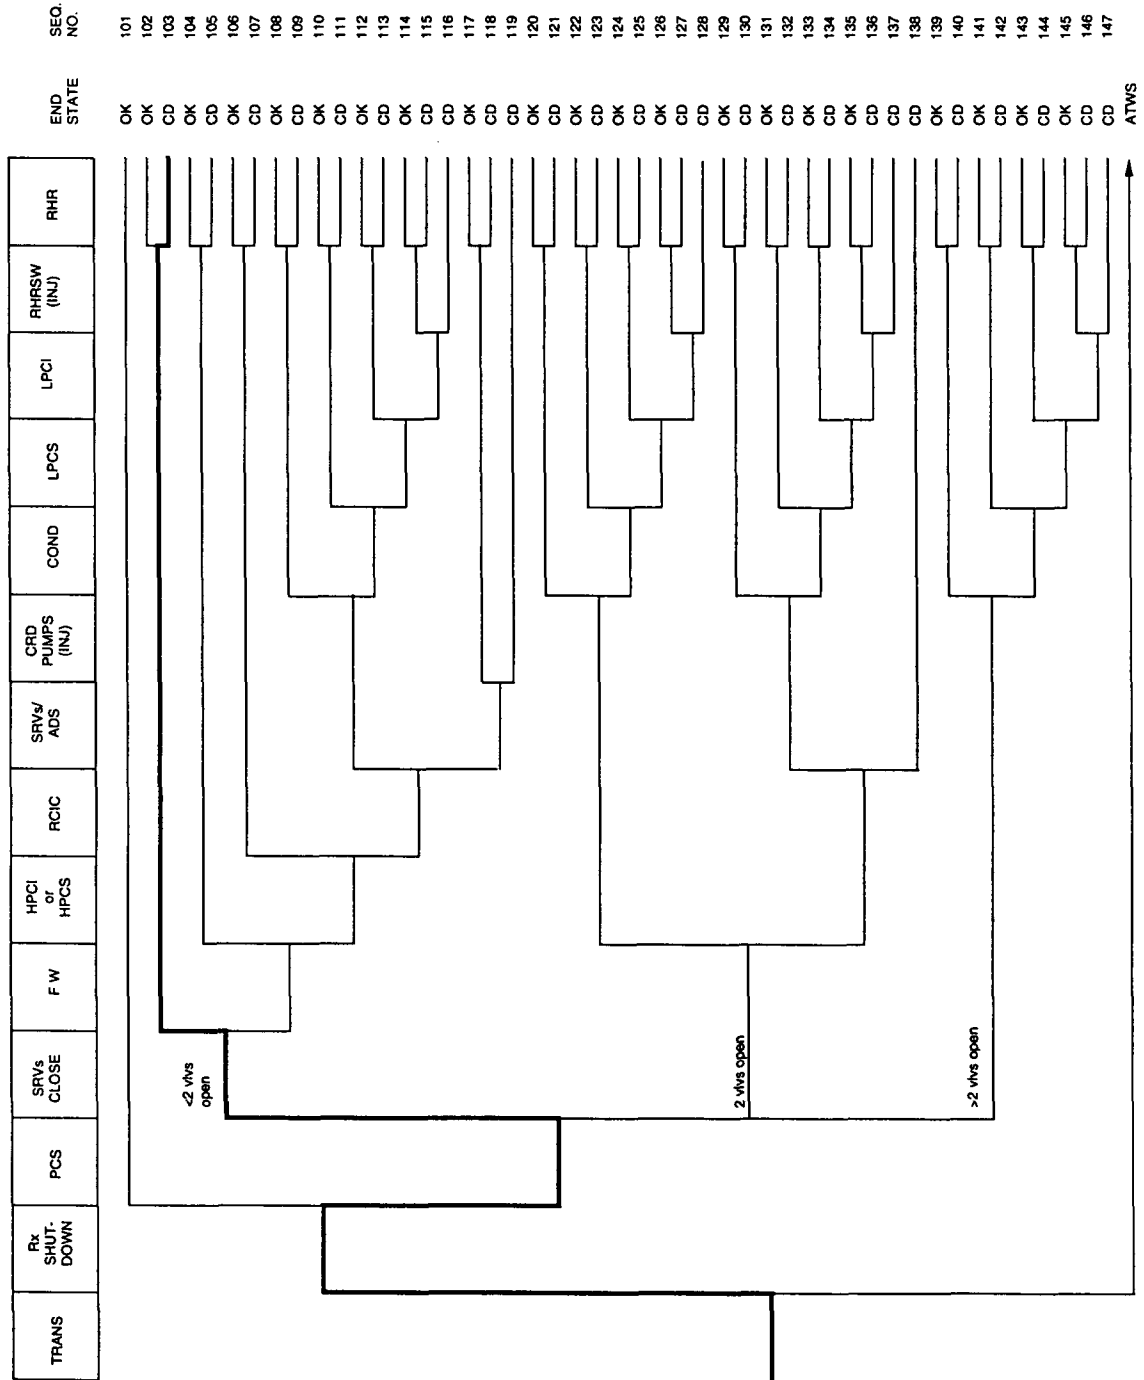
Figure B.43.1 Dominant core damage sequence for LER 366/83-042, -055, and -056

The conditional core damage probability estimated for this event is 1.5×10^{-4} . The dominant core damage sequences, highlighted on the event tree in Figure B.43.1, involves the observed transient, failure of the power conversion system, main feedwater system success, and failure of the residual heat removal system.
