PRECURSOR DESCRIPTION AND DATA

NSIC Accession Number: 166384

Title: LOOP at Monticello

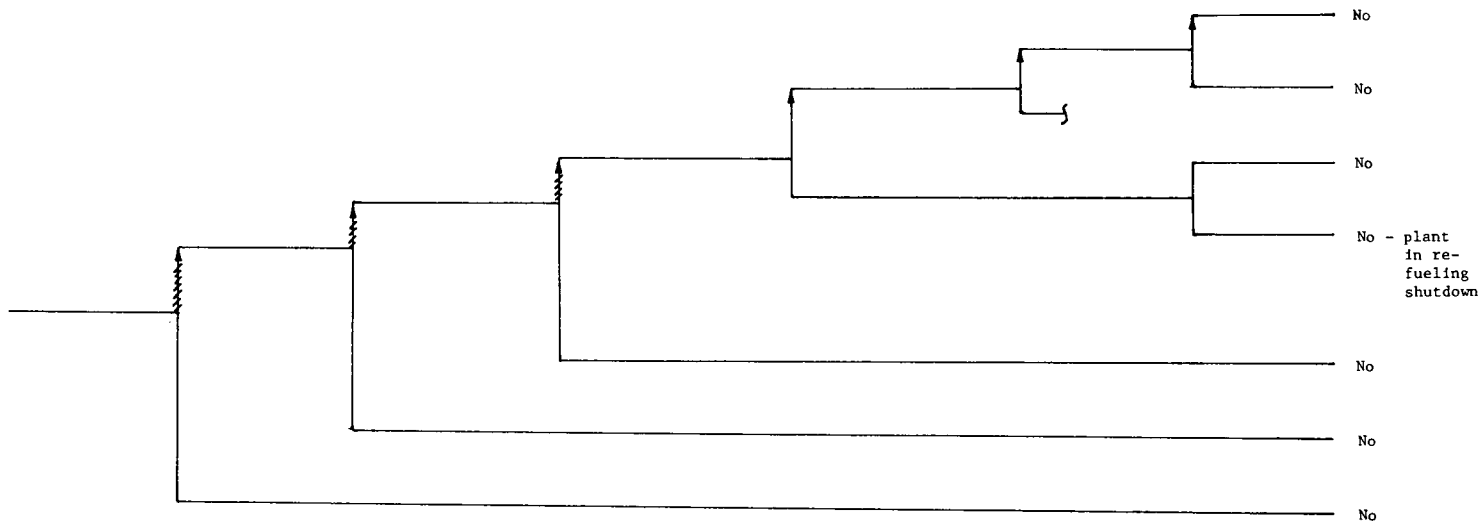
NSIC 166384 - Actual Occurrence for LOOP at Monticello

1. During a refueling outage an energized 4.16 kV breaker was racked out under load due to an operator error.
2. The resulting flashover created an electrical fault on No. 16 4.16 kV essential bus.
3. The No. 16 bus fault was picked up by the undervoltage relays on the 1R transformer, which then tripped off before the overcurrent relays on bus No. 16 could trip off.
4. Sensing of the undervoltage condition on the 1R transformer actuated automatic isolation of the entire 4.16 kV distribution system from the power source.
5. A momentary loss of all 4.16 kV busses occurred.
6. The No. 1AR transformer and the No. 12 diesel generator closed into the faulted bus and subsequently tripped due to undervoltage and overcurrent, respectively.
7. The No. 11 diesel generator came on line and successfully supplied power to the No. 15 4.16 kV essential bus.

1. Operator action restored the unfaulted 4.16 kV buses to service by returning transformer 1R to service.
2. The faulted essential bus and damaged breaker were isolated.
3. Operator retraining program was revised to include proper breaker operations.
