## PRECURSOR DESCRIPTION AND DATA

NSIC Accession Number: 171939

Title: Inadvertent Steam Dump Valve Opening and Safety Injection at North Anna 2

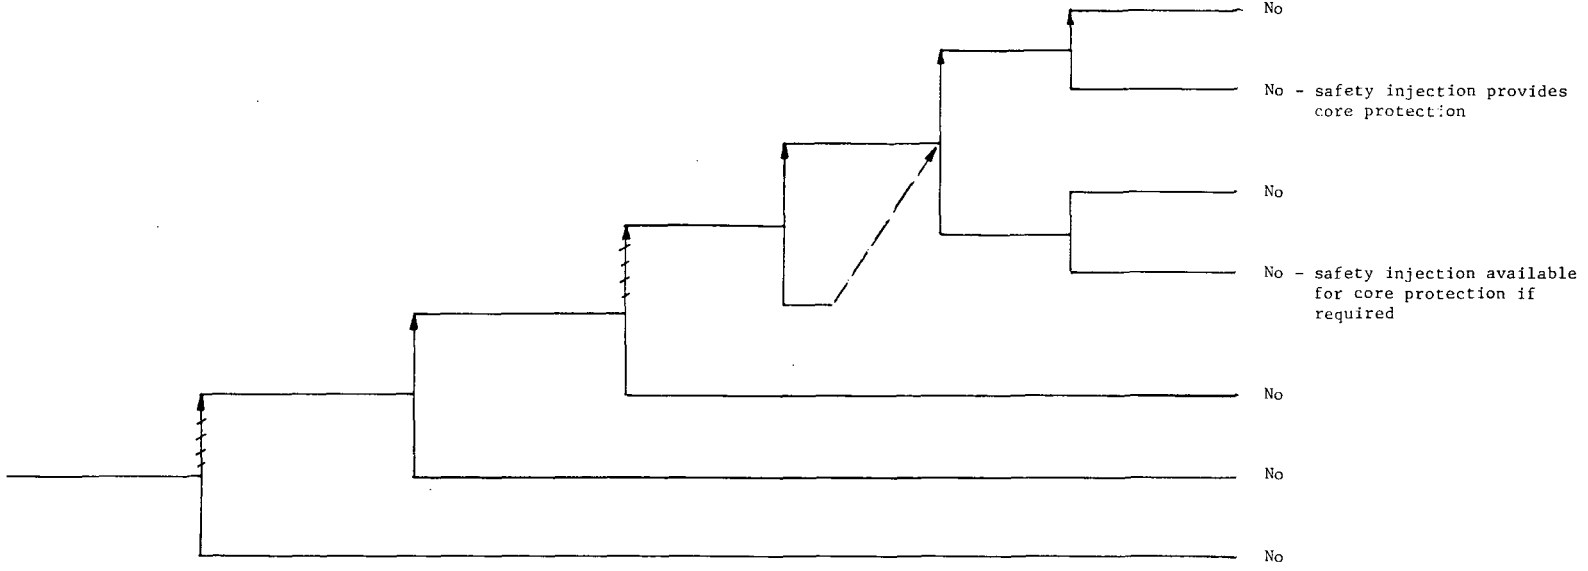
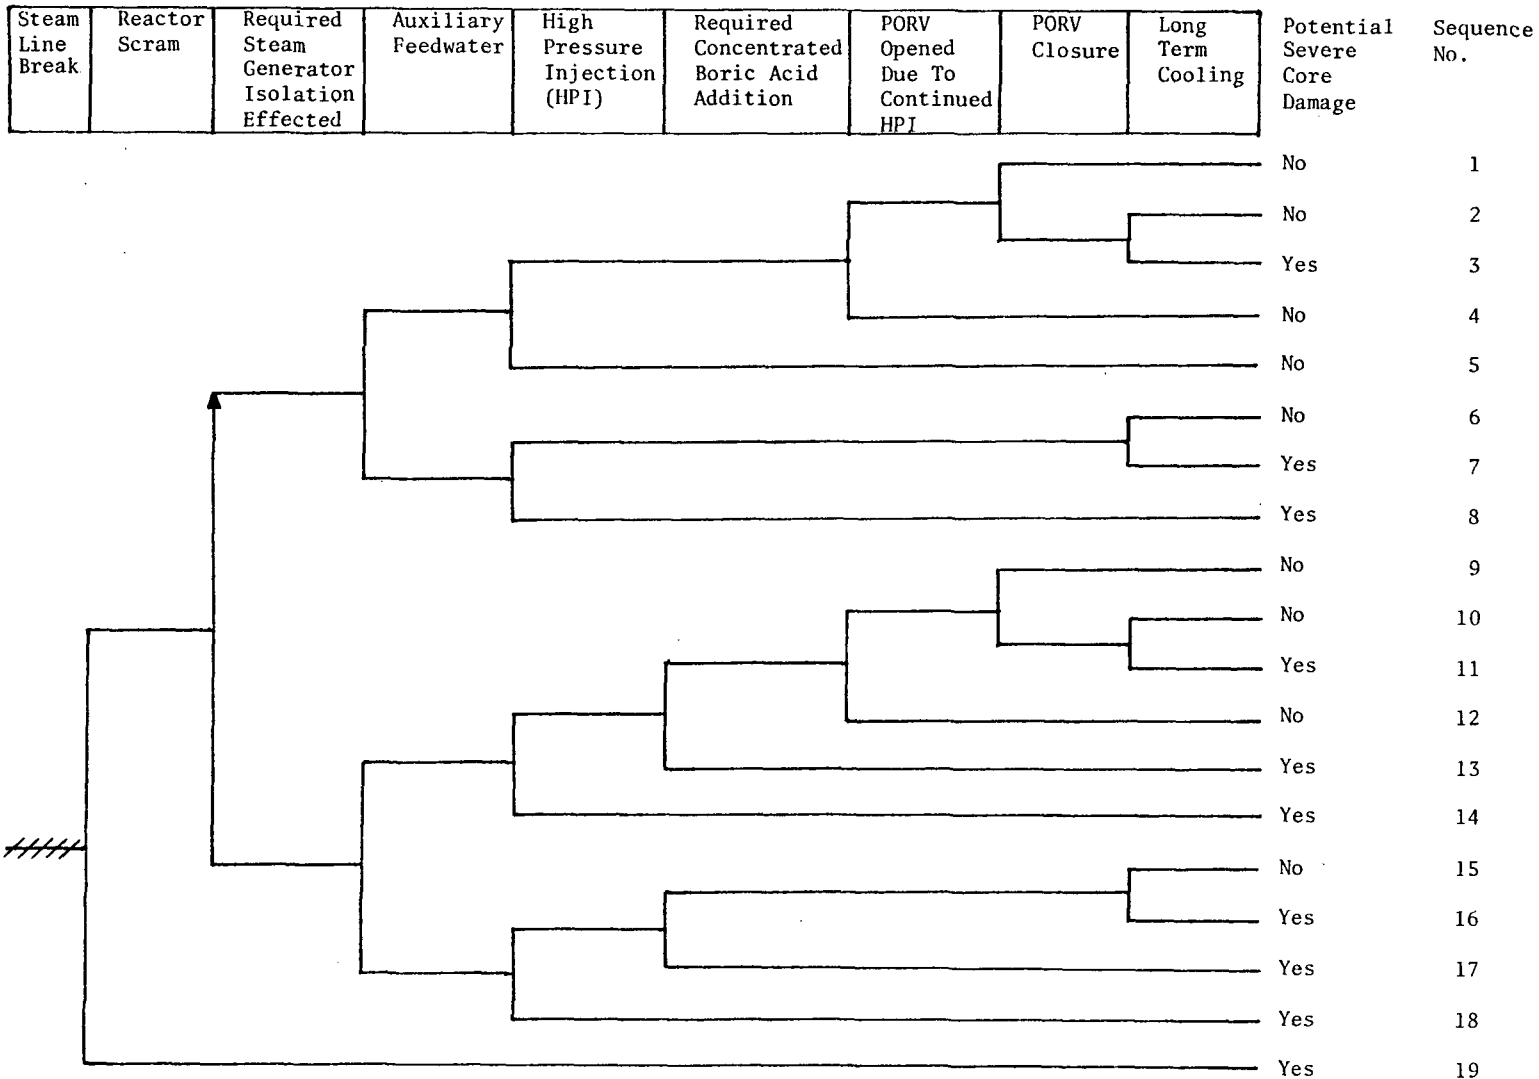
NSIC 171939 - Actual Occurrence for Inadvertent Steam Dump Valve Opening and Safety Injection at North Anna 2

Turbine/previous reactor trip due to EHC line failure to #4 governor valve	Operator observes steam dump selector in $T_{avg}$ mode in lieu of steam pressure mode (reactor at 2% power)	Operator switches to steam pressure mode and shifted the steam dump controller to auto	Inadvertent opening of all 8 atmospheric dump valves (cause not determined)	Operator immediately switches to manual on controller and to $T_{avg}$ on steam dump selector switch	Safety injection initiated	Dump valves closed due to either the operator's actions or to low-low $T_{avg}$ interlock
--	--	--	---	--	----------------------------	---

Potential Severe Core Damage
