U. S. NUCLEAR REGULATORY COMMISSION
REGION IV

Inspection Report: 50-382/95-23

Facility Name: Waterford Steam Electric Station, Unit 3

Areas Inspected: A special, announced inspection to review the licensee's corrective actions for the existence of voids in the auxiliary component cooling water (ACCW) system and to review the maintenance and testing for Containment Spray (CS) Valves CS-125A and -125B.

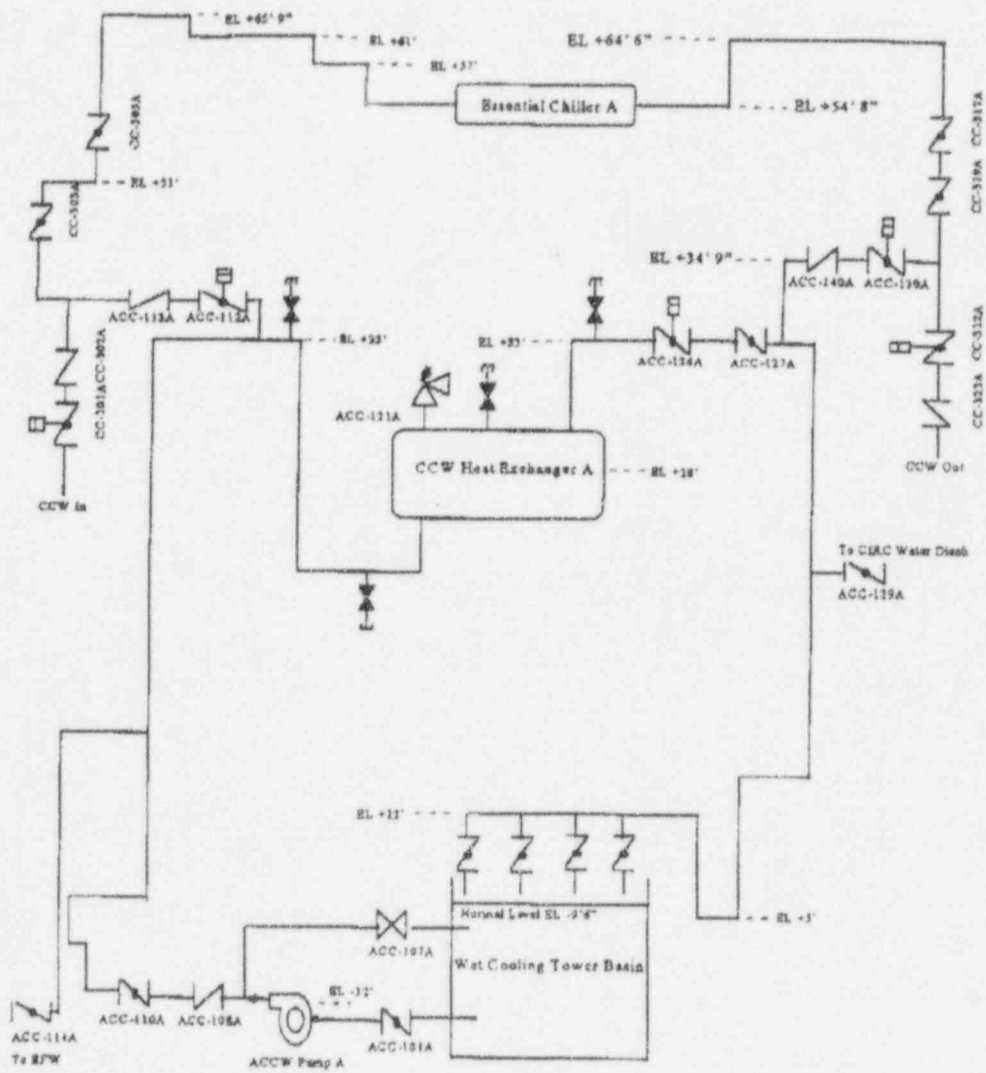
Simplified Elevation View of the CCW/ACCW Systems

The system is constructed such that an ACCW pump, located at the minus 32-foot elevation, takes a suction from the wet cooling tower basin and discharges the water through the ACCW/CCW heat exchanger, located at the plus 28-foot elevation. After passing through the ACCW/CCW heat exchanger, the water returns to the basin, where it repeats the cycle. See Attachment 2 for a simplified diagram of the system.

The approximately 60-foot elevation difference between the basin and the heat exchanger can cause water to drain out of the system into the basin and can result in the creation of voids in the 16-inch diameter inlet and outlet piping of the heat exchanger. The rate of void creation is dependent on the leak tightness of the upper portions of the system piping and components. The sources of void creation are: (1) air comes out of solution when a vacuum forms in the ACCW system by column separation, (2) air drawn into the ACCW system through leaking valve packing when a vacuum is developed in the ACCW system by column separation or leakage from the system, and (3) air enters the system during maintenance and is not fully vented after the maintenance is completed. The rate of void formation is directly dependent on the extent of the system leakage.

In addition to the creation of voids due to air leaks into the system, voids can also be created by column separation in the approximately 60-foot length of vertical piping from the pump elevation to the heat exchanger elevation. Column separation occurs when water leaks out of the system and there is no source of air to fill the void that is created. As a result, a vacuum is created in the void space. At the bottom of this vertical piping, a pump discharge check valve (Valves ACC-108A and -108B) is installed and the function of the check valve is to ensure that water does not drain from the vertical piping back into the basin and create a void.
