UNITED STATES
NUCLEAR REGULATORY COMMISSION
WASHINGTON, D. C. 20555

LICENSEE: Alabama Power Company (APCo)
FACILITY: Joseph M. Farley Nuclear Plant, Units 1 and 2
SUBJECT: SUMMARY OF MEETING HELD ON JANUARY 15, 1988, BETWEEN NRC AND
APCo REPRESENTATIVES TO DISCUSS GENERIC IMPLICATIONS OF A
CRACKED 6-INCH SAFETY INJECTION PIPE AT FARLEY UNIT 2 (TAC
66773)

Farley Nuclear Plant Unit 2 Cold Leg
Safety Injection Line Crack

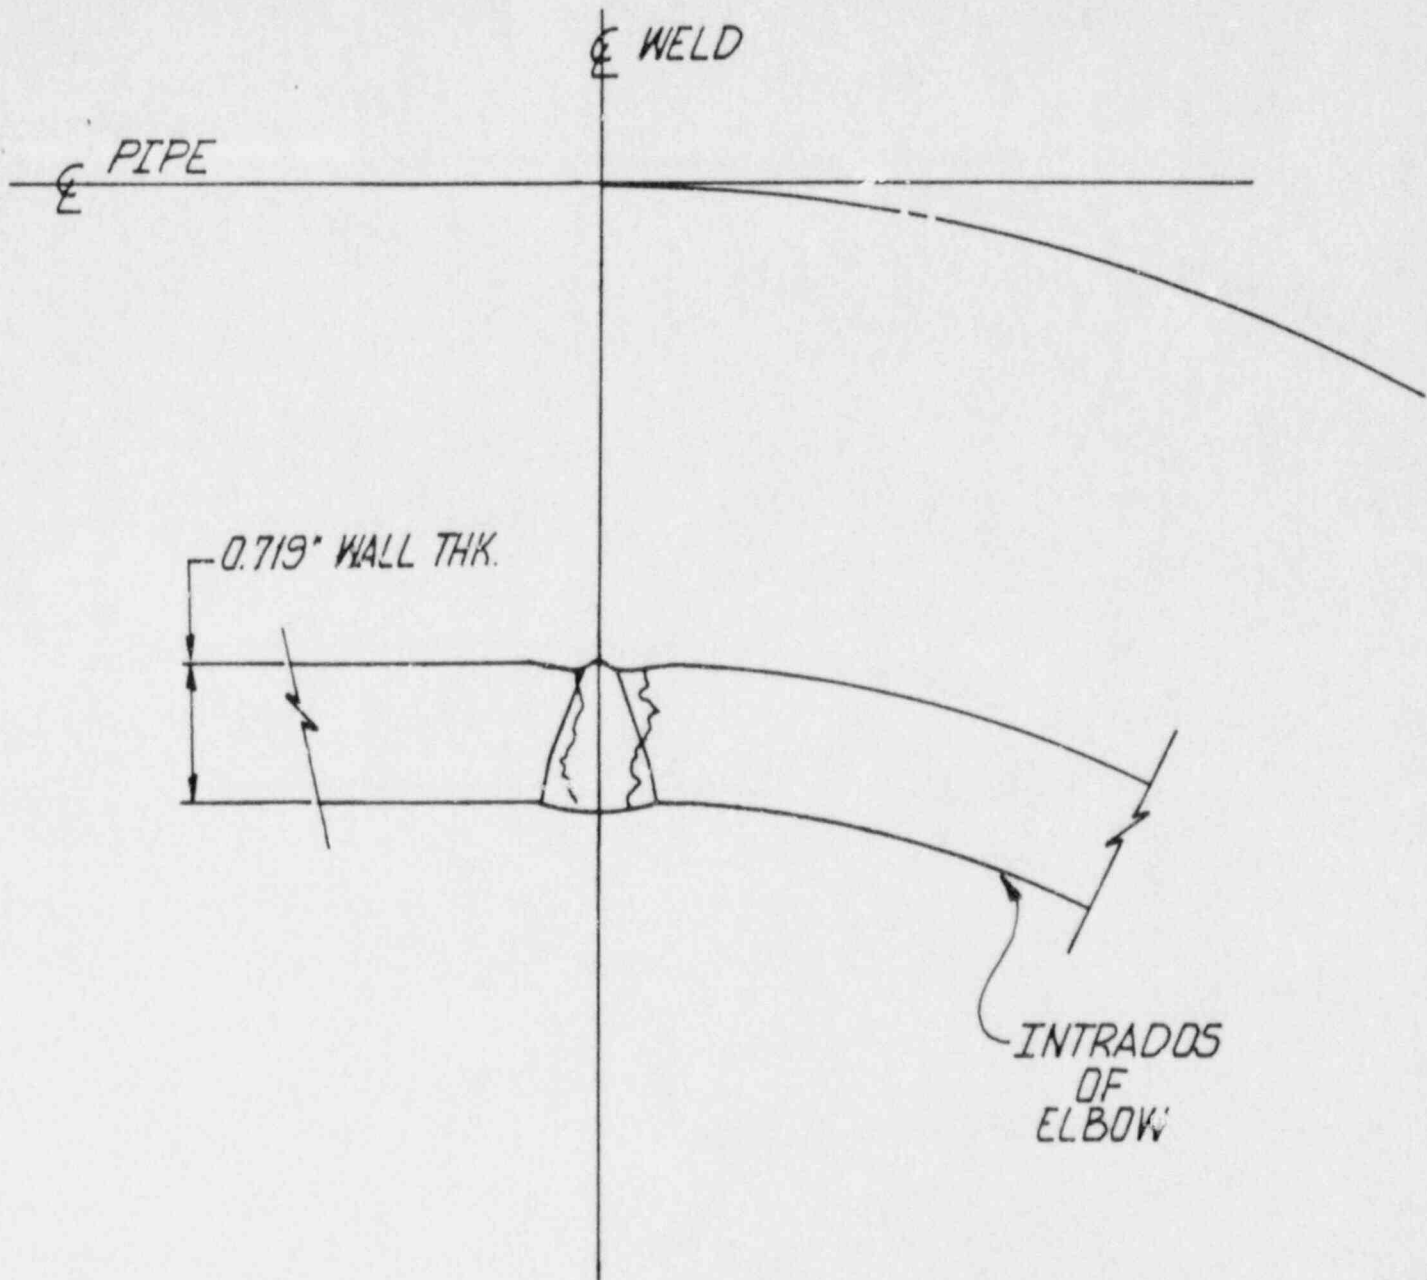
FARLEY NUCLEAR PLANT
UNIT 2
APR-1 4210 WELD NO. 16

- ° Radiographic Examination
 - Ir 192 source at 54 curies
 - Double loaded cassettes using Type M film or equivalent
 - Confirmed presence of crack with line filled

- ° crack located on elbow side
 - ° approximately 2 1/2" long

- Confirmed presence of cracks with line empty
 - ° cracks located on both sides of weld
 - ° approximately 6" long (total combined length)
- ° Visual Examination (Information Only)

- Corrective actions:
 - ° Unit 2, Loop B - None required as both welds were removed as a part of the repair (Table 1 and Figure 3)
 - ° Unit 2, Loop A - Both welds were radiographed and results were satisfactory

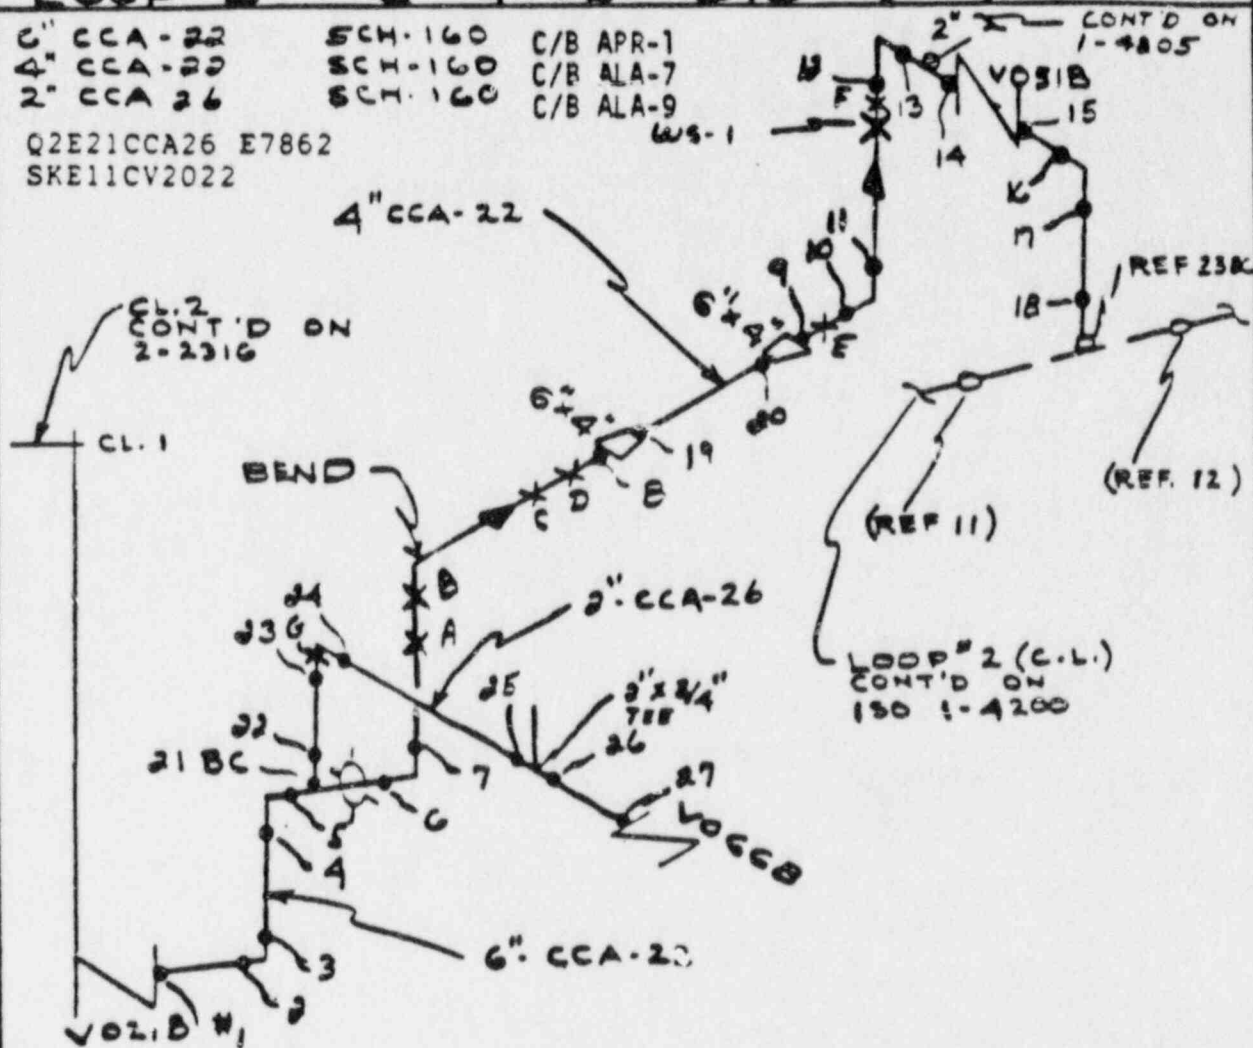
1. Crack-like indications determined to be approximately 6" long and 100% through-wall for a distance of 1" and centered at the 6 o'clock position.
2. Partial examination due to support clamp.
3. Slag indication 3/16" long evaluated to be acceptable.
4. Porosity with linear indications located outside the area of interest.
5. These welds were removed and replaced as a part of the repair.
6. Weld No. 17 was radiographed to confirm the absence of defects as a result of a non-recordable indication found by UT.
7. Informational radiographs verified the presence of cracks on both sides of the weld.

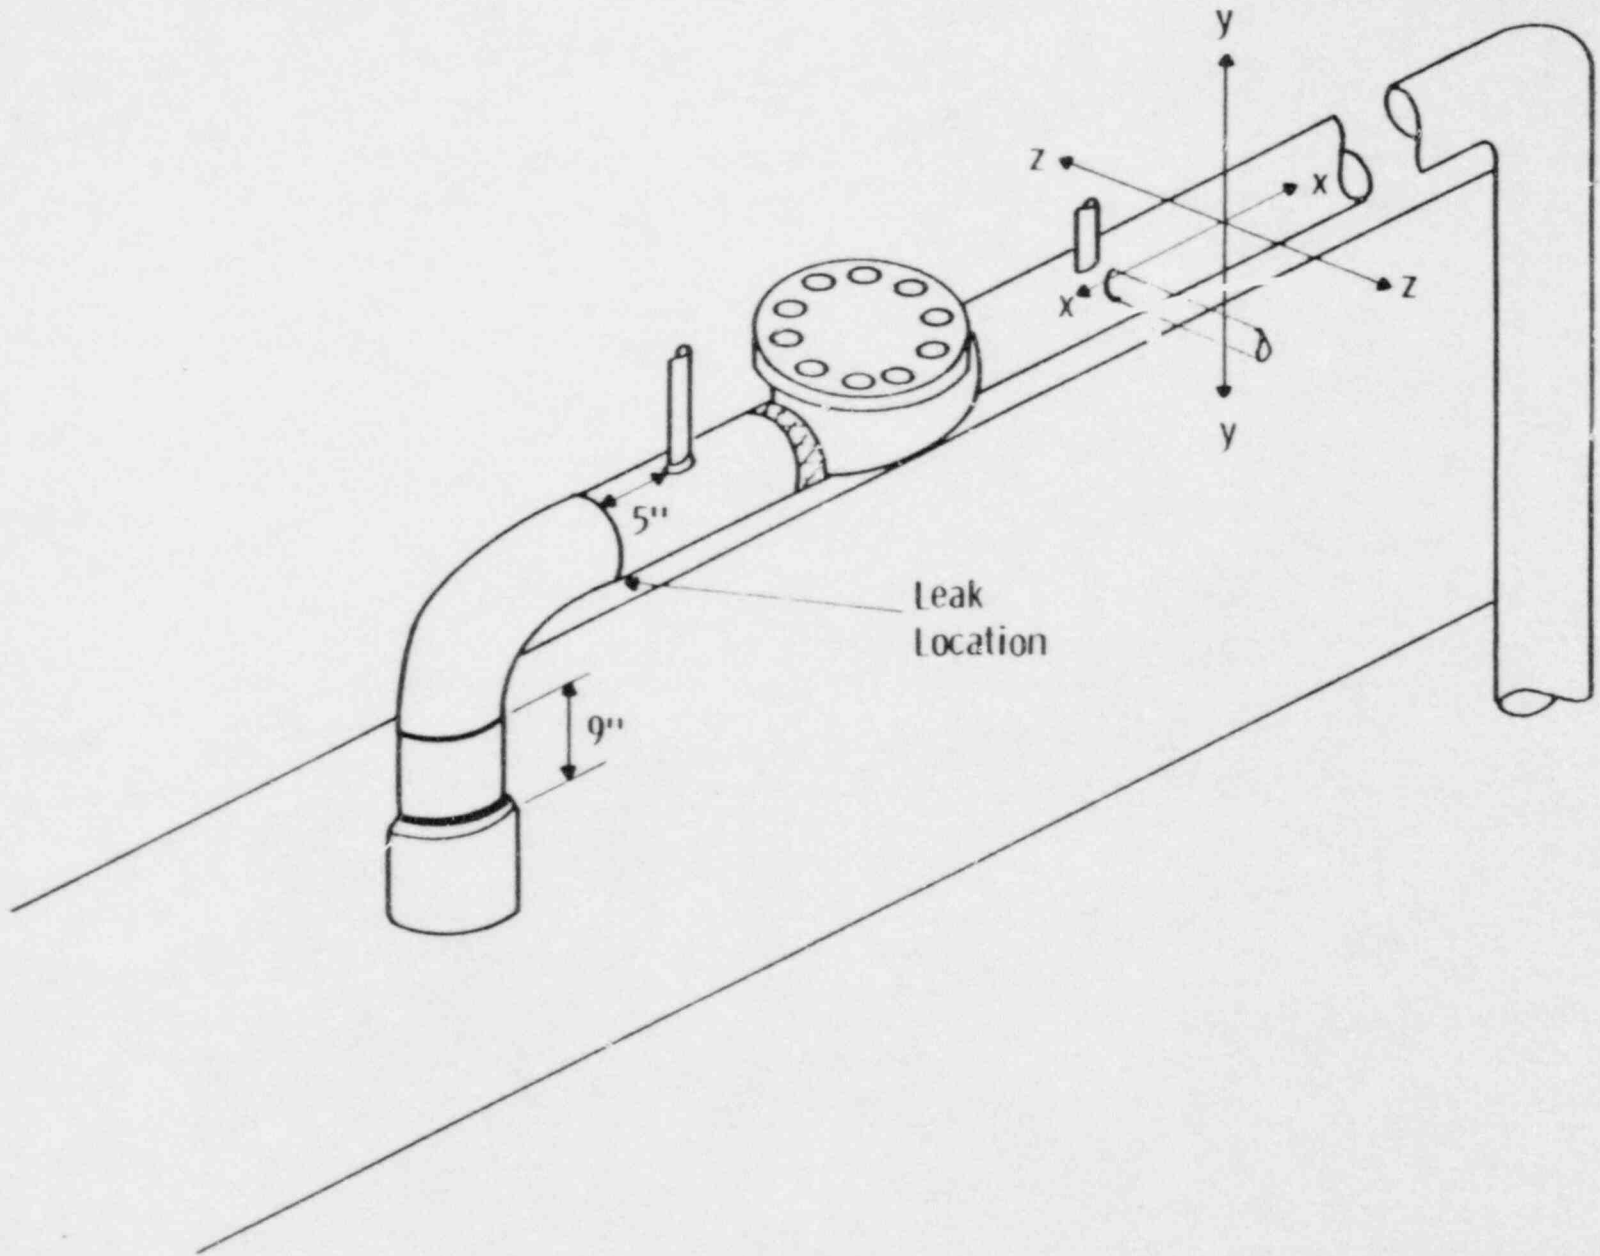
Fig. — Schematic illustration of the SI line configuration showing the location of leakage.

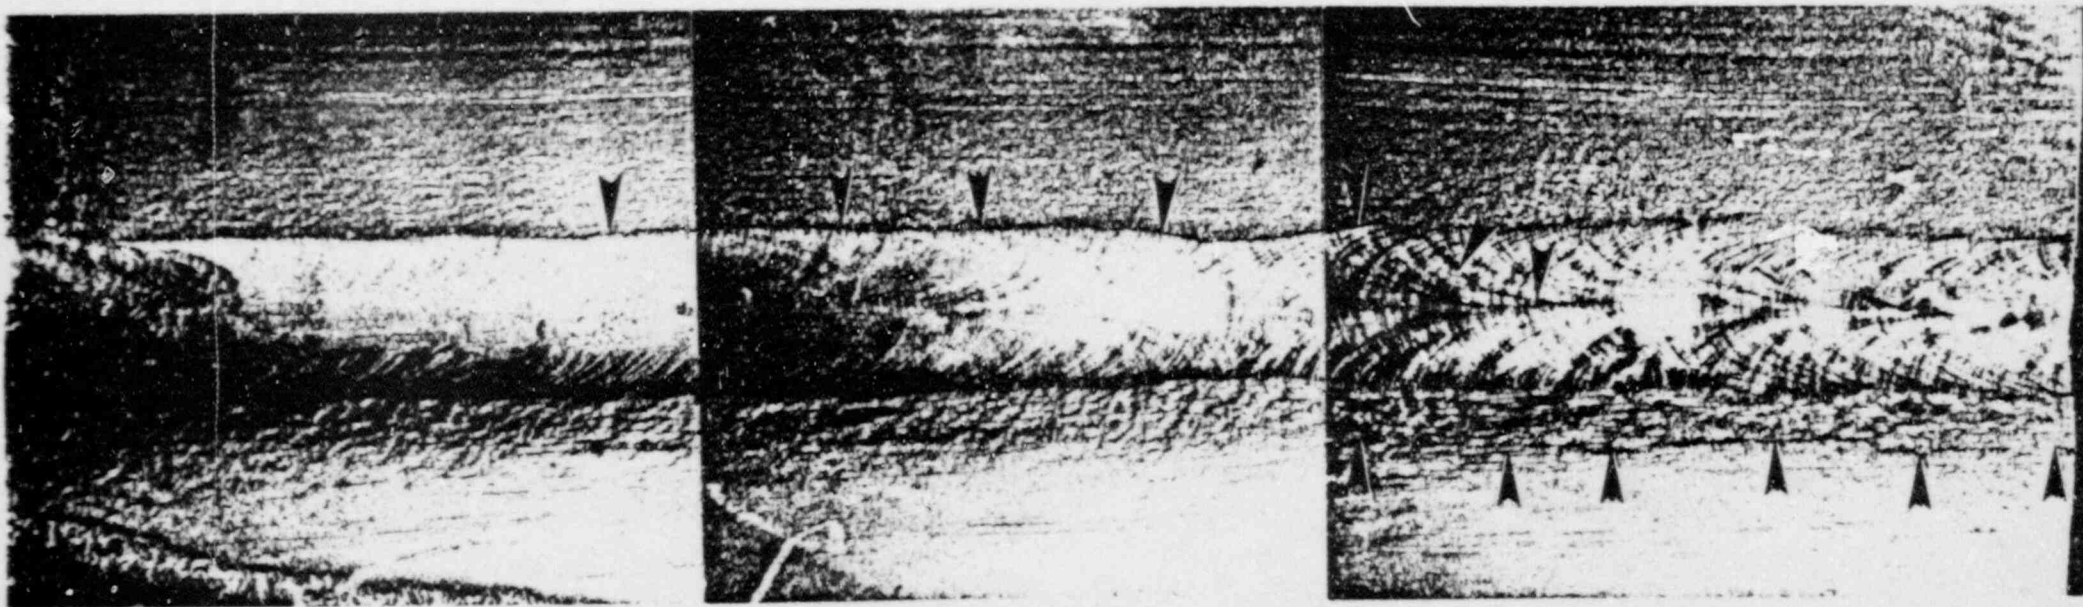
ID surface examination results of the elbow-to-horizontal pipe weld joint showing the location of cracks seen on the elbow side and the pipe side. (3.25x)

- 0 SURFACE EXAMINATION RESULTS OF THE ID SURFACE OF THE WELD JOINT AT THE LEAK LOCATION CONFIRMED THE PRESENCE OF CIRCUMFERENTIAL CRACKS ONE ON EACH SIDE OF THE WELD. THE CRACK ON THE PIPE SIDE WAS LOCATED AT THE WELD INTERFACE, MEASURED APPROXIMATELY THREE INCHES LONG, AND RAN INTO THE WELD METAL NEAR THE SIX O'CLOCK LOCATION OF THE PIPE. THE CRACK ON THE ELBOW SIDE WAS LOCATED IN THE COUNTERBORE REGION OF THE BASE METAL, RAN ALONG THE SURFACE MACHINING GROOVES, AND MEASURED APPROXIMATELY THREE INCHES IN LENGTH.

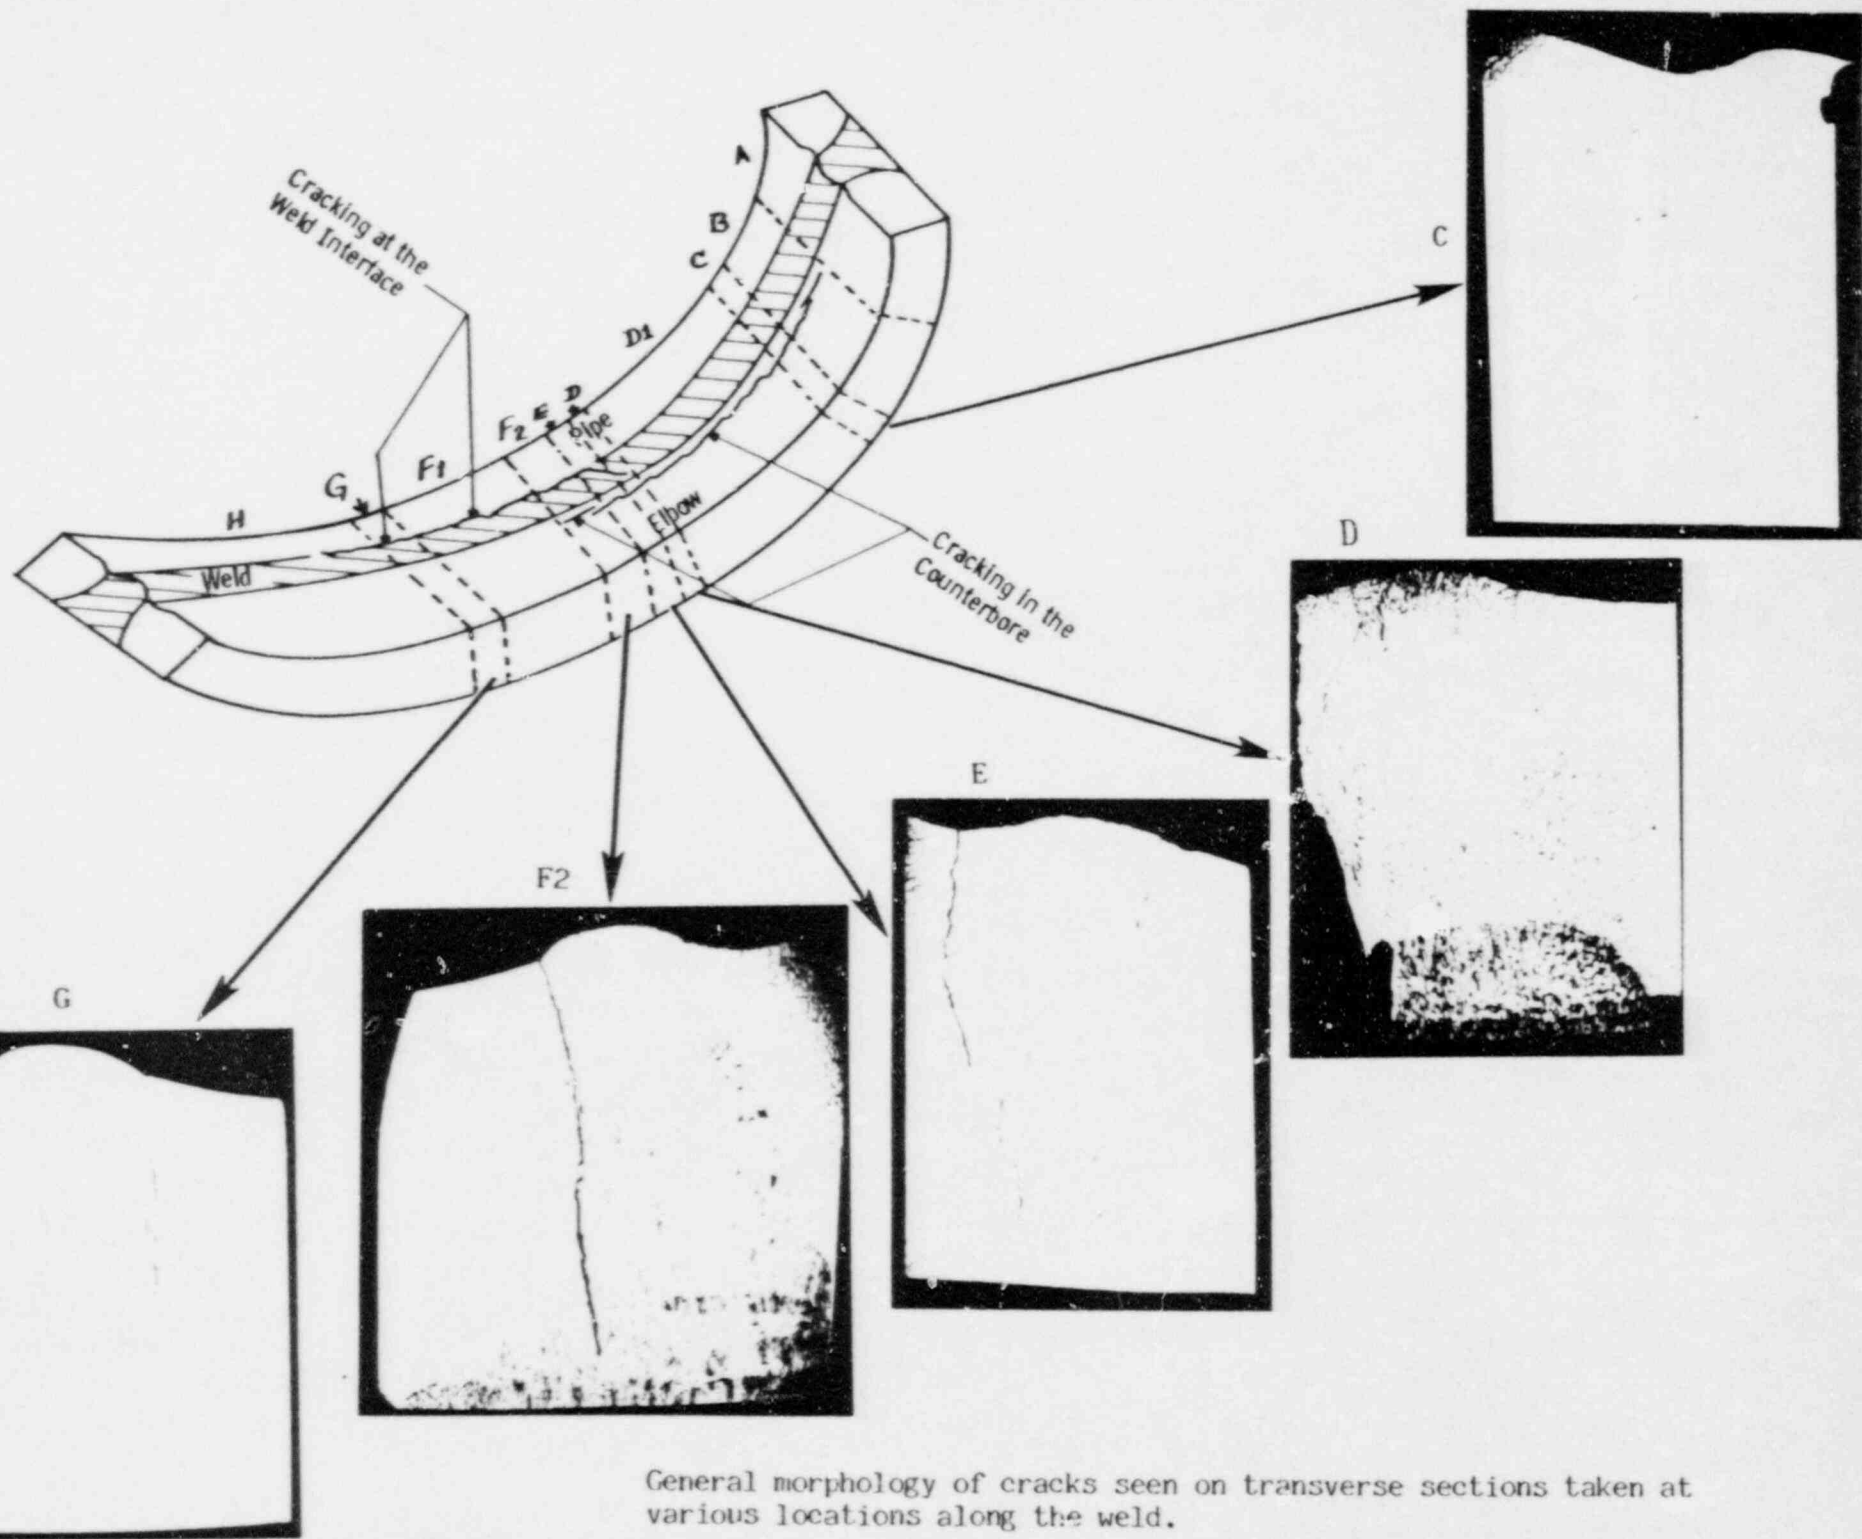
General morphology of cracks seen on transverse sections taken at various locations along the weld.

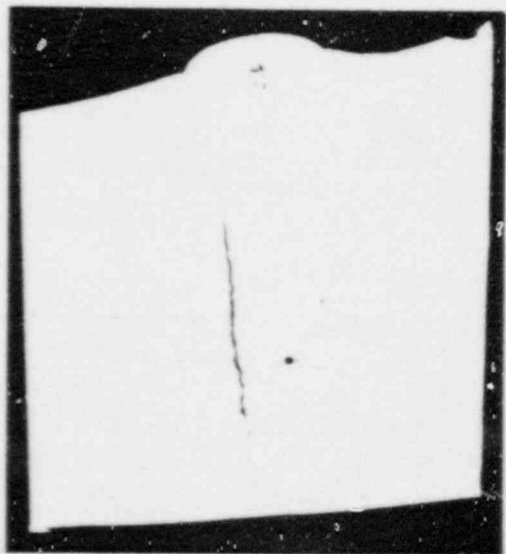
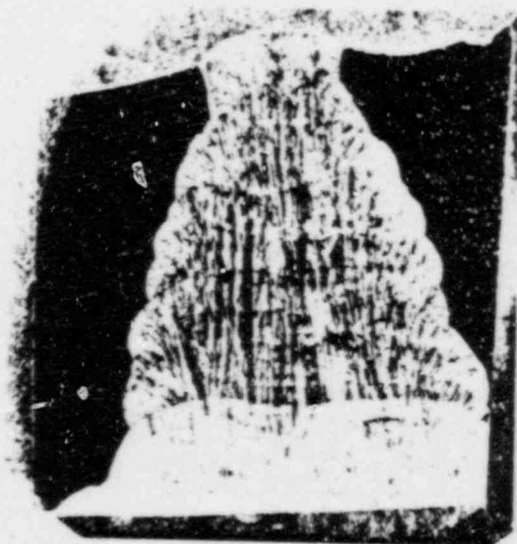
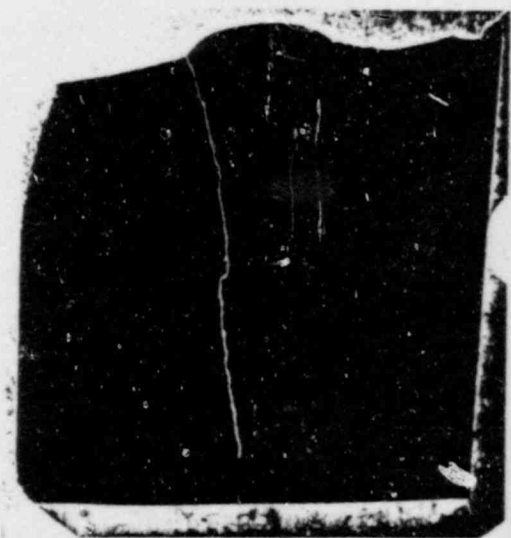
Light optical micrographs shown in different lighting conditions,
illustrating the location and morphology of crack at the weld-to-pipe
interface(F-2 3.25X)

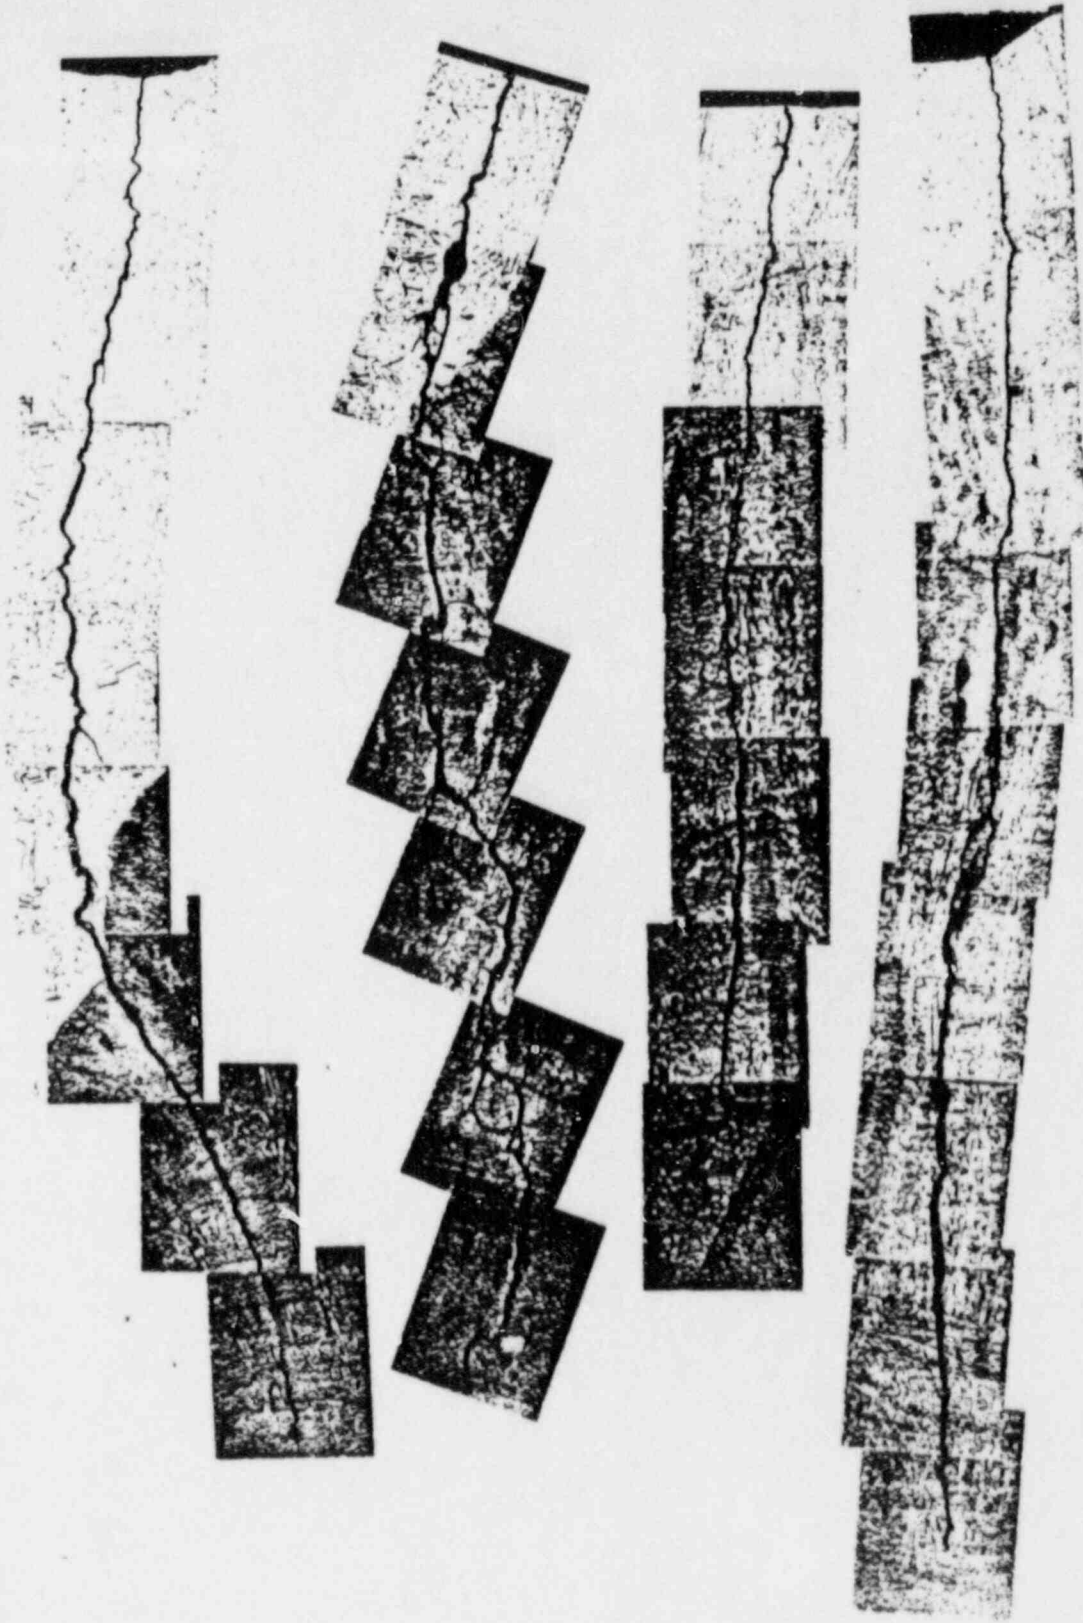
General morphology of cracks seen on transverse sections taken at various locations along the weld.

0 METALLOGRAPHIC EXAMINATIONS CONDUCTED ON TRANSVERSE SECTIONS TAKEN AT SEVERAL CIRCUMFERENTIAL LOCATIONS IN THE REGION OF CRACKING, CONFIRMED THAT THE ID SURFACE CRACKING WAS EXTENDED DEEP INTO THE PIPE THICKNESS ALL THE WAY UP TO THE OD SURFACE OF THE PIPE. THE RESULTS SHOWED THAT THE MAJOR CRACK IN THE ELBOW SIDE INITIATED AT THE KNEE OF THE COUNTERBORE REGION, PROGRESSED THROUGH THE BASE METAL AND TERMINATED IN THE WELD METAL. THE CRACK ON THE PIPE SIDE WAS INITIATED AT THE WELD METAL TO BASE METAL INTERFACE AND PROGRESSED THROUGH THE WELD METAL TOWARDS THE OUTSIDE DIAMETER SURFACE. THE CRACKING WAS PRIMARILY STRAIGHT AND TRANSGRANULAR IN CHARACTER. NO APPRECIABLE BRANCHING OR CRACK DEPOSITS WERE OBSERVED. METALLOGRAPHIC EXAMINATIONS CONDUCTED ON SEVERAL SECTIONS THROUGH THE MAJOR CRACKS FAILED TO CONFIRM THE PRESENCE OF ANY MAJOR DEFECTS IN THE WELD METAL. THE METALLOGRAPHIC EXAMINATIONS ALSO CONFIRMED THE PRESENCE OF SEVERAL FINE CRACKS INITIATED FROM THE MACHINED GROOVES OF THE COUNTERBORE REGION OF THE ELBOW.

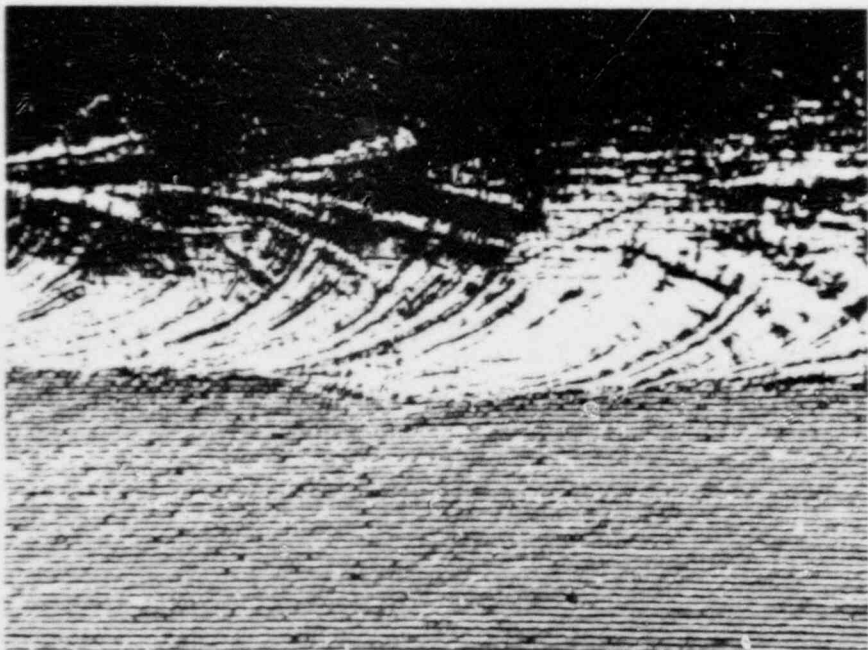
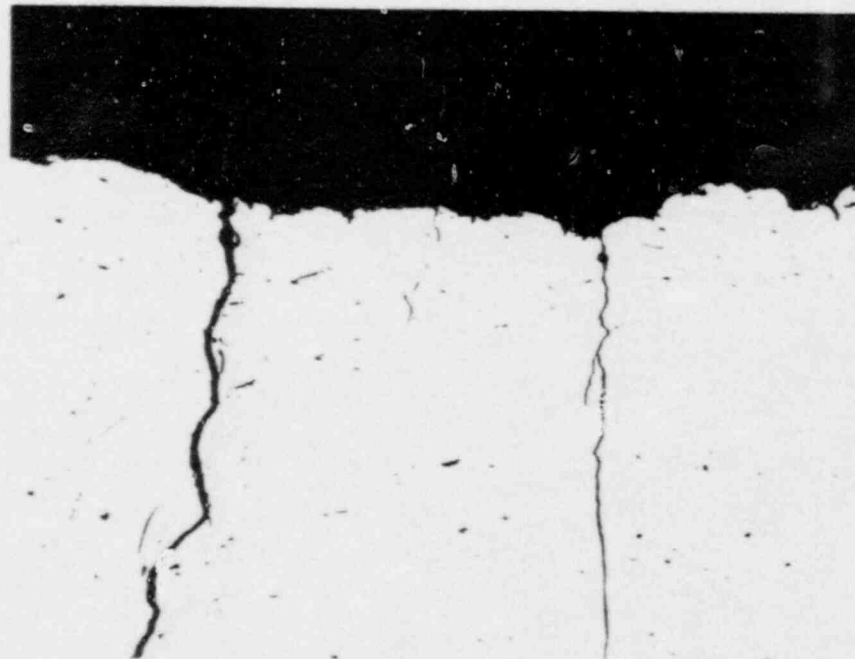
Illustration of the initiation of cracks at the ID surface machining grooves in the counterbore region of the elbow.

- 0 MACHINING MARKS IN THE COUNTER BORE REGION (IN THE ELBOW) AND THE WELD INTERFACE (IN THE PIPE) SERVED AS PREFERRED SITES FOR CRACK INITIATION.

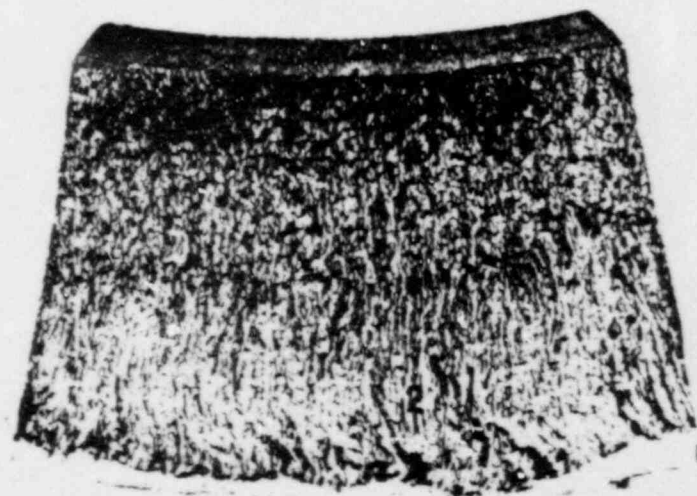
Light optical fractographs illustrating the fracture morphology of the cracks seen in pieces B and D. (3.25x)

- 0 FRACTOGRAPHIC EXAMINATION OF THE FRESHLY OPENED CRACKS BOTH IN THE BASE METAL AND WELD METAL REGIONS SHOWED THAT THE CRACKING WAS INITIATED ON THE INSIDE DIAMETER SURFACE AND PROGRESSED RADIALY OUTWARDS TO THE OUTSIDE DIAMETER SURFACE. CRACKING APPEARS TO HAVE BEEN INITIATED AT SEVERAL LOCATIONS OVER A BROADER REGION OF THE ID SURFACE RATHER THAN FROM A SINGLE ISOLATED INITIATION SITE. THE FRACTURE MORPHOLOGY FOLLOWED TRANSGRANULAR FACETS. HIGHER MAGNIFICATION SCANNING ELECTRON FRACTOGRAPHY CONFIRMED THE PRESENCE OF FATIGUE STRIATIONS PROGESSING FROM THE INSIDE DIAMETER SURFACE TO ALL THE WAY TO THE CRACK TIP NEAR OUTSIDE DIAMETER SURFACE. THE EVIDENCE OF FATIGUE STRIATIONS WAS ALSO CONFIRMED IN THE FRESHLY OPENED CRACK IN THE WELD METAL. HIGH RESOLUTION TRANSMISSION ELECTRON MICROSCOPY CONDUCTED ON REPLICAS TAKEN FROM VARIOUS LOCATION THE ENDOXED FRACTURE FACES CONFIRMED THAT THE FATIGUE STRIATION SPACING RANGED FROM APPROXIMATELY 4×10^{-6} TO 8×10^{-6} INCHES.

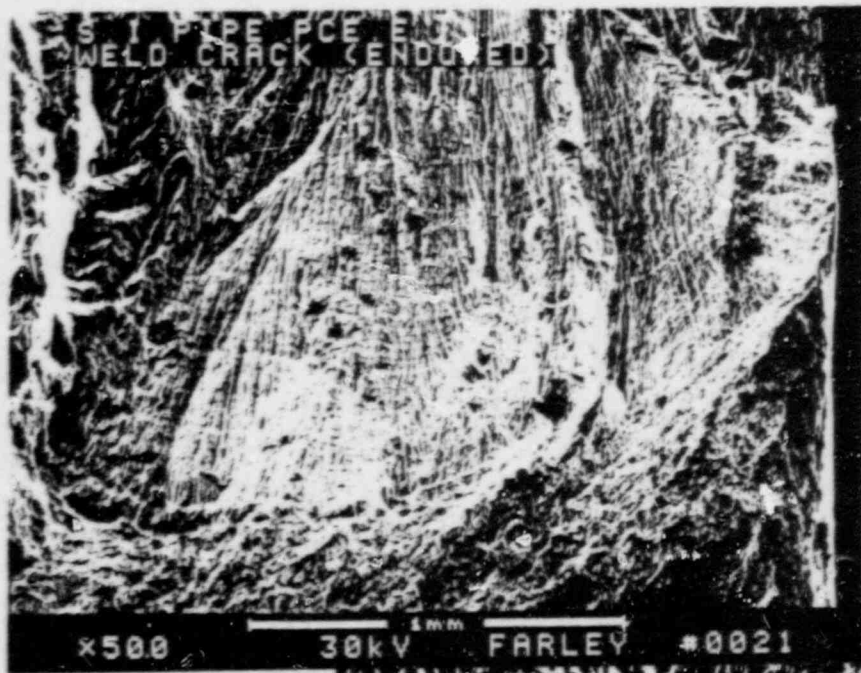
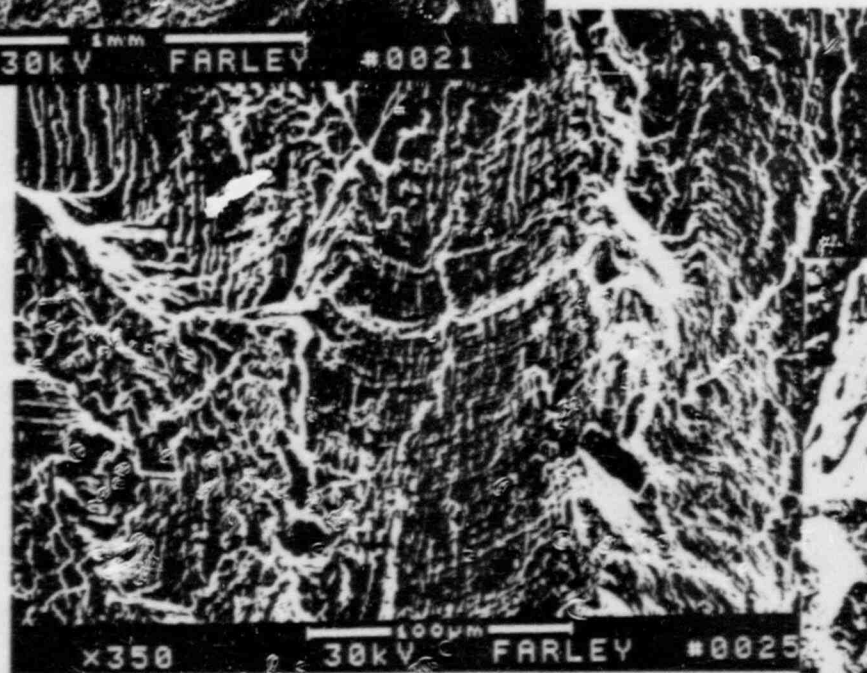
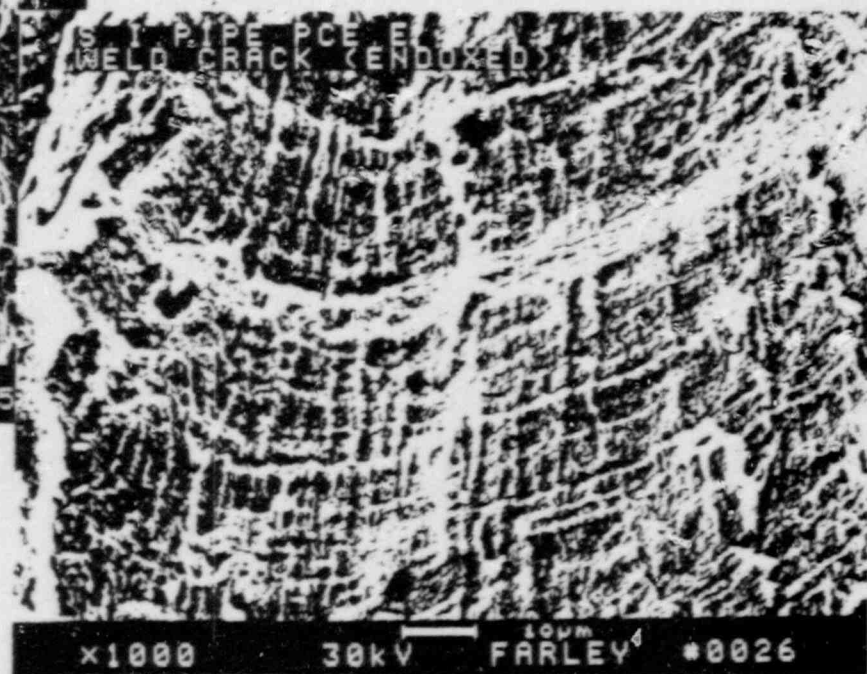
Scanning electron fractographs of the endoxed weld crack on the pipe side illustrating the evidence of fatigue striations.

- 0 THE FATIGUE STRIATION SPACINGS ON THE FRACTURE FACE VARIED APPROXIMATELY BETWEEN 2×10^{-6} IN. TO 8×10^{-6} IN.

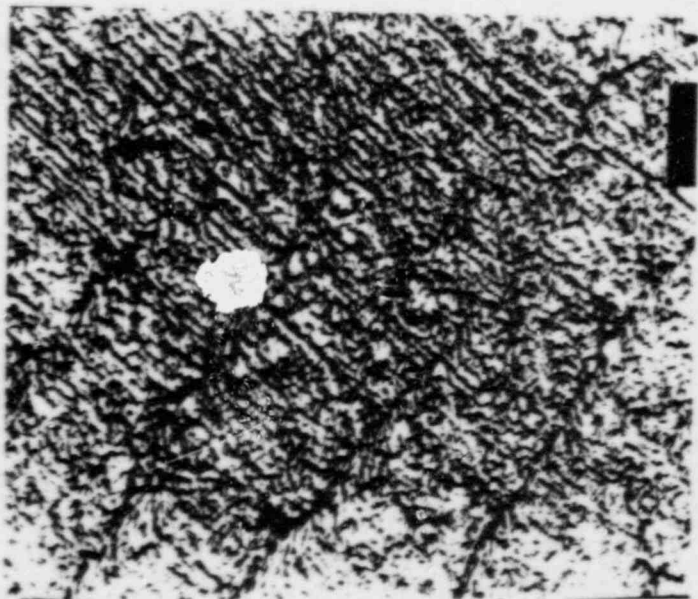
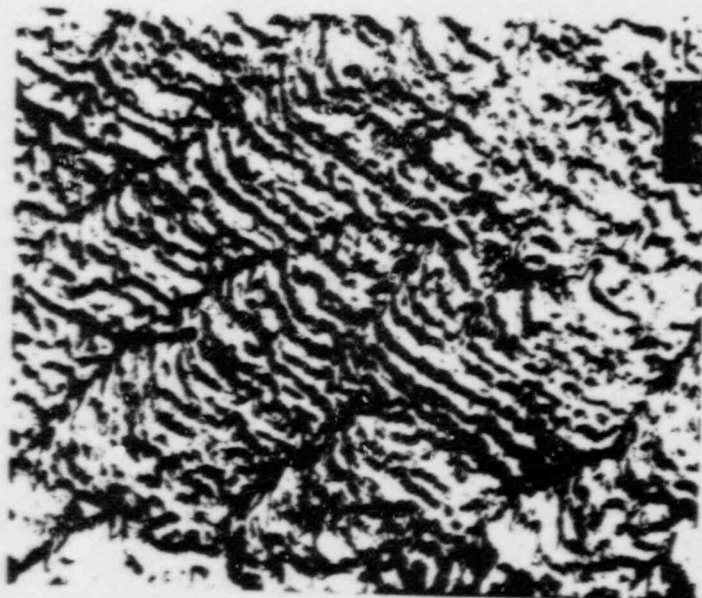
Replica transmission electron micrographs illustrating the typical appearance of the fatigue striations seen at grid location G in sample B.

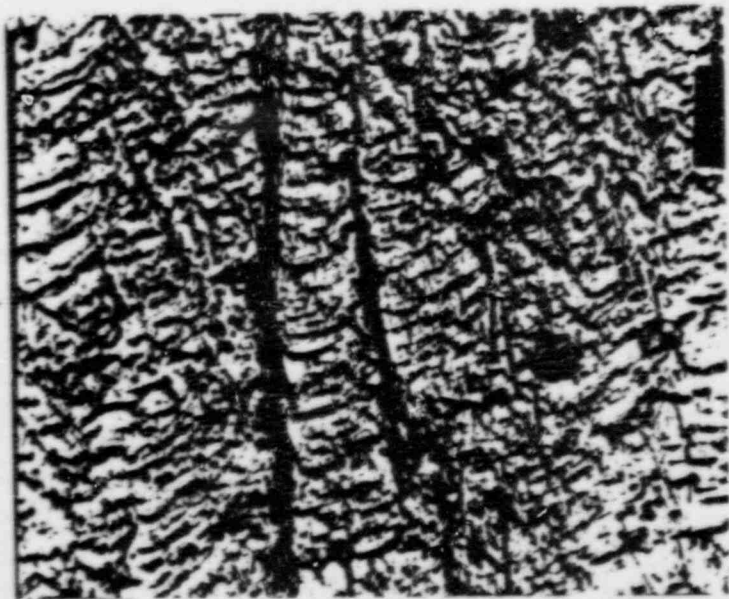
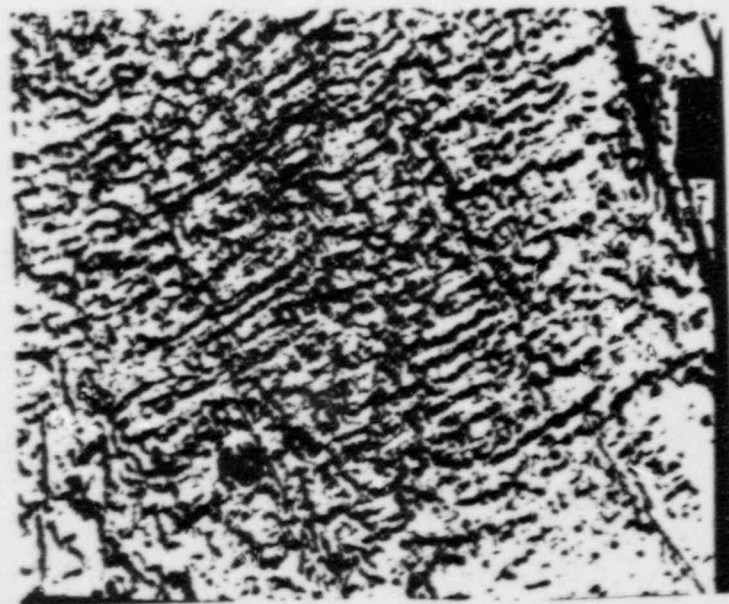
Replica transmission electron micrographs illustrating the typical appearance of the fatigue striations seen at grid location I in sample D.

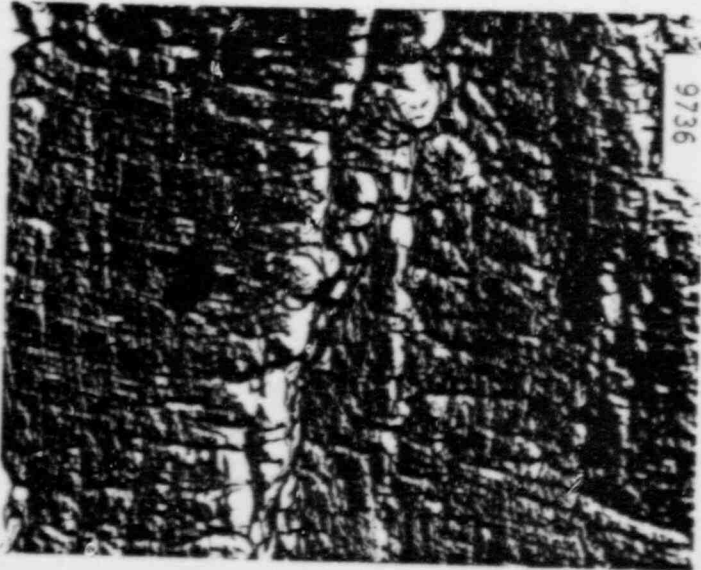
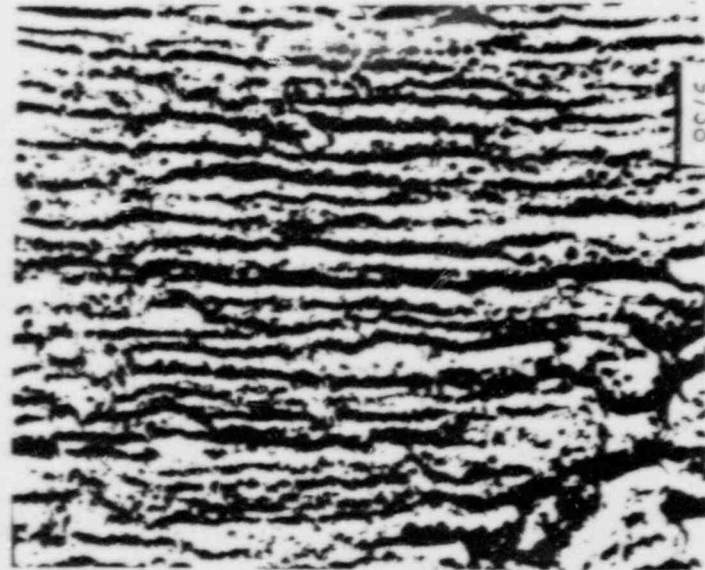
Replica transmission electron micrographs illustrating the typical appearance of the fatigue striations seen at grid location F in sample B.

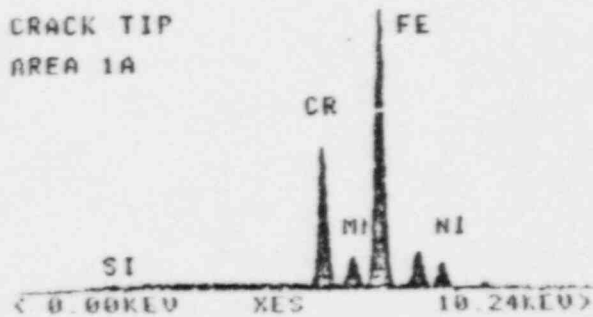
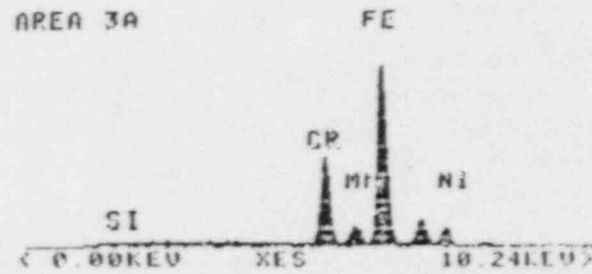
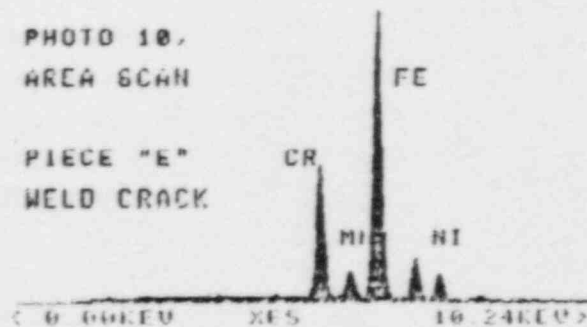
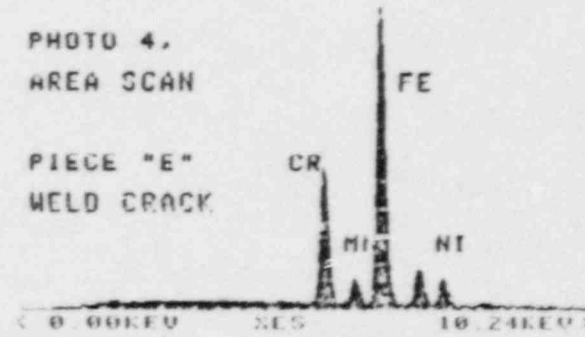
Typical energy dispersive X-ray analysis results obtained from the crack deposits seen on the a) elbow and b) pipe cracks, in the "as opened" conditions.

- 0 CHEMISTRY EVALUATION OF CRACK DEPOSITS BY ENERGY DISPERSIVE X-RAY ANALYSIS FAILED TO CONFIRM EVIDENCE OF ANY AGGRESSIVE ELEMENTS CONTRIBUTING TO THE CRACKING PROCESS. WET CHEMISTRY ANALYSIS RESULTS OF THE PIPE, ELBOW AND WELD MATERIALS SHOWED THAT THE ELBOW AND PIPE MATERIALS MEET THE TYPE 304 STAINLESS STEEL REQUIREMENTS WHILE THE WELD METAL MEETS THE TYPE 308 STAINLESS STEEL REQUIREMENTS.
