SUBJECT: ENFORCEMENT CONFERENCE SUMMARY  
(NRC INSPECTION REPORT NOS. 50-348/88-02 AND 50-364/88-02)

Subject: Potential for Excessive Exposure as a Result of Unauthorized Entry into an Exclusion Area/High Radiation Area

ALABAMA POWER COMPANY  
NRC ENFORCEMENT CONFERENCE  
POTENTIAL OVEREXPOSURE INCIDENT OF 12-28-87  
AGENDA

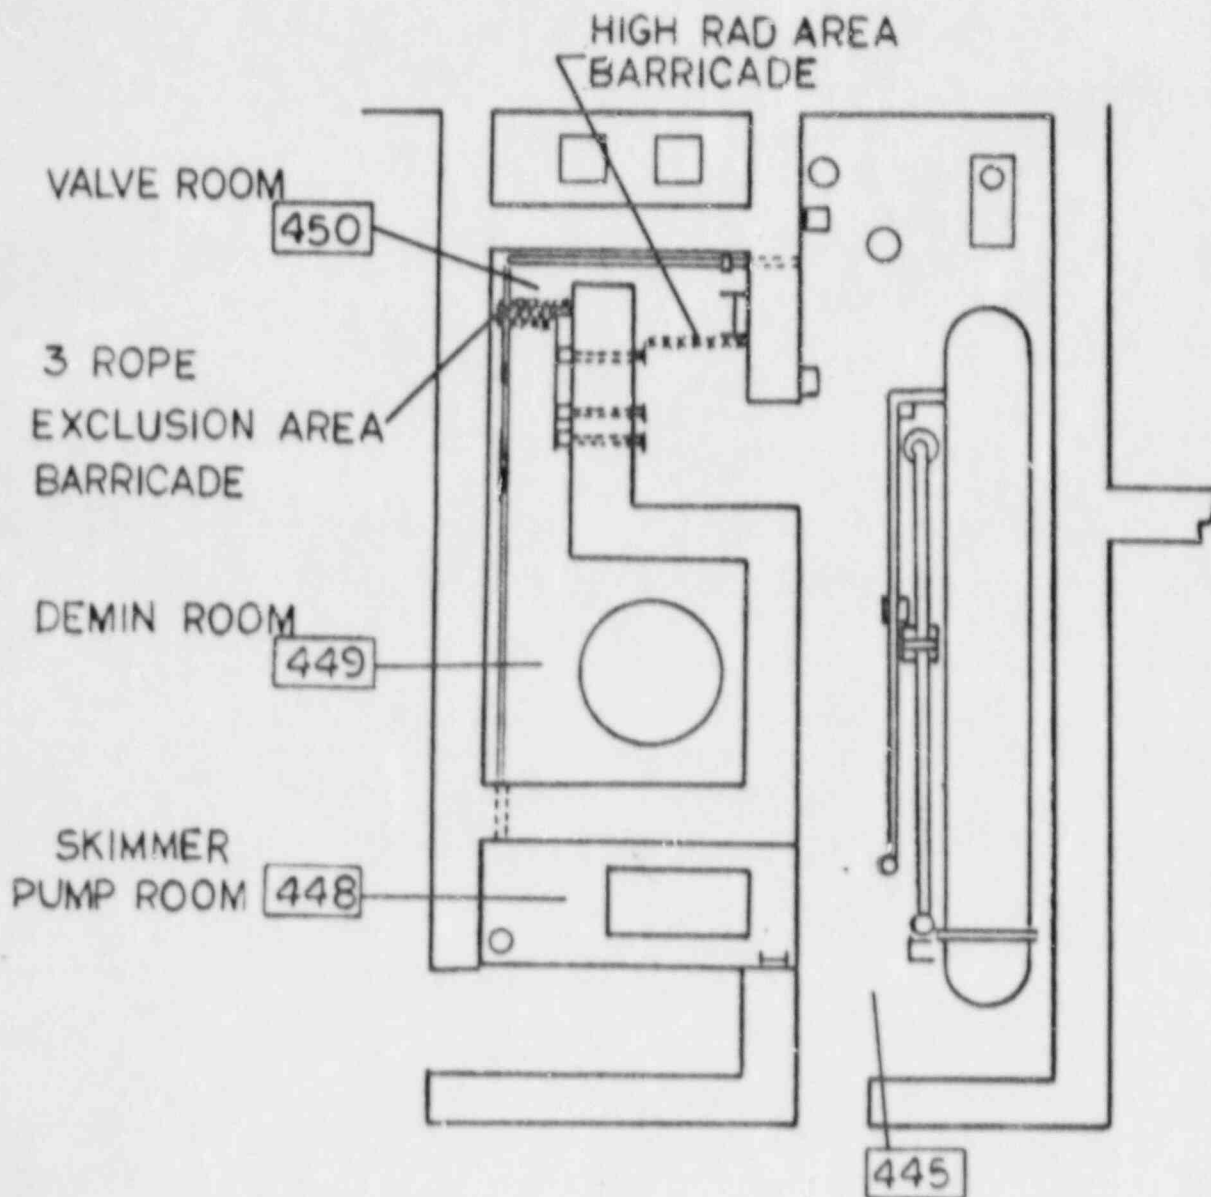
SPENT FUEL POOL IA HX ROOM

OVER  
WALL  
30 R/hr @ 6 ft  
150 R/hr MAX

## HIGH RADIATION AREA EXCLUSION AREA

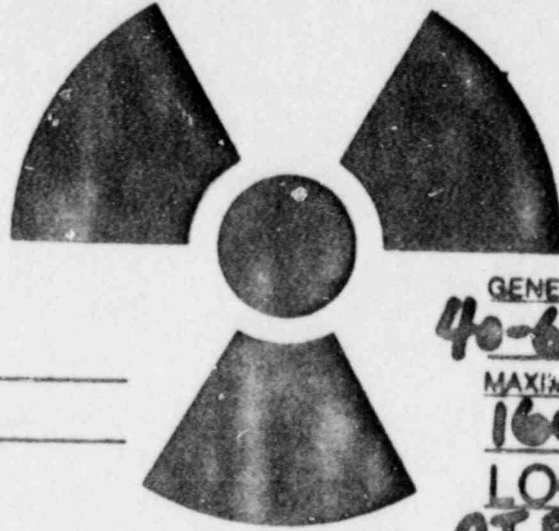
GENERAL AREA DOSE RATE  
**40-60** MR/HR  
MAXIMUM DOSE RATE  
**160** MR/HR  
LOCATED  
**AT BOUNDARY**

**HIGH  
RADIATION AREA  
SEE RWP FOR  
ENTRY  
REQUIREMENTS**

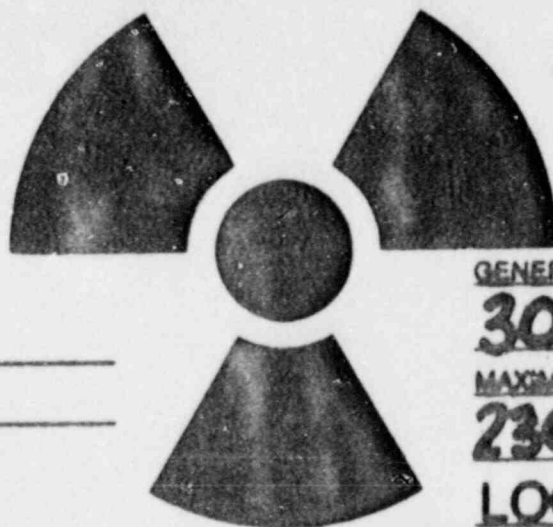
GENERAL AREA DOSE RATE

**30**

MAXIMUM DOSE RATE

**230**

**CONTACT ON DEMIN**

## HIGH RADIATION AREA EXCLUSION AREA
