In Reply Refer To:
Docket: 50-267

FORT ST. VRAIN

NRC - PSC

MANAGEMENT CONFERENCE

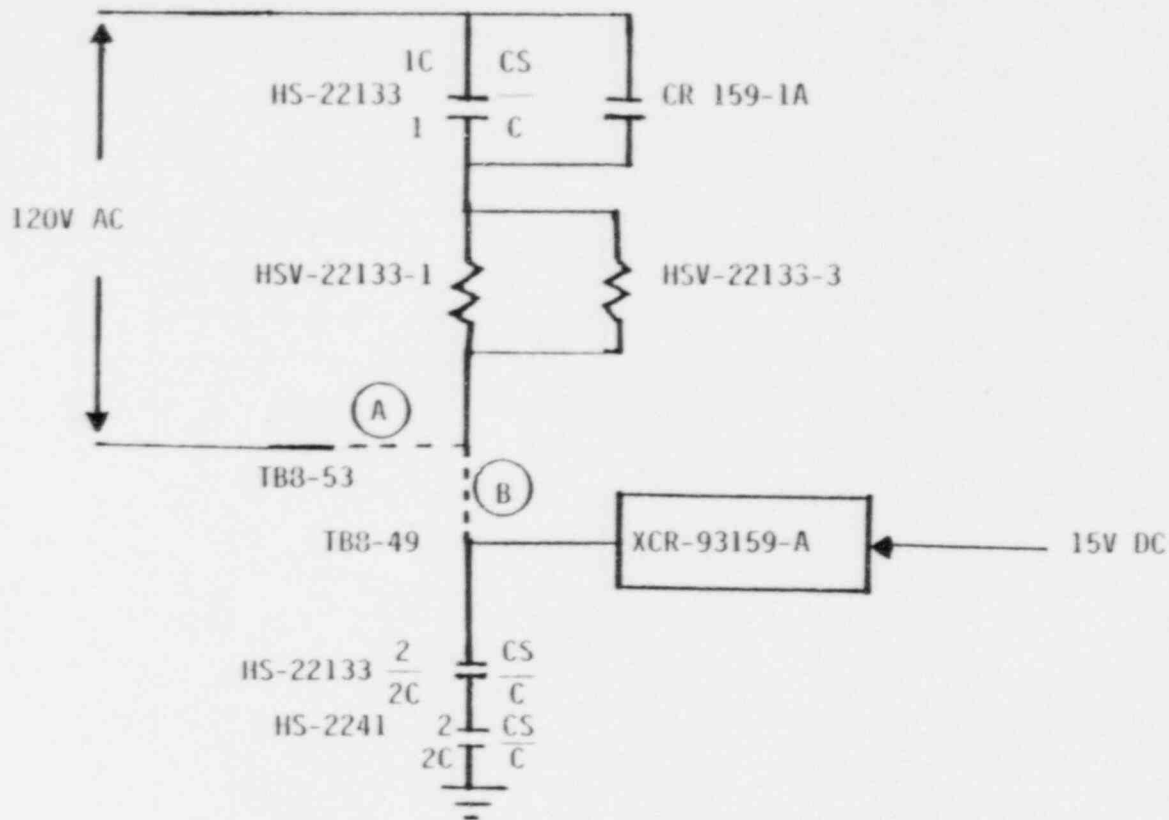
MISLANDED PPS LEAD

- EVENT DESCRIPTION
 - FIRE RECOVERY ACTIVITY
 - ELECTRICIAN PLACED TERMINATIONS ON POINTS 46, 47, 48, AND 49, VERSUS POINTS 46, 47, 48, AND 53
- CAUSE DESCRIPTION - PERSONNEL ERROR
- ACTIONS TAKEN
 - RELANDED LEAD
 - SITUATION DISCUSSED, PERSONNEL ADMONISHED

- A. Design lead connection.
- B. Miswired lead connection.

On December 1, 1987, following work performed under Change Notice CR-2701, cable 7487 was returned to service. During the reconnection of the cable 7487 leads to IB8 in 1-05, the ground return wire for solenoids HSV-22133-1 and HSV-22133-3 was inadvertently connected to the reset circuit of relay XCR-93159-A at IB8-49 instead of the proper location at IB8-53. Independent verification failed to detect the mispositioned lead.

The application of 120V AC to XCR-93159-A damaged the relay and caused it to chatter when energized from the operation of hand switch HS-2241. This chattering induced noise into the wide range channel neutron flux rate of change circuits and produced the reactor scram actuations. Refer to IER 87-029.

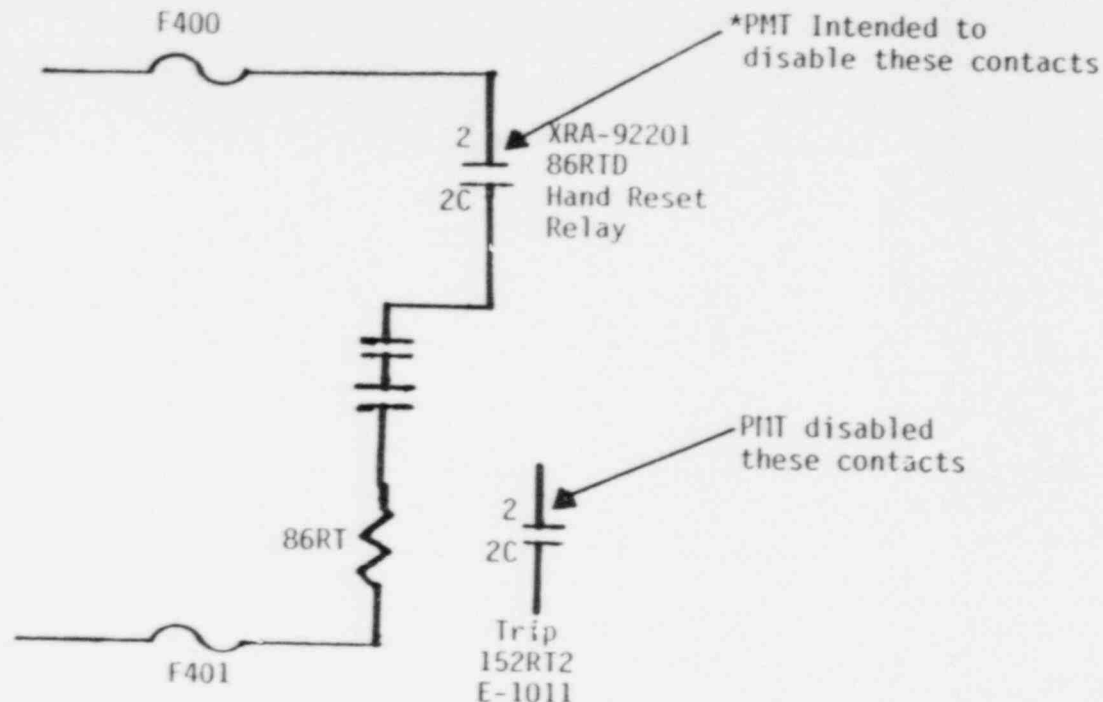
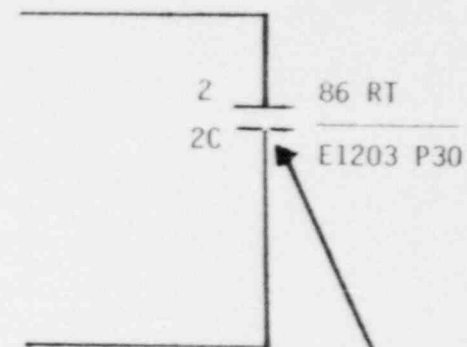
TRIP OF RESERVE AUXILIARY TRANSFORMER

- EVENT DESCRIPTION
 - POST MAINTENANCE TEST ACTIVITY
 - TEST PROCEDURE PREPARED BY BACKUP SYSTEM ENGINEER
 - RAT TRIP FUNCTION TO BE DISABLED FOR PURPOSE OF TEST
 - FIELD WALKDOWN OF PMT RESULTED IN INCORRECT CHANGE TO PROCEDURE
 - FIELD ERROR FAILED TO DEFEAT RAT TRIP DURING TEST
- CAUSE DESCRIPTION
 - PERSONNEL ERROR
 - PROCEDURAL INADEQUACY
- ACTIONS TAKEN
 - PROCEDURE CORRECTED
 - ORIGINAL DESIGN FUNCTION OF EQUIPMENT VERIFIED
 - IN-PLANT OPERATING EVENT REVIEW PERFORMED (OER 87-22)
 - ADMINISTRATIVE PROCEDURE BEING REVISED TO INCORPORATE INDEPENDENT REVIEW FOR PMT DEVELOPMENT

This is a portion of drawing E-1011. It was on this drawing that the 2-2c contacts of 86RT were mistaken for the 2-2c contacts of 86RTD.

Prior to reactor startup, a Post Maintenance Test was to be performed on firewater deluge control relay CR-4505. This relay initiates numerous actions including local and remote alarms, firewater pump starts, and firewater system valve closures. CR-4505 was disassembled and cleaned following the inadvertent RAT deluge actuation that occurred on October 30, 1987. Following these maintenance activities, Post Maintenance Testing (PMT) was required. The test plan was to actuate the RAT deluge system and CR-4505, via HS-4516 and verify completion of the various automatic actions that are initiated by CR-4505. Actuation of the RAT deluge system automatically opens the RAT feedbreakers; this automatic RAT trip function was to be disabled. To accomplish this, without disabling other functions, one of the leads on the 2-2C contact of XRA-92201 (86RTD) was to be lifted. After a field walkdown it was discovered that due to its physical location, XRA-92201 was relatively inaccessible; to remove its housing cover as to allow the disconnection of the 2-2C contact leads would require a substantial amount of time. Plant electrical drawings were referenced. On E-1011, the 2-2C contacts of 86RT (see Figure 2) were mistaken for the 2-2C contact of 86RTD. This error failed to prevent the automatic opening of the RAT feedbreakers during the test as intended.

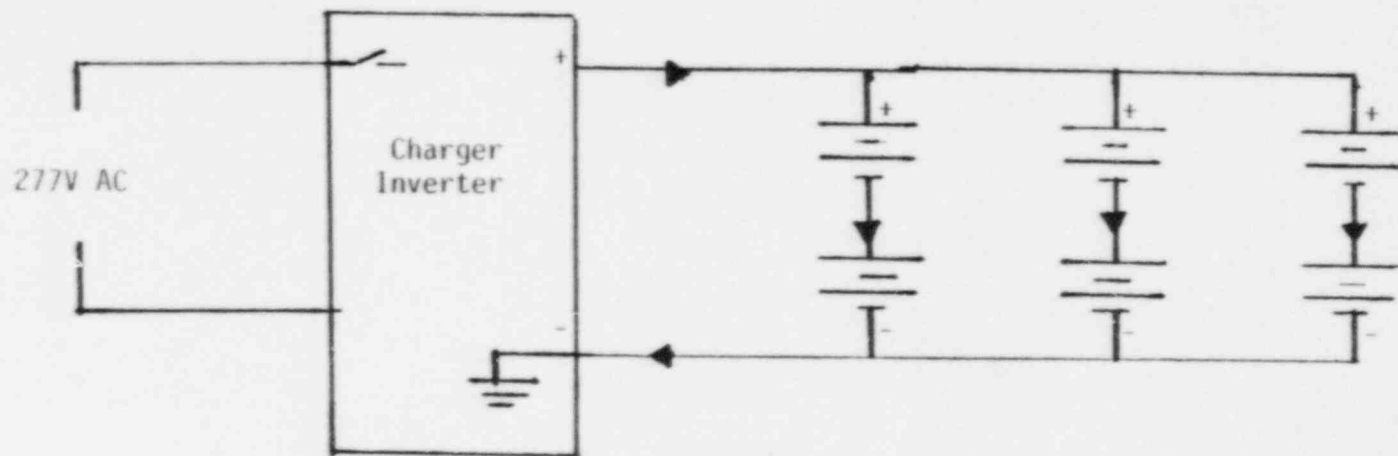
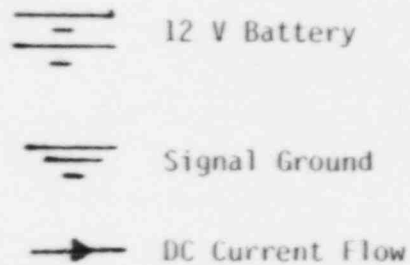
EMERGENCY LIGHTING BATTERIES DAMAGE

- EVENT DESCRIPTION
 - VENDOR INSTALLATION PRECAUTION NOT INCORPORATED INTO FIELD INSTALLATION INSTRUCTIONS
 - INSTALLATION RESULTED IN DAMAGE TO BATTERIES
 - PROBLEM DISCOVERED DURING PRE-OPERATIONAL TESTING
- CAUSE DESCRIPTION - PROCEDURAL INADEQUACY
- ACTIONS TAKEN
 - NEW BATTERIES OBTAINED AND INSTALLED CORRECTLY (IN PROGRESS)
 - THE DESIGN CHANGE PROCESS IS BEING CHANGED WITH ONE OF THE OBJECTIVES BEING IMPROVING WORK PACKAGES

The charger inverter supply was turned off with the batteries connected. This allowed the batteries to completely discharge. When the switch was turned on, high current for charging boiled the electrolyte and ruined the batteries.

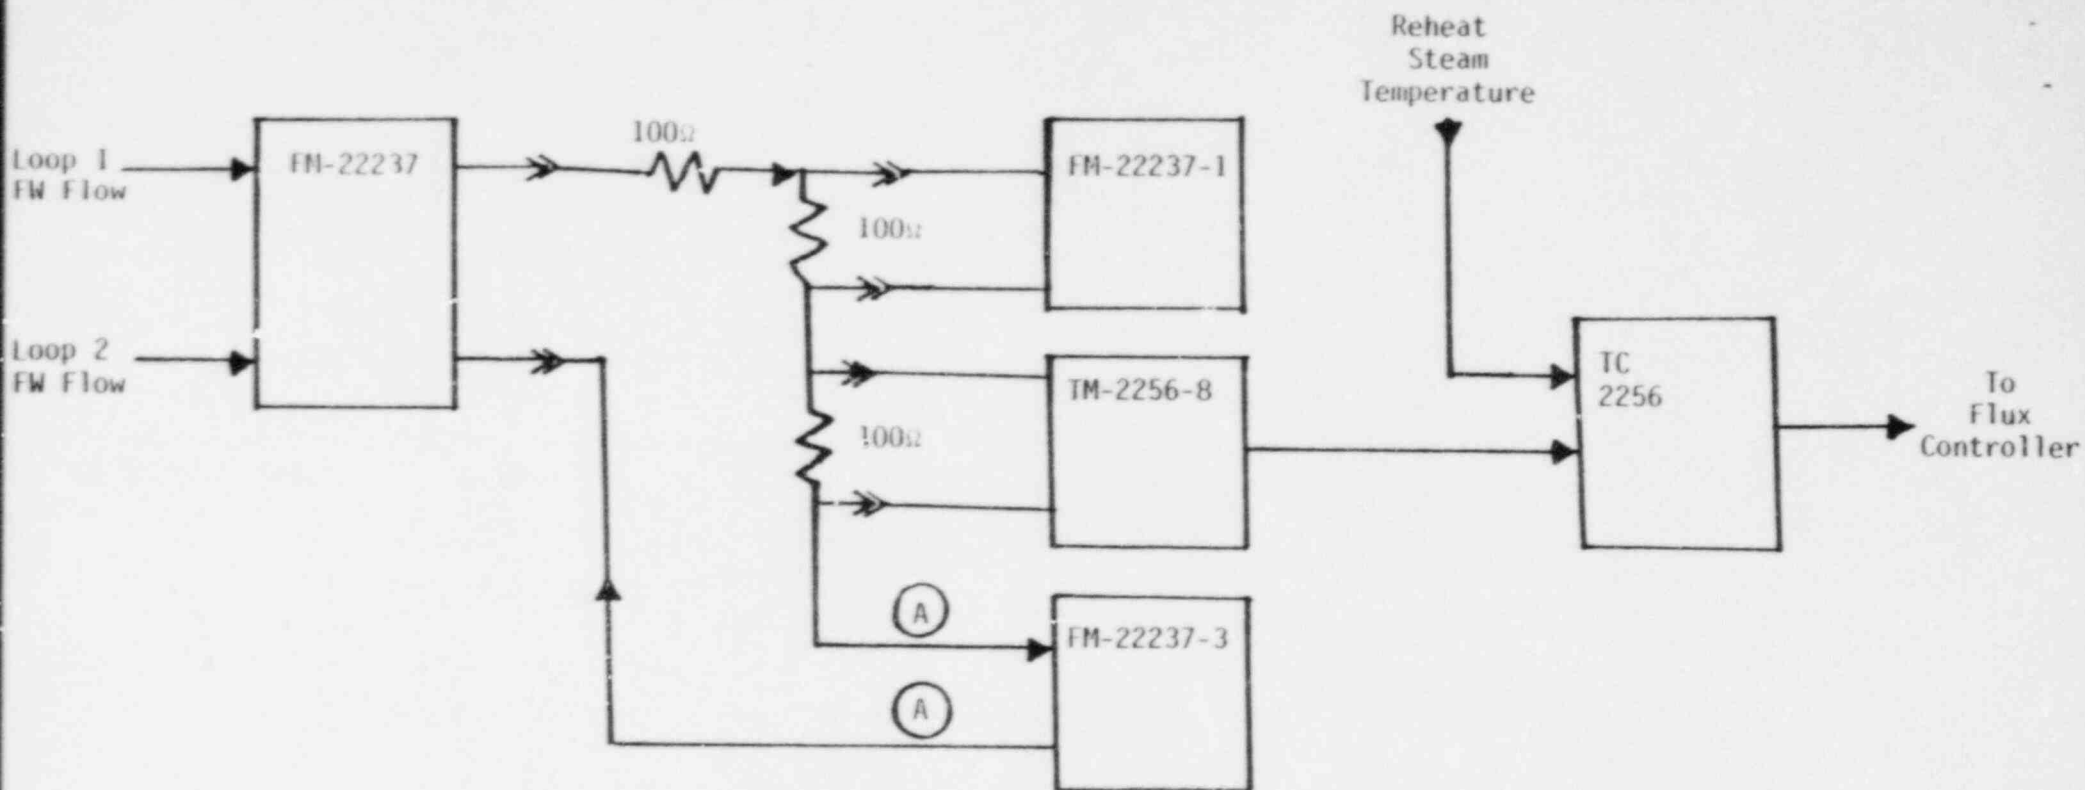
HOT REHEAT ROD RUNBACK

- EVENT DESCRIPTION
 - TROUBLESHOOTING EFFORT FOR CORRECTIVE MAINTENANCE UNDERWAY
 - SYSTEM WAS RECONFIGURED FOR PRIMARY EFFECTS WITHOUT ADEQUATE CONSIDERATION OF SECONDARY EFFECTS
 - MAINTENANCE ACTIVITY INTRODUCED UNANTICIPATED SECONDARY CIRCUIT RESPONSE
- CAUSE DESCRIPTION
 - PROCEDURAL INADEQUACY
 - ADMINISTRATIVE CONTROLS
- ACTIONS TAKEN
 - OPERATOR RESPONSE MINIMIZED EFFECT OF TRANSIENT
 - SECONDARY CIRCUIT AND OTHER CONTROLS WERE CONFIGURED TO MAINTAIN PARAMETERS
 - CONTROLS RECALIBRATED AS INTENDED

(A) Leads disconnected by Instrument Tech.

Results: When the leads to FM-22237-3 were disconnected the current (ma) output of FM-22237 went to zero.

The loss of input to TM-2256-8 feeds through to the setpoint of TC-2256 and the flux controller as an error. The magnitude was sufficient to cause a rod runback.

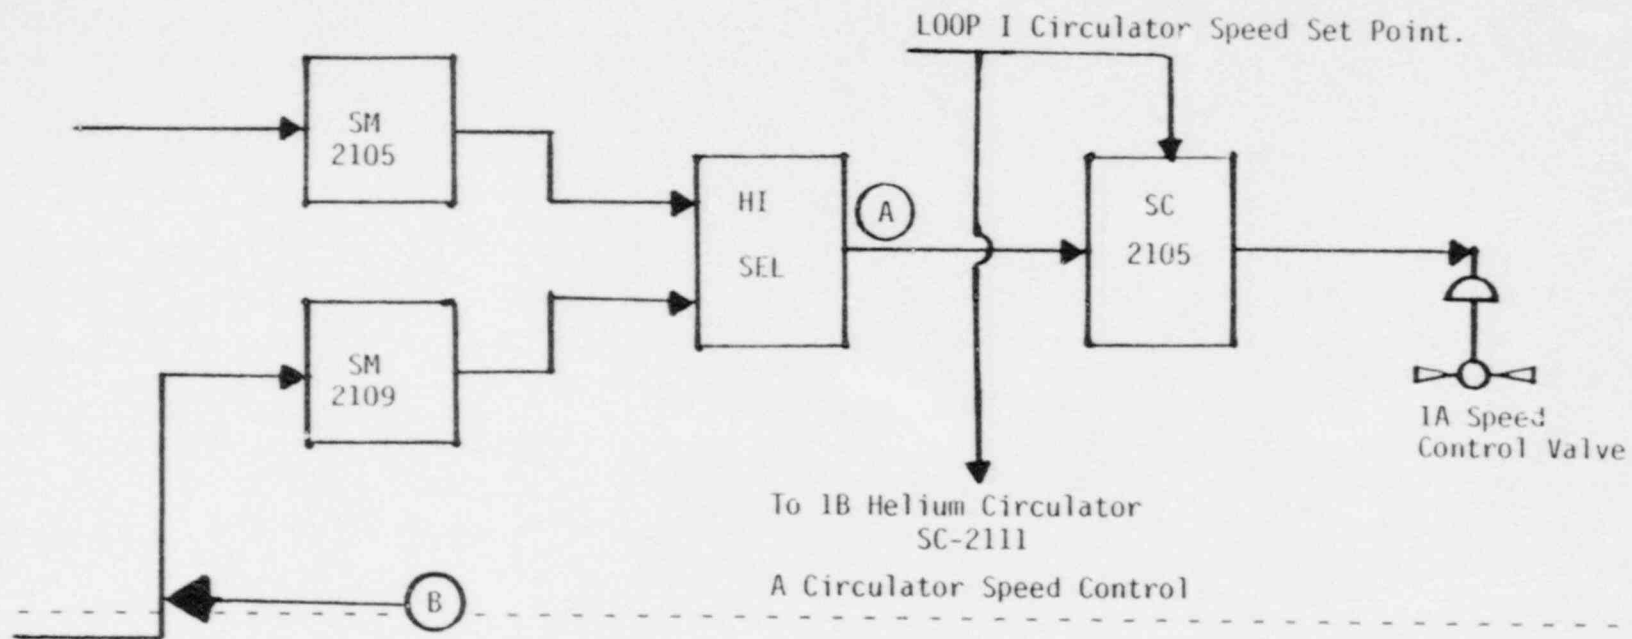
MISLANDED CIRCULATOR SPEED CABLES

- EVENT DESCRIPTION
 - PLANT PERFORMANCE TESTING IDENTIFIED POTENTIAL PROBLEM
 - CORRECTIVE MAINTENANCE ACTIVITY UNDERTAKEN
 - INCORRECT CABLE FROM 'B' CIRCULATOR ATTACHED TO 'A' CIRCULATOR CONTROLS
 - PLANT TRANSIENT RESULTED FROM 'A' CIRCULATOR CONTROLS RESPONDING TO 'B' CIRCULATOR PROCESS INPUTS
- CAUSE DESCRIPTION
 - PERSONNEL ERROR
 - PROCEDURAL INADEQUACY
- ACTIONS TAKEN
 - ALL SPEED CABLES COLOR CODED FOR CORRESPONDING CIRCULATORS
 - CABLE NUMBERS AND LOCATIONS VERIFIED TO DESIGN DOCUMENTS, NO OTHER DEFICIENCIES FOUND
 - PLANT PERFORMANCE TEST SURVEILLANCE WAS REVISED TO DOCUMENT CABLE CHANGES AND PROVIDE FOR INDEPENDENT REVIEW OF SURVEILLANCE DRIVEN ACTIVITIES

A. 1A Helium Circulator measured signal.

B. 1B Helium Circulator speed cable improperly connected to 1A Helium Circulator.

RESULT: When B Helium Circulator speed exceeds A Helium Circulator speed and is above the speed set point.

1. 1A Helium Circulator speed controller starts closing the speed valve which decreases 1A Helium Circulator speed. This process repeats until 1A Circulator trips on programmed speed low.

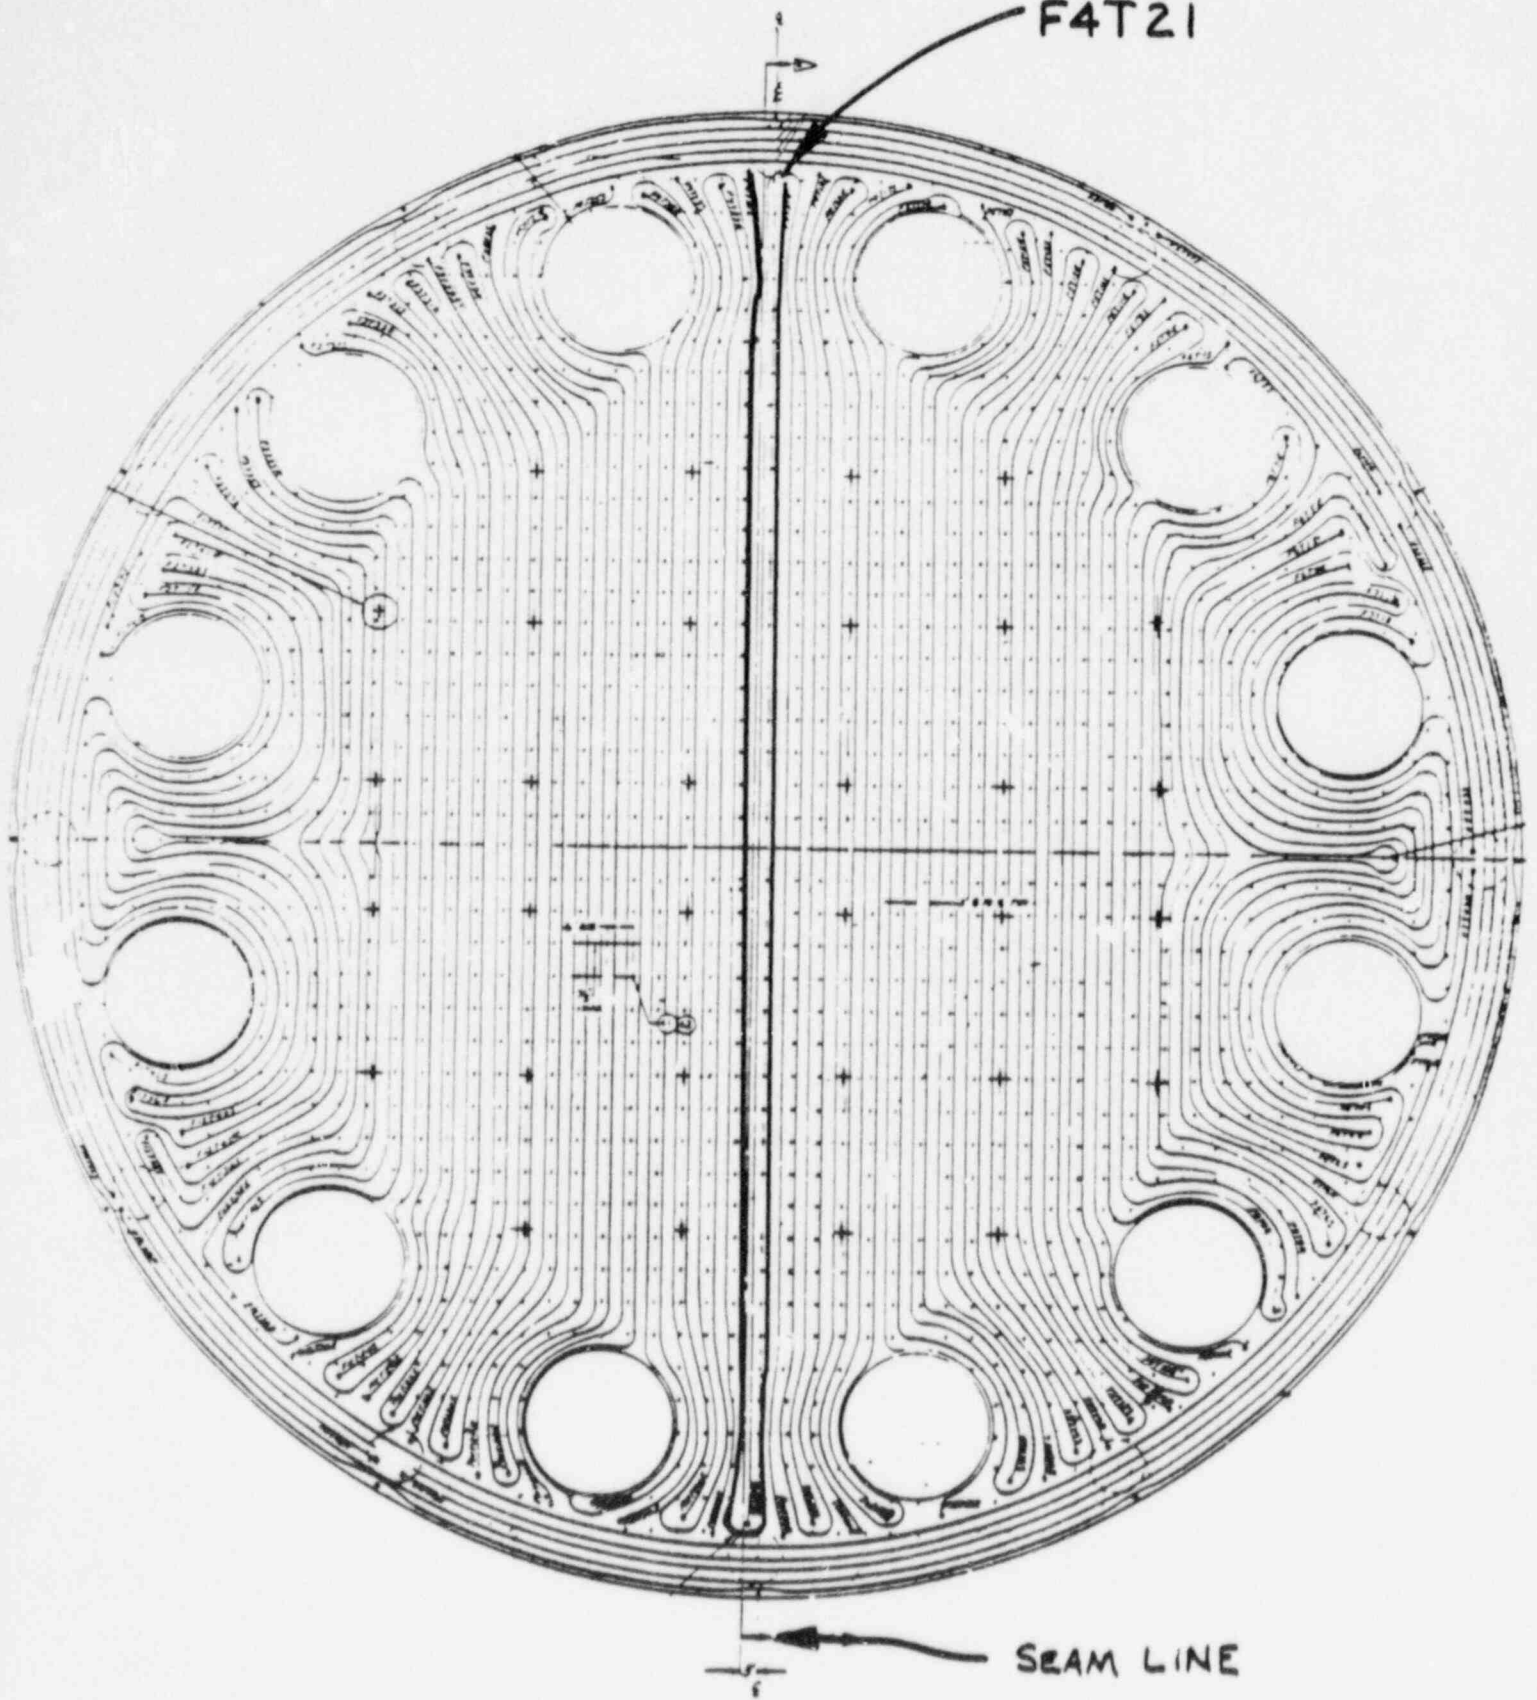
- o APRIL 1982 ANOTHER LEAKING CSF TUBE IDENTIFIED TOP HEAD TUBE (F4T21)

- o CSF COOLING TUBE F4T21 WAS REMOVED FROM SERVICE AND CAPPED EXTERNAL TO THE PCRV
- o SEPT, 1982 SIGNIFICANT CSF VENT GAS FLOW NOTED FOLLOWING A REACTOR SCRAM FROM 70% POWER
- o TWO (2) OF THE ORIGINALLY EPOXY REPAIRED CSF SIDEWALL TUBES WERE IDENTIFIED AS LEAKING
- o INSTALLED A LAMINAR FLOW ELEMENT IN THE CSF VENT SYSTEM TO PERMIT FLOW DETERMINATION MONITORING AND TRENDING (DEC 1982)
- o CHARACTERIZED CSF LINER LEAK BASED ON PRIMARY COOLANT CONDITIONS

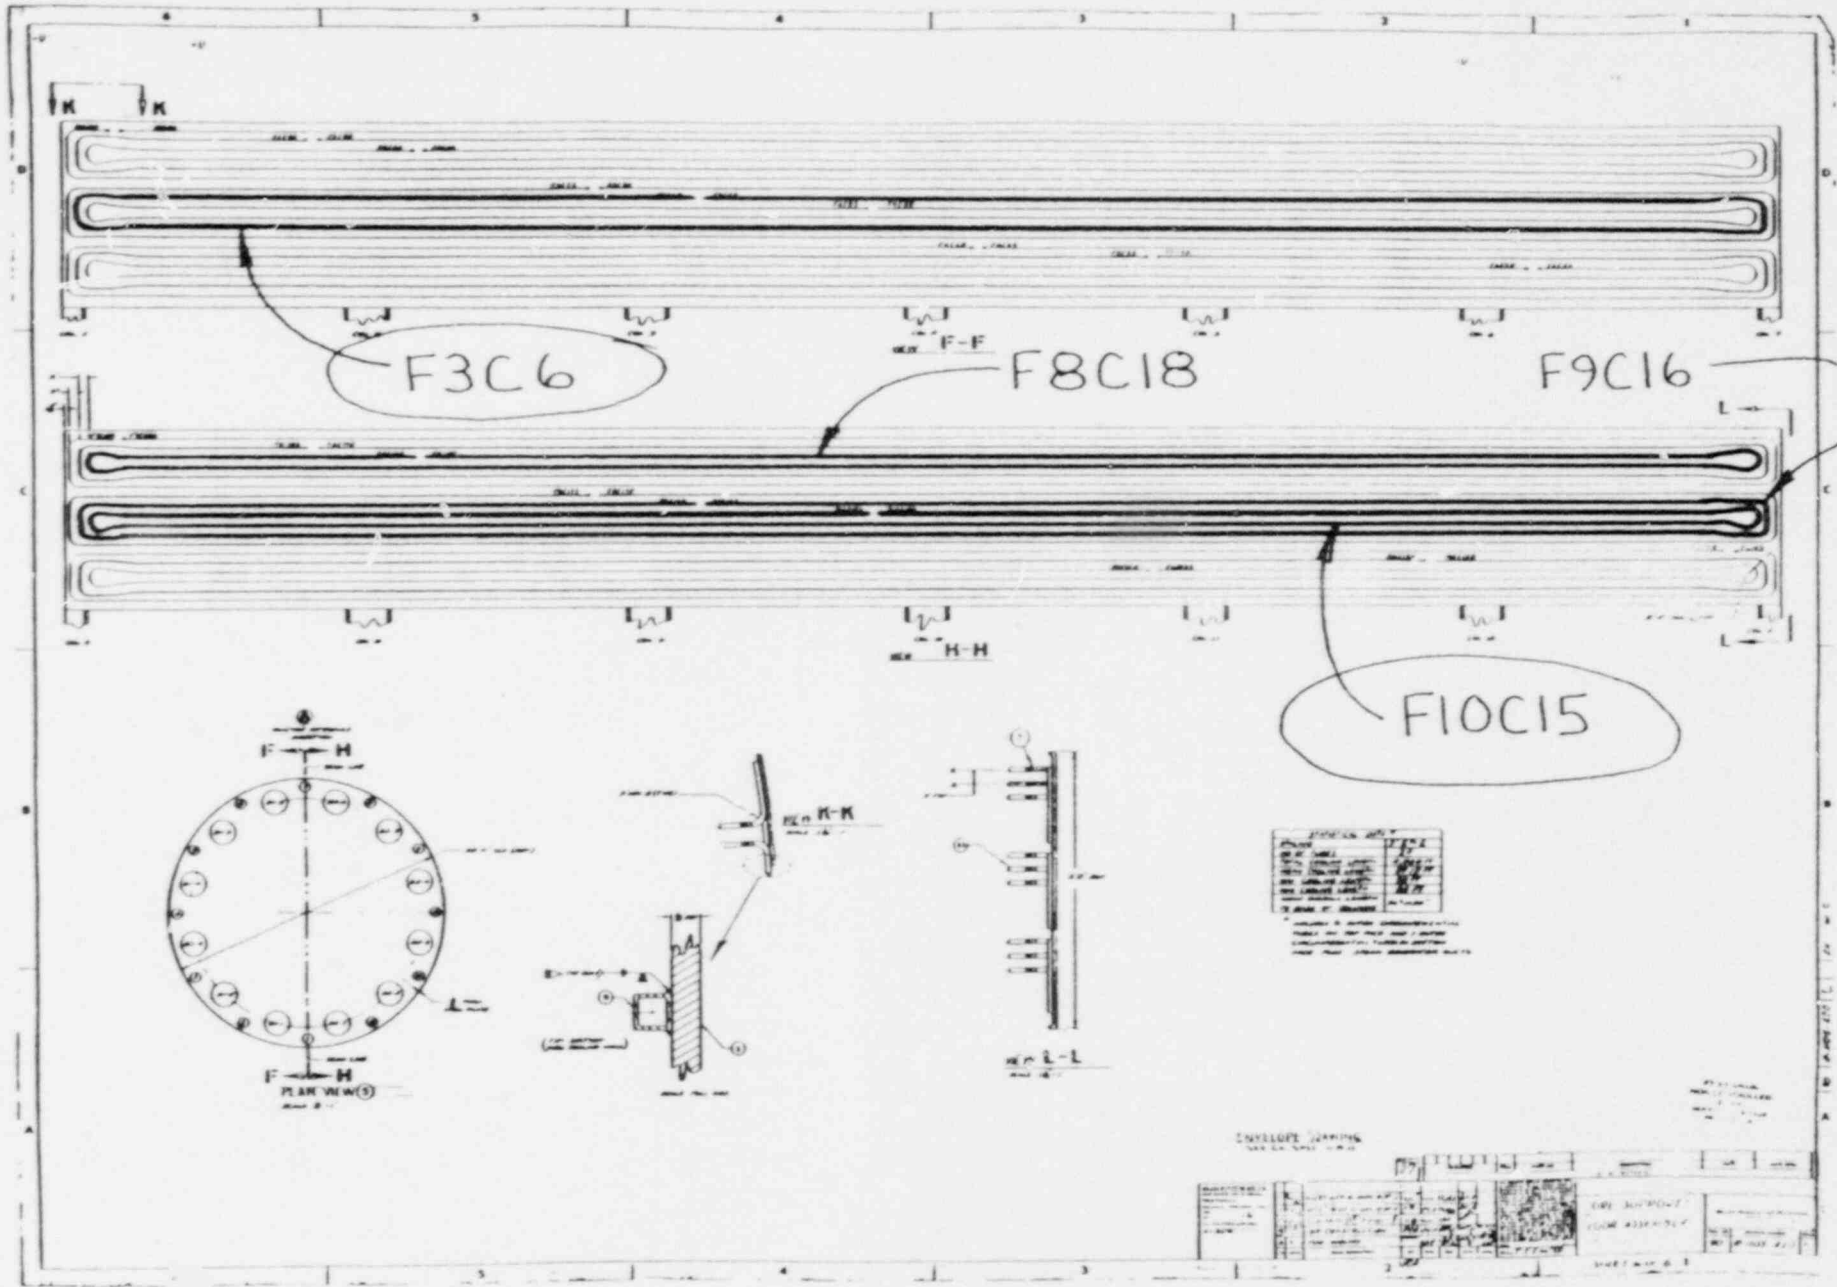
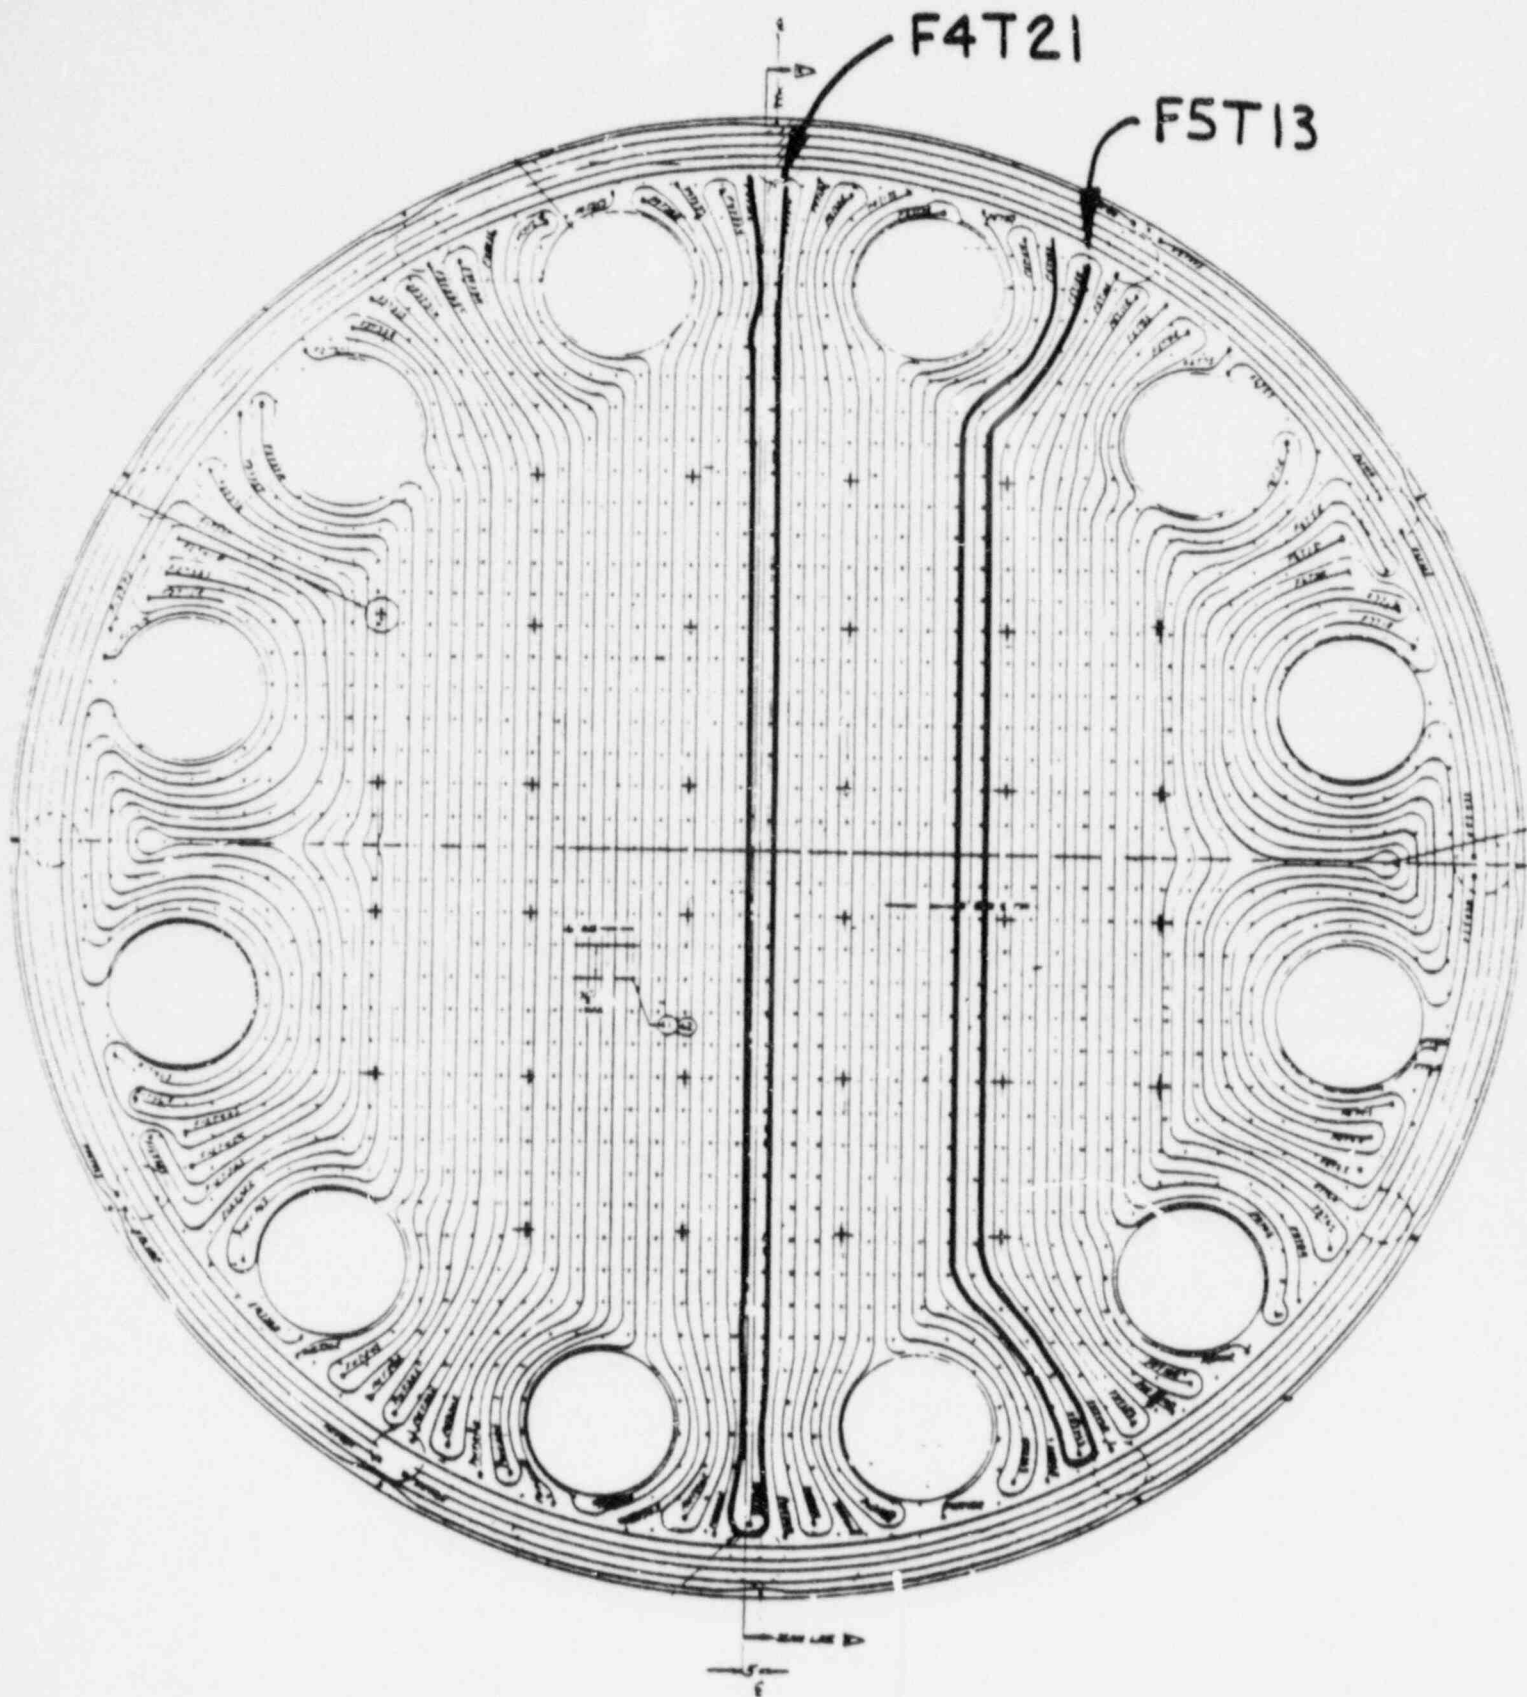
- o EARLY 1984 - SUCCESSFULLY REPAIRED THE TWO (2) RECURRING CSF SIDEWALL TUBE LEAKS

- o SPRING 1984 - IDENTIFIED ANOTHER CSF TOP HEAD COOLING TUBE LEAK (F5T13)

- o THIS TUBE WAS VALVED OUT OF SERVICE AND REMAINS OUT OF SERVICE AT THE PRESENT TIME
