LICENSEE EVENT REPORT (LER)

FACILITY NAME (1) Sequoyah, Unit 2	DOCKET NUMBER (2) 0 5 0 0 0 3 2 8	PAGE (3) 1 OF 07
---------------------------------------	--	---------------------

Title: Inadequate Configuration Control Caused Two Auxiliary Feedwater Flow Paths To Be Inoperable Resulting In Noncompliance With Technical Specification 3.7.1.2

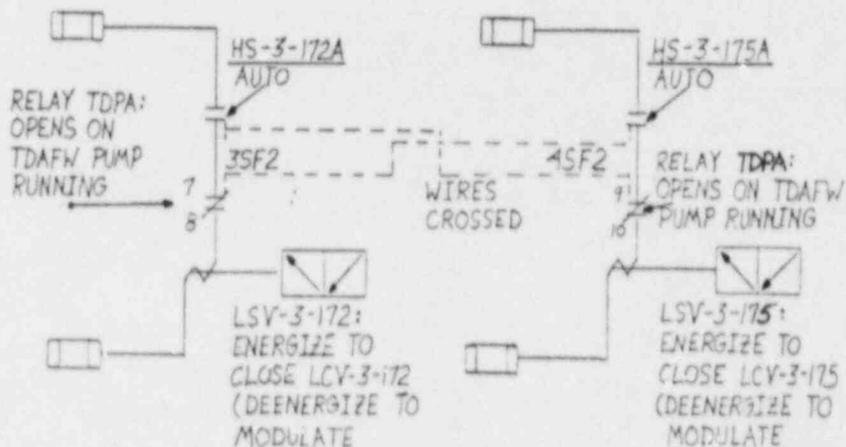
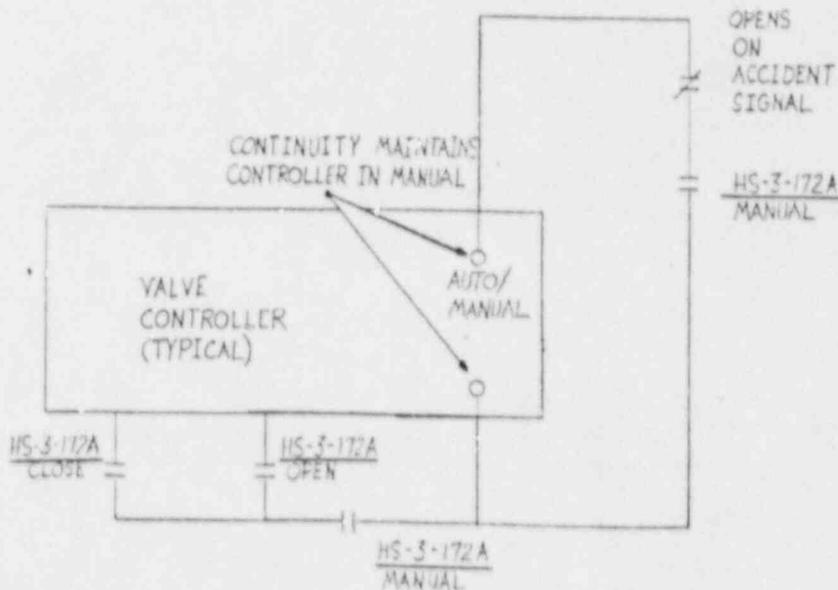
FIGURE 1

The immediate cause of the interaction between 2-LCV-3-172 and -175 was an incorrect wiring configuration. The crossing of wires 3FS2 and 4SF2 completed the circuit from handswitch 2-HS-3-172A to solenoid valve 2-LSV-3-175, and from handswitch 2-HS-3-175A to solenoid valve 2-LSV-3-172 (see Figure 1). Thus, with both valves in the automatic mode, the associated solenoid valves remained energized and both valves remained closed. However, when 2-HS-3-172A was placed in MANUAL, the circuit to solenoid valve 2-LSV-3-175 was opened and the subject valve lost power. Deenergizing 2-LSV-3-175 then allowed 2-LCV-3-175 to modulate; however, since the circuit through 2-HS-3-175A to solenoid valve 2-LSV-3-172 remained energized, 2-LCV-3-172 remained closed. The incorrect wiring configuration would also have allowed 2-LCV-3-172 to modulate if handswitch 2-HS-3-175A was switched to MANUAL while 2-LCV-3-172 remained in the automatic mode.

The root cause of this event was the failure to comply with established configuration control requirements. Although the specific work activity that caused this event could not be determined, TVA believes that the failure to uniquely identify the wires that were lifted during a performance of IMI-99 RT611A/B (before November 5, 1987) resulted in wires 3FS2 and 4SF2 being improperly reterminated. IMI-134, "Configuration Control of Instrument Maintenance Activities," requires wire lifts to be recorded in sufficient detail

As immediate corrective action, wires 3FS2 and 4SF2 were reterminated at their proper terminals in accordance with WR B290386. Following verification that 2-LCV-3-172 and -175 were capable of performing their intended function, LCO 3.7.1.2 was exited.
