Reactor Operating Experiences

1975 - 1977

U.S. NUCLEAR REGULATORY COMMISSION LICENSEE OPERATIONS EVALUATION BRANCH

REACTOR OPERATING EXPERIENCES
1975-1977

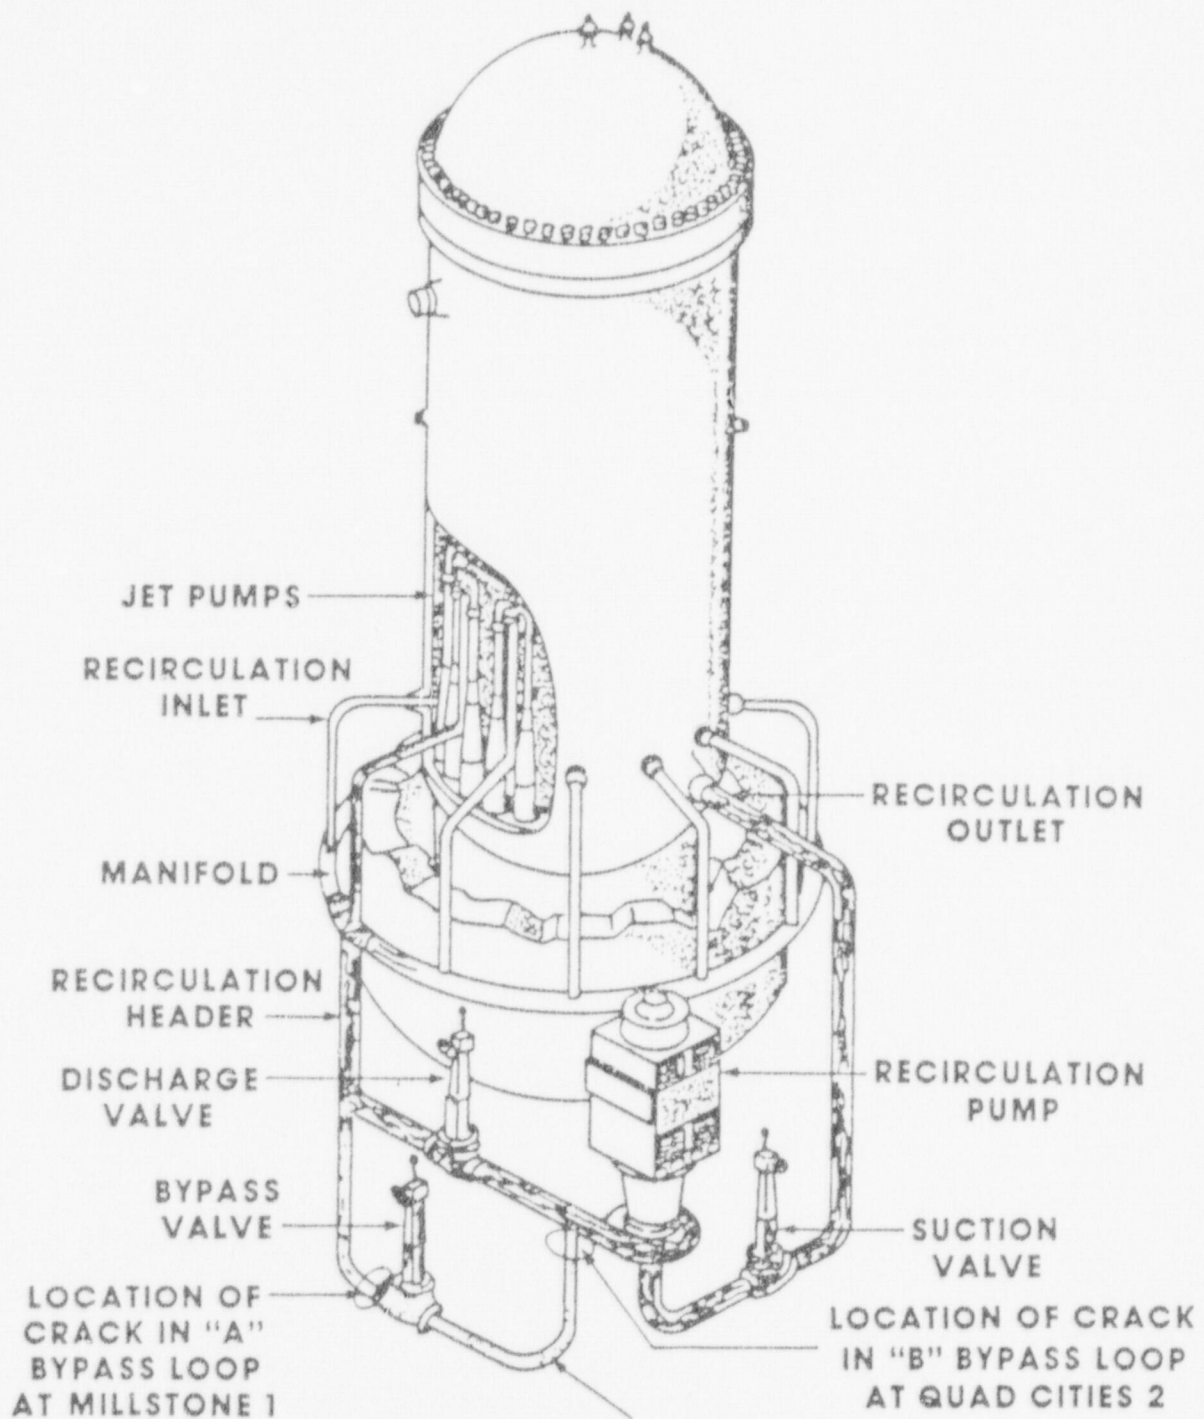
FIGURE 3

4" DIAMETER BYPASS LINE
 THERE IS ANOTHER IDENTICAL BYPASS
 LINE BUT IT IS NOT SHOWN IN THIS FIGURE

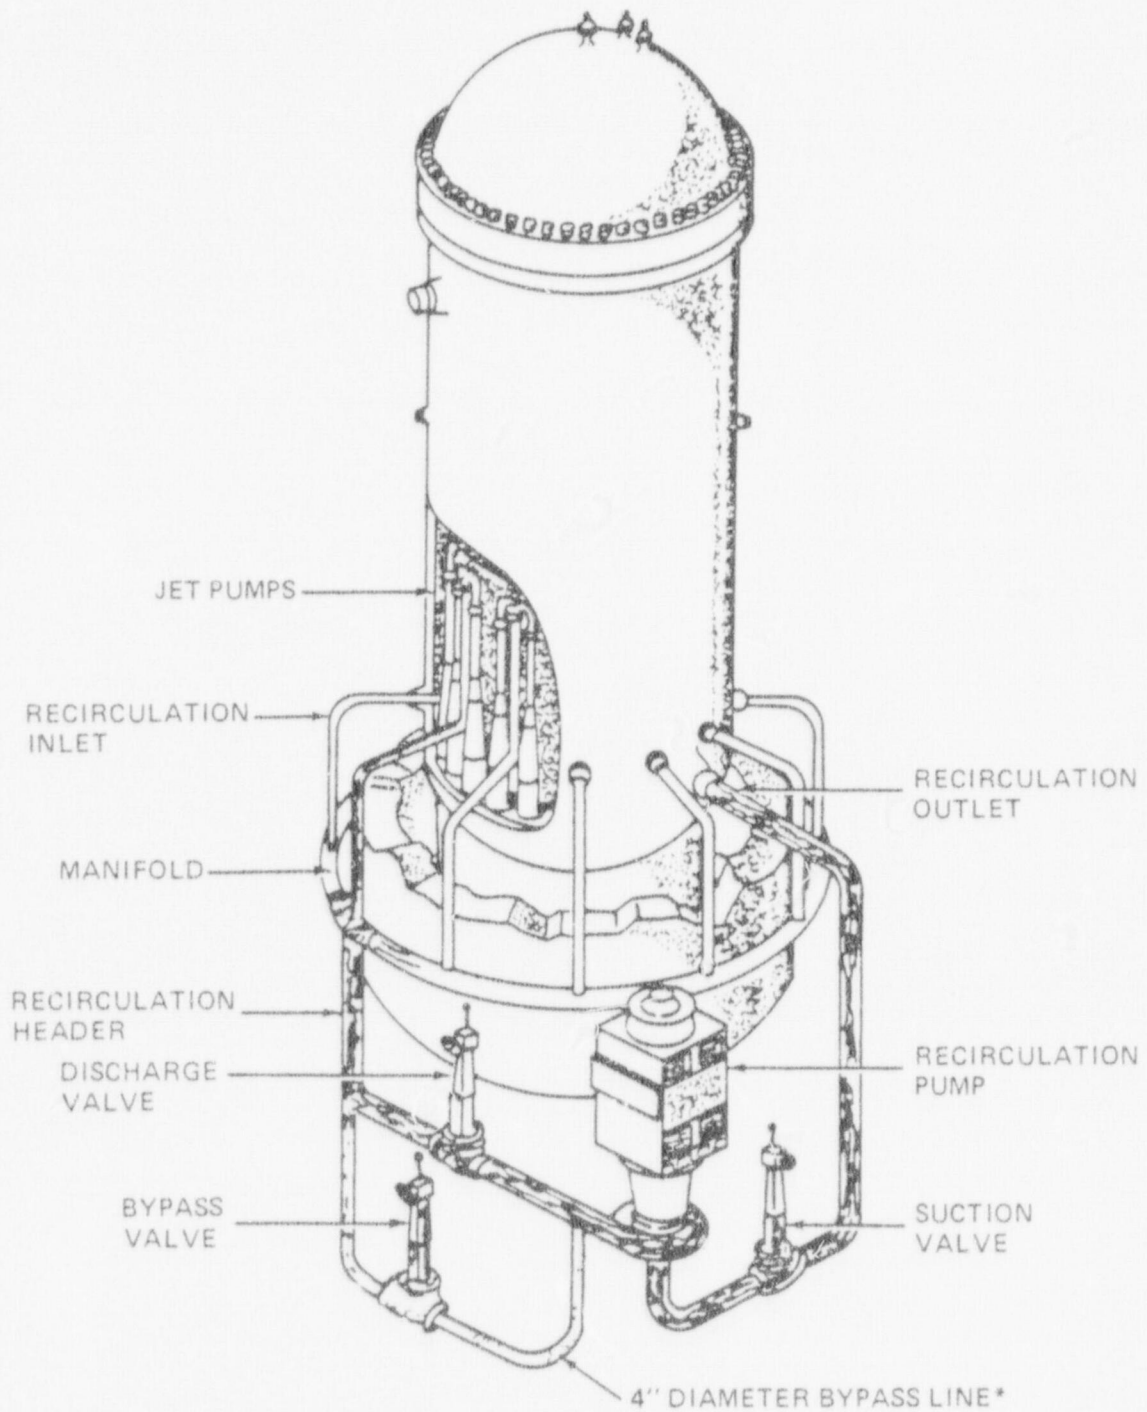
Figure 1

*THERE IS ANOTHER IDENTICAL BYPASS LINE BUT IT IS NOT SHOWN IN THIS FIGURE

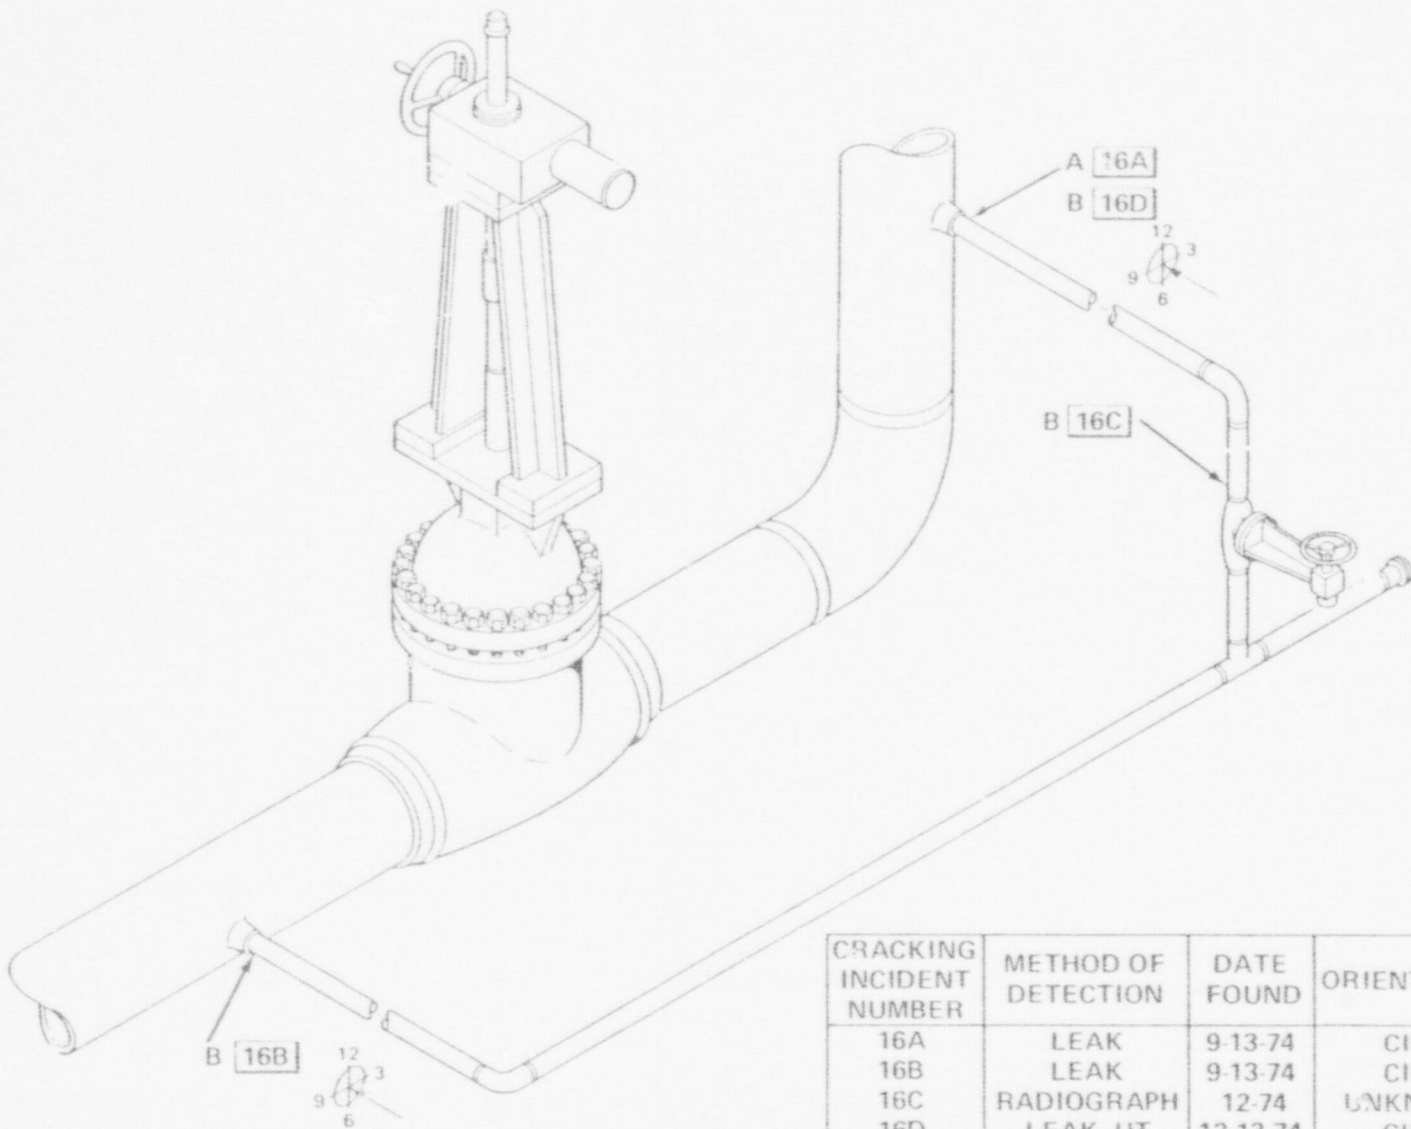
Figure 3. Crack Locations – Dresden 2 Recirculation Bypass Lines – Loops A and B

CRACKING INCIDENT NUMBER	METHOD OF DETECTION	DATE FOUND	ORIENTATION	AZIMUTHAL LOCATION
16A	LEAK	9-13-74	CIRC	3:00
16B	LEAK	9-13-74	CIRC	12:00
16C	RADIOGRAPH	12-74	UNKNOWN	UNKNOWN
16D	LEAK, UT	12-13-74	CIRC	3:00-5:00 6:00-10:00

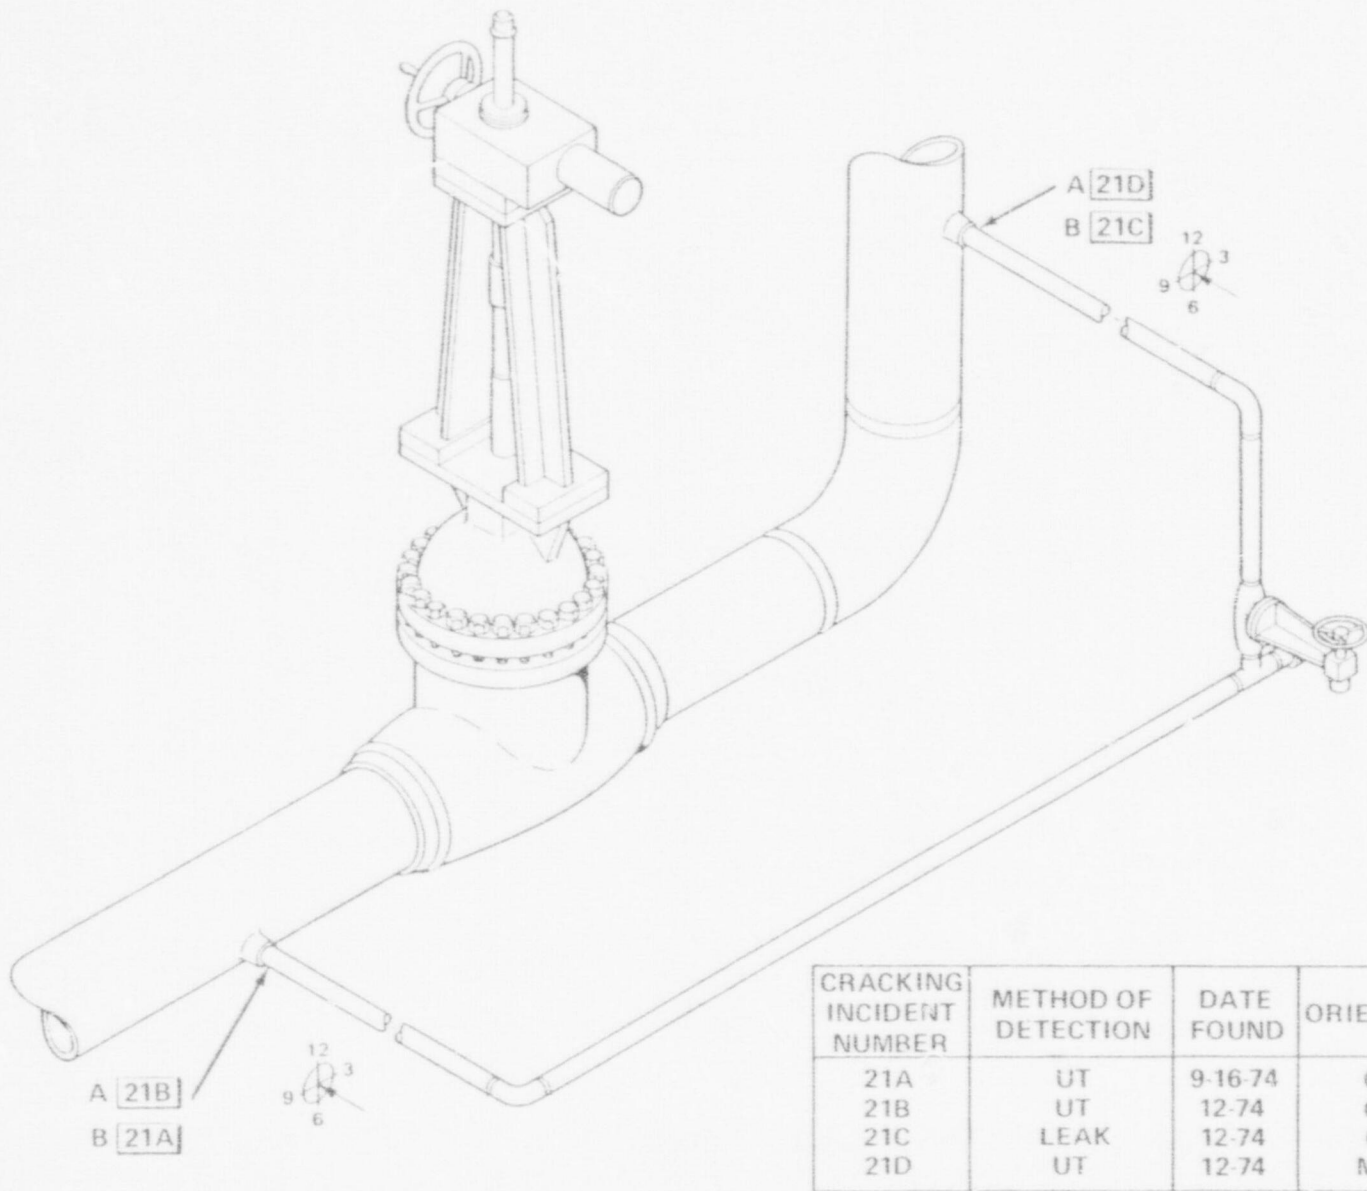
Figure 4. Crack Locations – Quad Cities 2 Recirculation Bypass Lines – Loops A and B

CRACKING INCIDENT NUMBER	METHOD OF DETECTION	DATE FOUND	ORIENTATION	AZIMUTHAL LOCATION
21A	UT	9-16-74	CIRC	3:00
21B	UT	12-74	CIRC	UNKNOWN
21C	LEAK	12-74	CIRC	10:30
21D	UT	12-74	MIXED	1:30

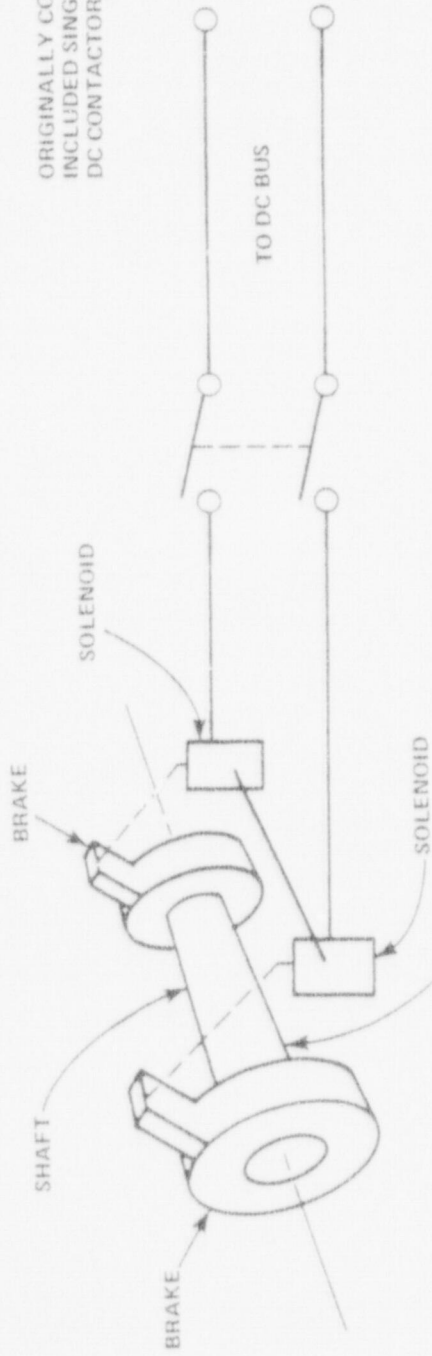
ORIGINALLY CONTACTORS INCLUDED SINGLE SIZE 2 DC CONTACTORS IN SERIES
