UNITED STATES
 NUCLEAR REGULATORY COMMISSION
 REGION II
 101 MARIETTA STREET, N.W.
 ATLANTA, GEORGIA 30323

Report Nos.: 50-325/88-11 and 50-324/88-11

Facility Name: Brunswick 1 and 2

Inspection Conducted: February 29 - March 4, 1988 and March 14 - March 18, 1988

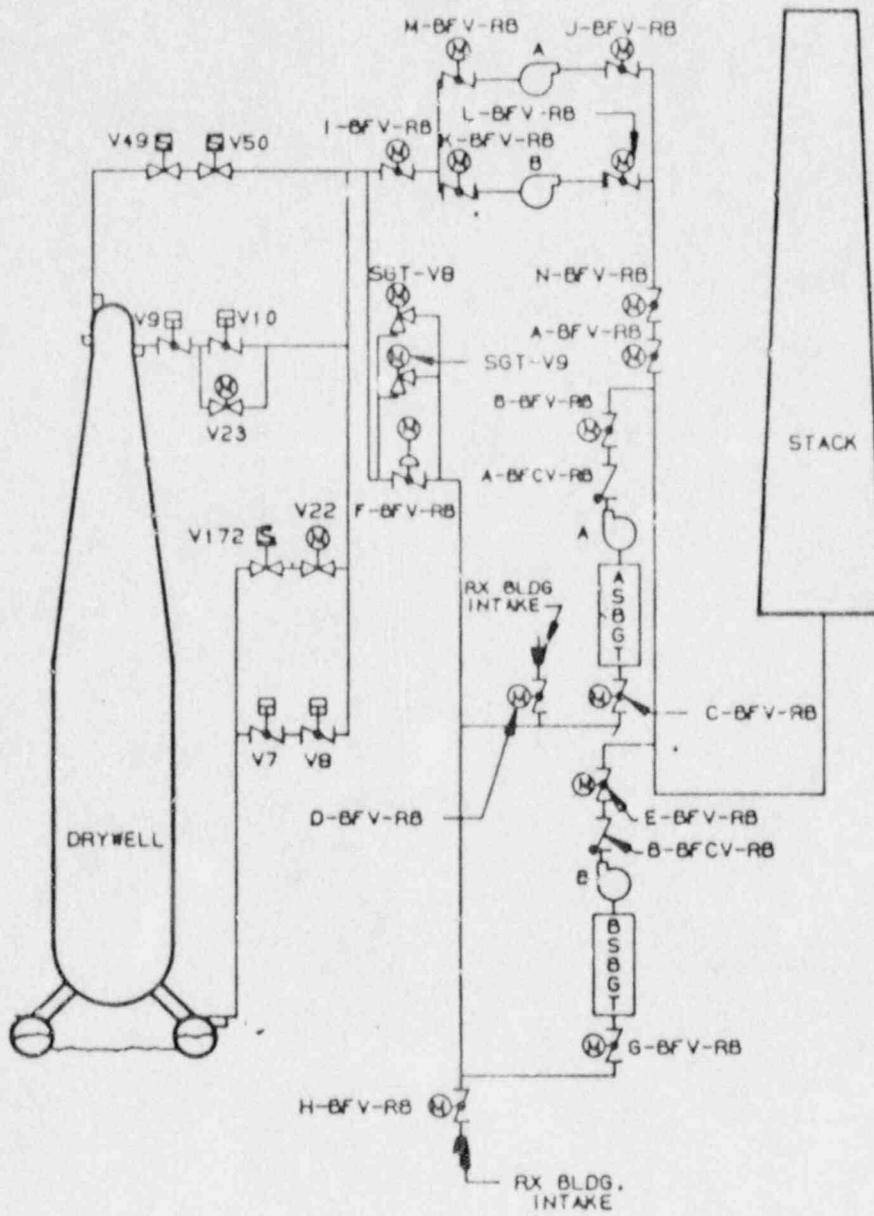
Figure 6.2

- The entire vent path is hard piping with the exception of a small section of duct at the purge exhaust fans. This duct contains what appears to be field fabricated expansion joints on each side of the fans that would be susceptible to failure during a vent. The licensee agreed with this comment and could not provide a design pressure rating for the joints.

- An analysis has not been performed to evaluate the effects of a release during venting from potential failure points in the vent path. Discussions with operators indicated the worst case scenario of a release at the purge exhaust fans could result in the loss of a standby liquid control train due to the proximity of the motor control center for this equipment.
