SUBJECT: TECHNICAL REPORT REGARDING MCGUIRE 2 REACTOR TRIP BREAKER FAILURE
AND METALLOGRAPHIC ANALYSES OF WELDS ON THE CATAWBA REACTOR TRIP
BREAKER POLE SHAFT (TACS 65955/65956)

Investigation of Trip Breaker
Failure at McGuire Unit 2

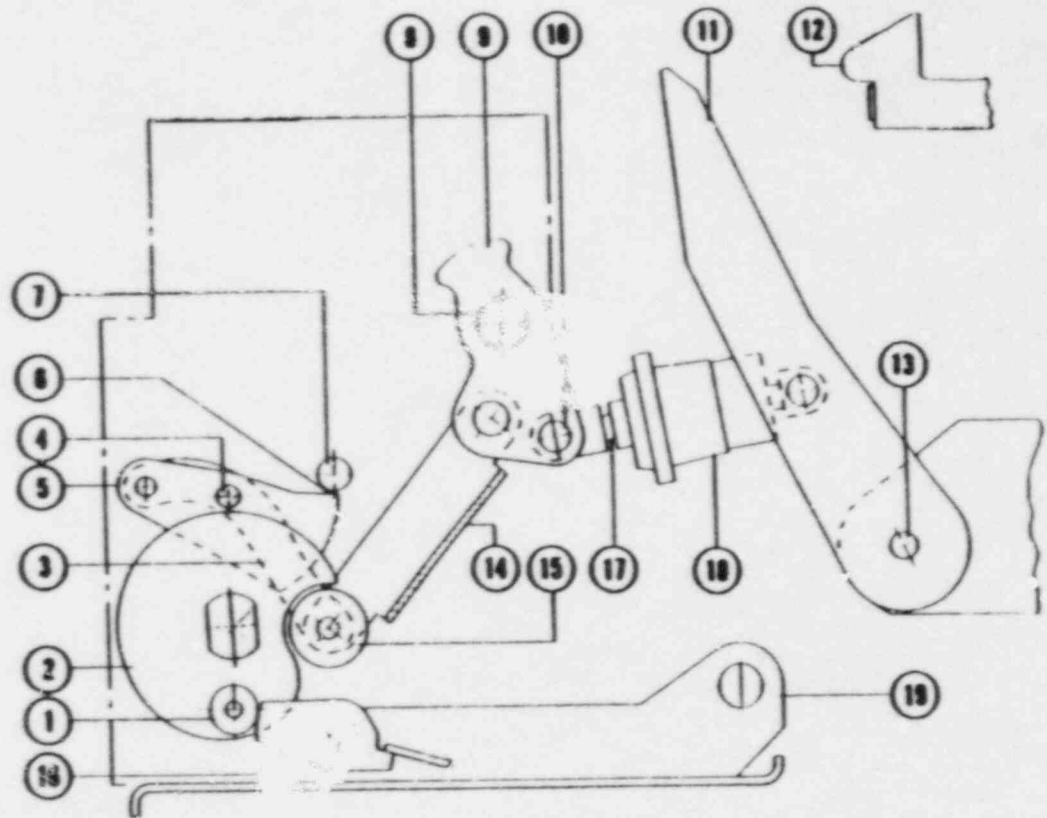
The cam had also been mushroomed by the drive link roller in a number of areas. Of key concern was mushrooming in the area of the stop roller (item 1 in Figure 1). The stop roller holds the mechanism in readiness for release of the closing latch. The extreme mushrooming impeded rotation of the stop roller. It is possible that continued mushrooming could totally prevent stop-roller operation, which could prevent closure of the circuit breaker upon demand. While not of concern for an RTB, a failure-to-close condition would be of concern for DS-type circuit breakers used in safety applications requiring energization of the connected loads.

Figure 1. Linkages of DS-416 Breaker Mechanism Shown with CB Open and Springs Charged (Source: Reference 5)

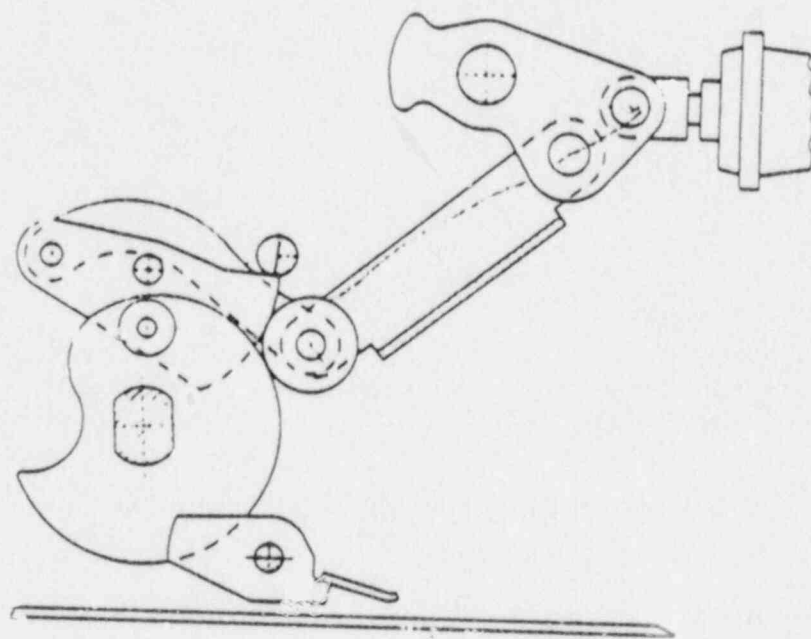
Figure 4. Position of Mechanism with RTB Closed (Source: Reference 5)

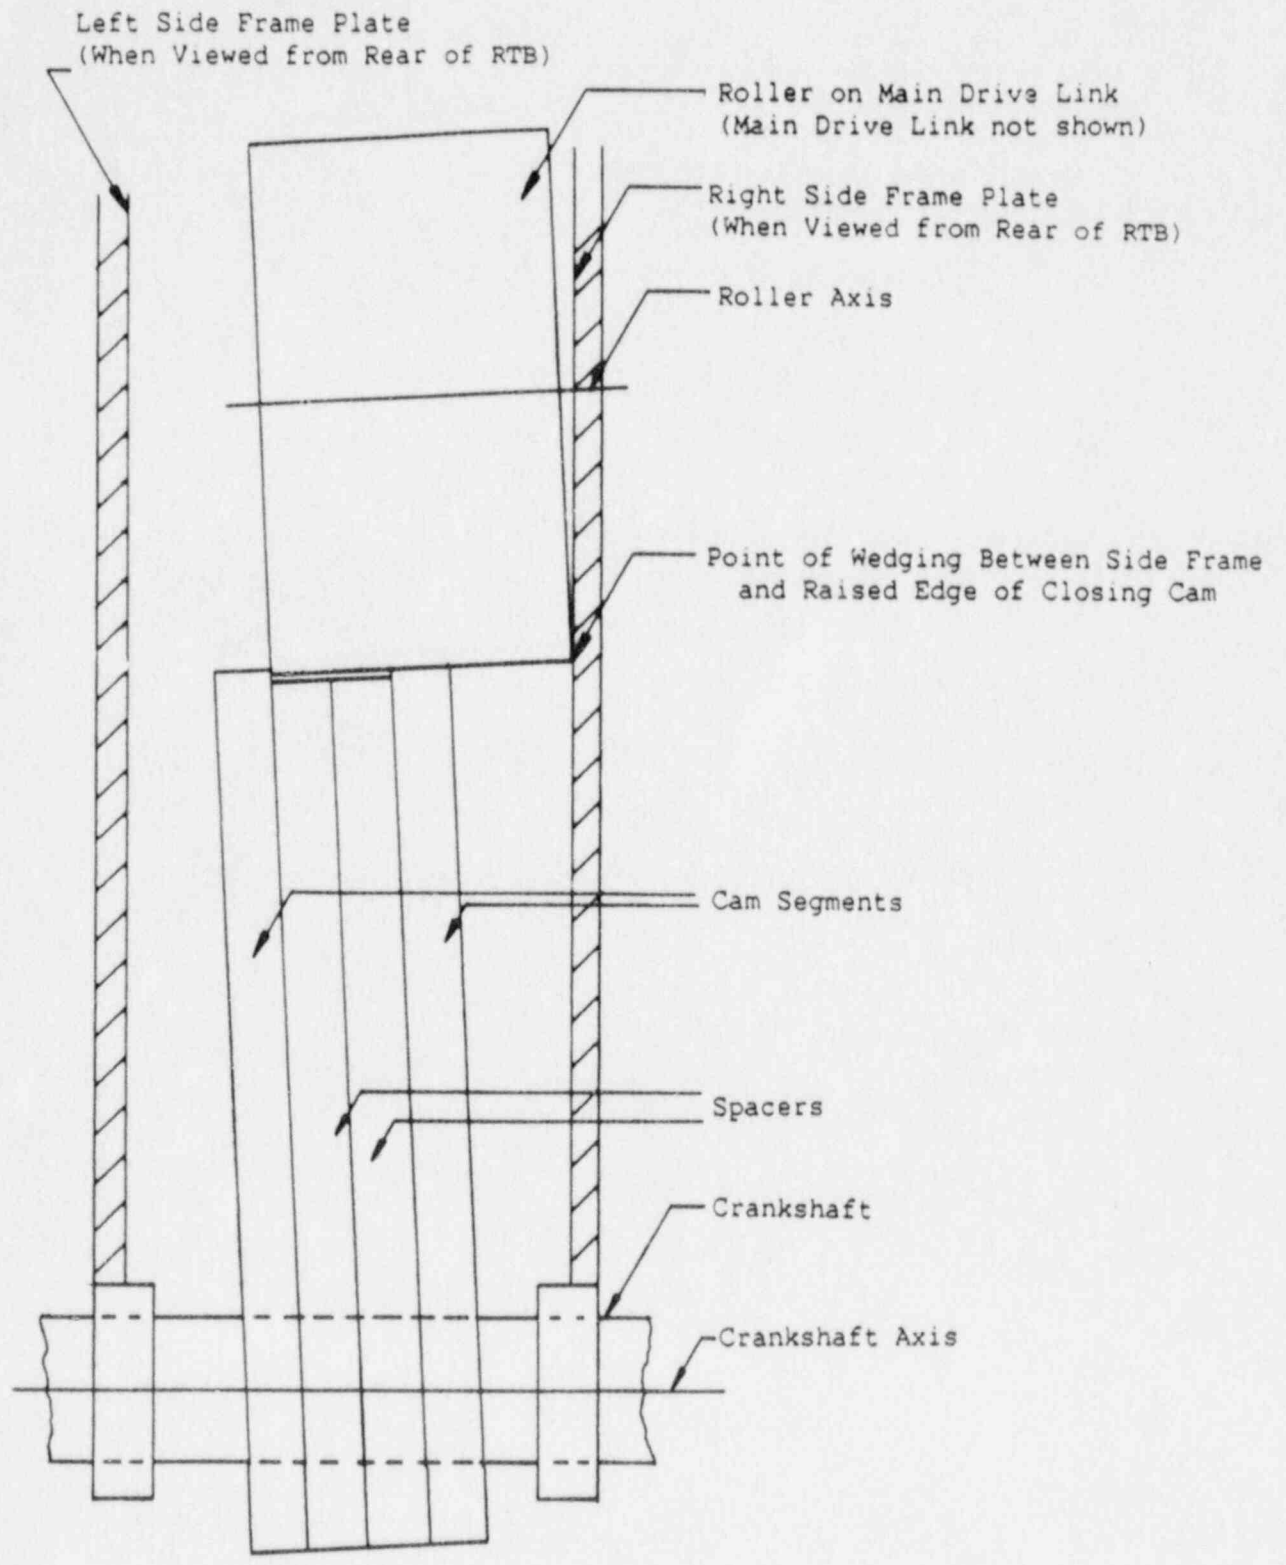
Upon removal of the original right side frame plate, the trip latch bearing was found to have a broken edge. The concern that binding of the trip latch was partially causing the jamming was alleviated during the second jamming of the RTB when the constraining link was removed and the RTB remained jammed. Binding of the crank shaft on which the close cam is mounted could also have partially caused the binding. However, the crank shaft was found to be free and turning properly when the RTB mechanism was disassembled. Elimination of trip latch and crank shaft binding confirmed that the sole cause of the failure was pinching of the roller between the edge of the close cam and the right side frame plate.

Figure 3. Roller Wedged Between Left Cam Segment and Right Side Frame Plate
(Conceptual Drawing, Not Fully to Scale)

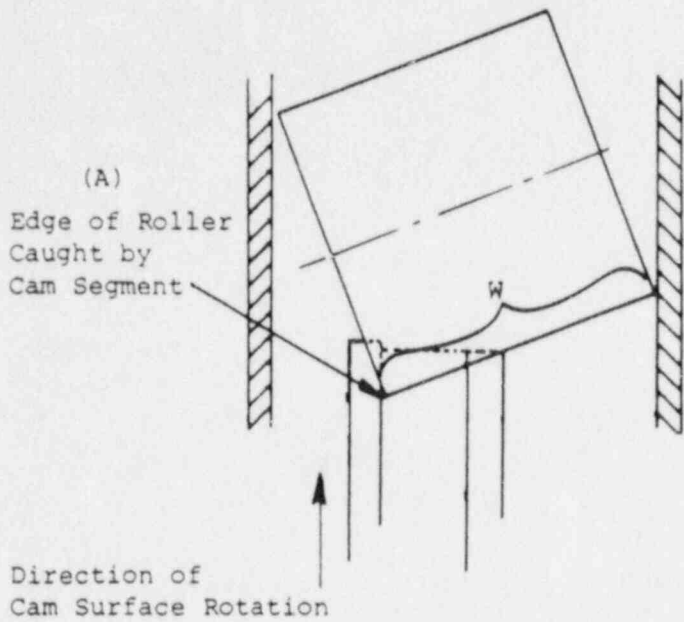
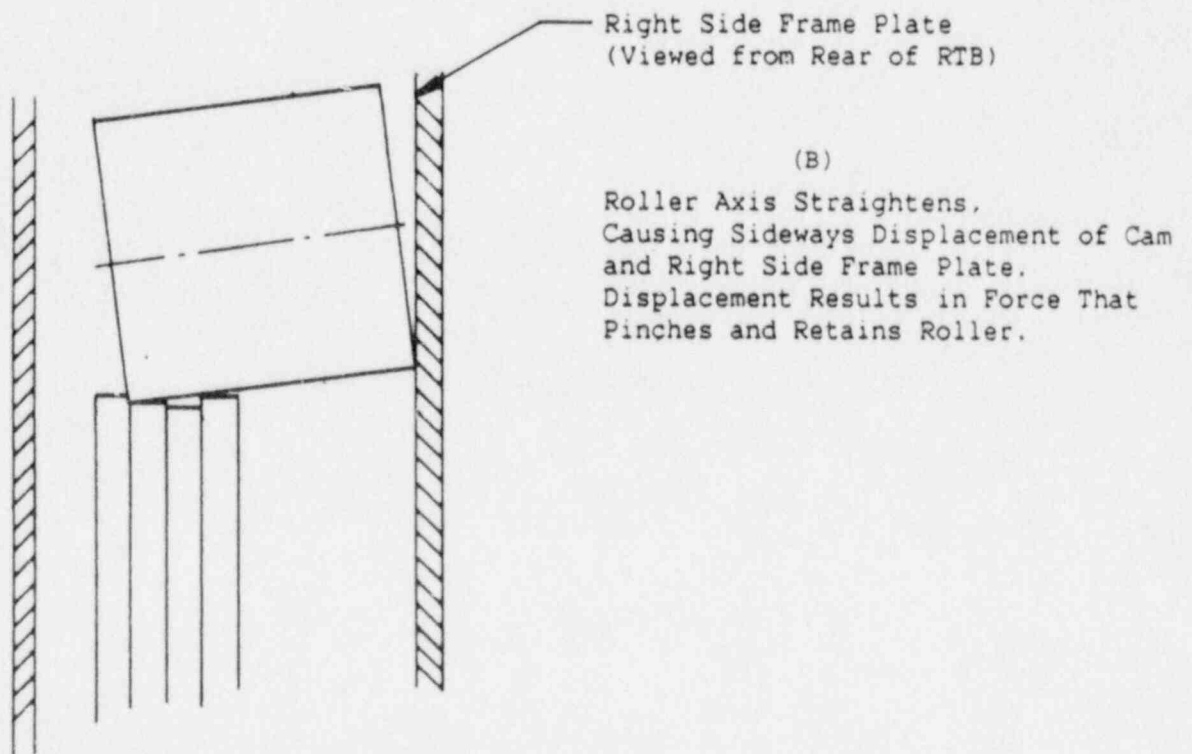
The roller becomes pinched during the closing action. As the closing cam rotates, the edge of the roller is caught between the outer laminate of the cam segment and a spacer (see Figure 4). Continued rotation of the cam causes the roller to straighten in a clockwise rotation about its axis. This action causes the edge of the roller (marked "W" in Figure 4A) to attempt to separate the cam and the side plate. However, the cam and side plate are not free to move and therefore pinch and bind the roller. When the trip latch is released, allowing the constraining link (item 3, Figure 1) to be free, the binding or jamming of the roller prevents the roller from rolling down the cam face to allow the circuit breaker to open. The jamming of the roller also prevents full discharge of the closing springs, leaving the closing cam 18 degrees from the fully rotated position.

Figure 4. Binding of Roller

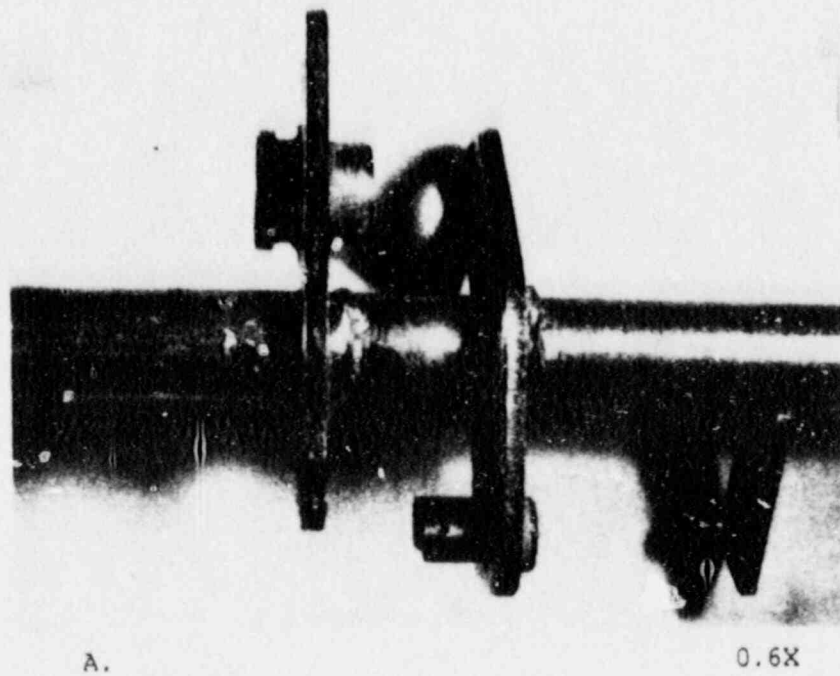
A segment of the pole shaft on which the two levers of primary interest (CP and AB) were fastened is shown in Figure 1. Dye penetrant residue from plant site testing of the welds was present at surface irregularities and at the LOF on the CP/PS joint at the weld start location, as shown in Figure 1. However, the dye did not highlight any cracks to such an extent that they were visually apparent. Using a binocular microscope with magnifications up to 40X, it was determined that there was a crack extending from the LOF into the weld on the CP/PS weld start, as pointed out in Figure 2; and there was a crack at the finish end of the fillet weld on each lever, as shown in Figures 3 and 4. The AB crack was open wider than the CP one; therefore, once it was detected under the microscope, it was possible, knowing its location, to observe it visually. In addition to the preceding defects, there was a highly irregular weld geometry at the start of the AB/PS weld, making it difficult to determine the presence, if any, of LOF and/or cracks.

Figure 1. Macrographs showing the shaft and the center-pole (left) and anti-bounce (right) levers. The arrow points to a gap, or lack of fusion, between the weld and the center-pole lever.

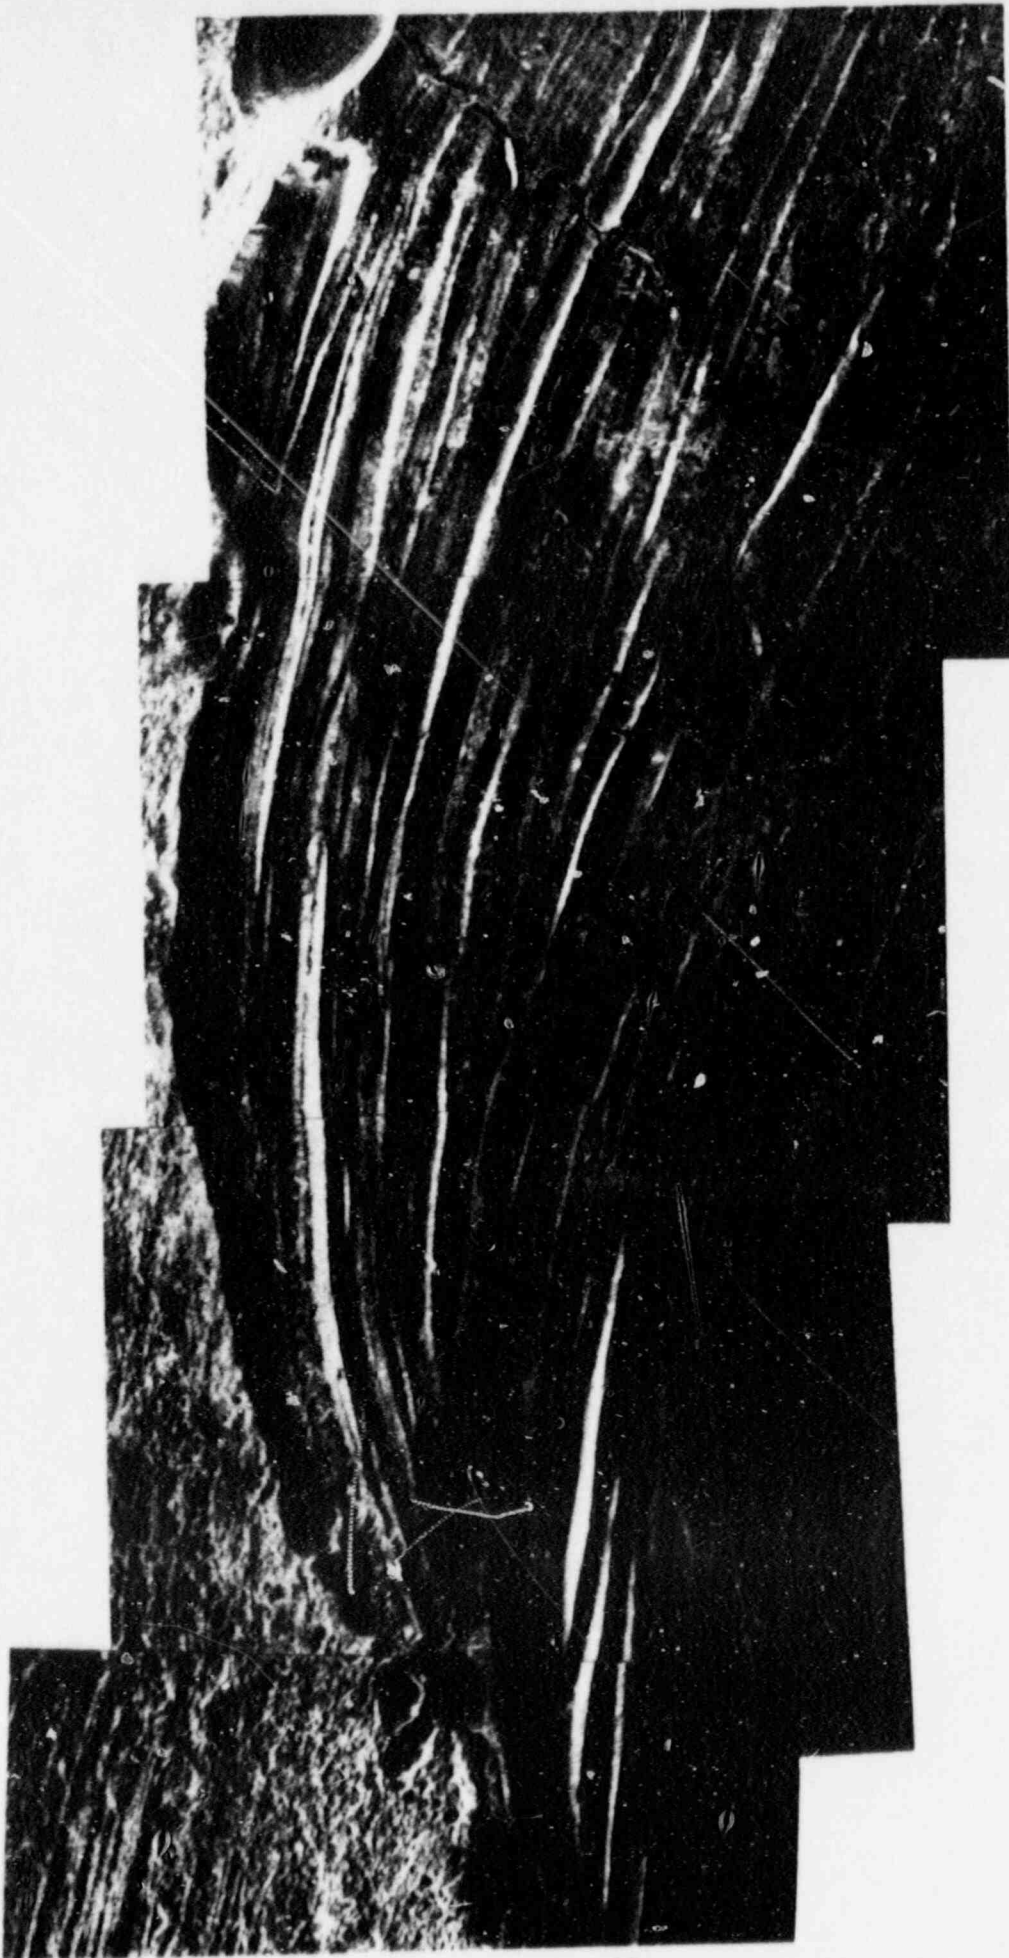
50X

Figure 5. Composite SEM micrograph showing cracking in the weld adjacent to the center-pole lever, as indicated in the macrograph in Figure 2.

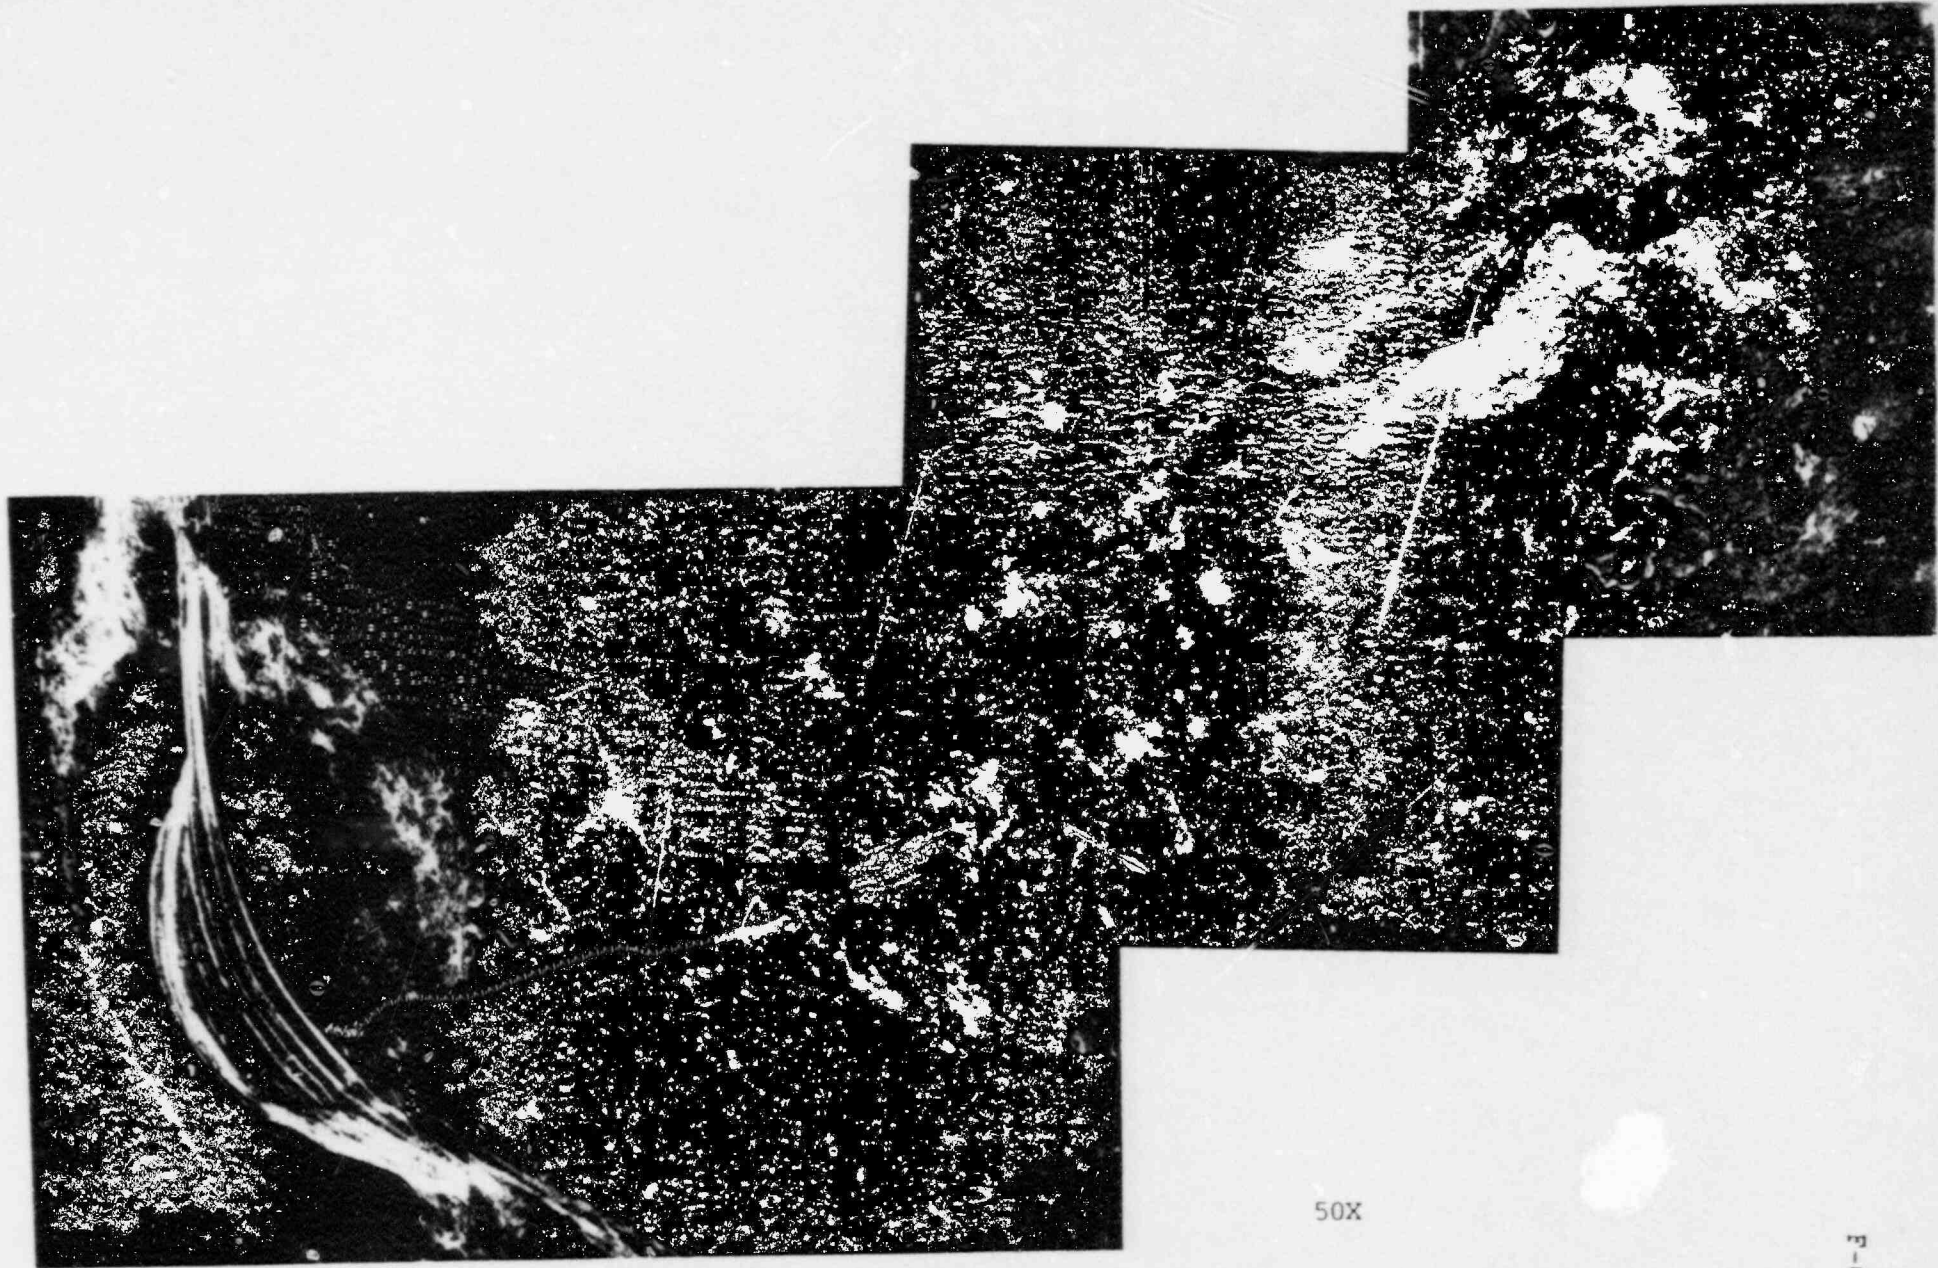
Figure 8. Composite SEM micrograph showing the crack at the end of the anti-bounce lever/shaft fillet weld. The crack, which is outlined by dye penetrant residue, had started at the end of the weld (at the upper left) and progressed through a dimple on the weld (near the center of the figure). The end of the crack at bottom left is difficult to define, even at 50X in the SEM.

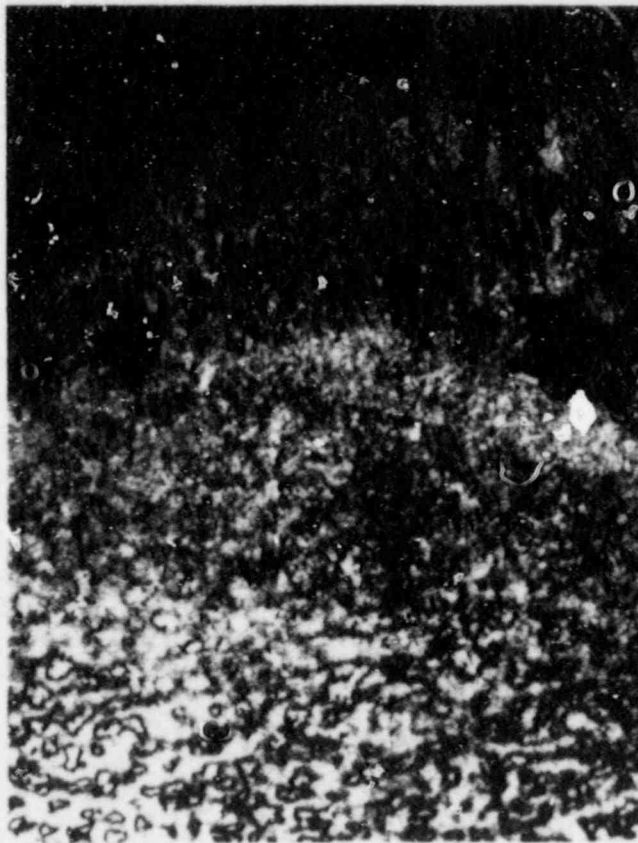
The AB/PS joint at the weld start was also subsequently ground and polished. Since the observations of the surface indicated only a short length of a defect, this shaft lever joint was initially sectioned only to the weld start. As shown in Figure 12, at the start of the weld its profile was highly irregular and there was some LOF to the lever face at the top of the weld. The surface crack-like defect evident in Figure 6 was found to be limited to this LOF, as shown in Figure 12 and, after further polishing, in Figure 13.

Figure 13. Micrographs showing the weld of Figure 12 after repolishing. Some lack of fusion at the lever is still present at the lever face and there is some porosity in the weld at the shaft.

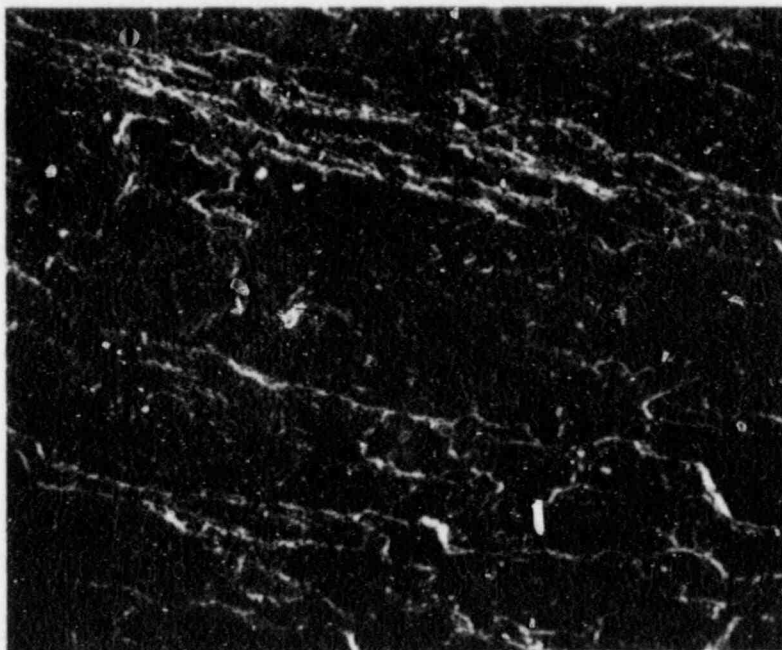
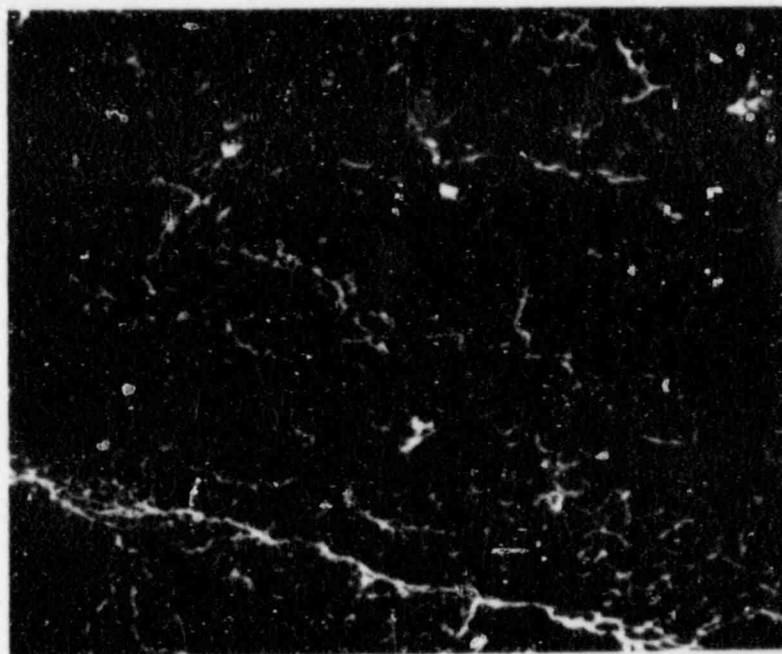
Figure 15. SEM micrographs showing a representative area on the weld fracture surface exposed by sectioning near the termination of the surface crack shown in Figures 4A and 8. Essentially the entire fracture surface morphology is ductile dimpled tearing.

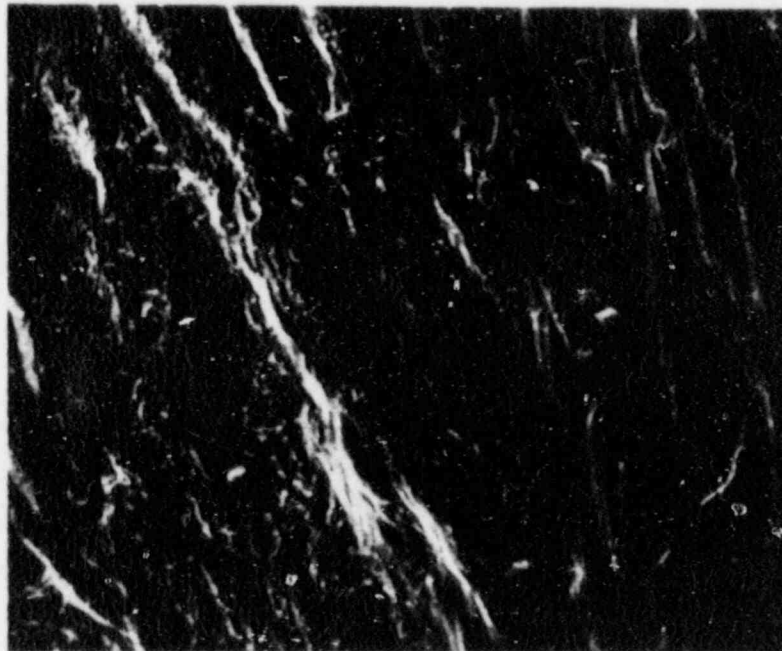
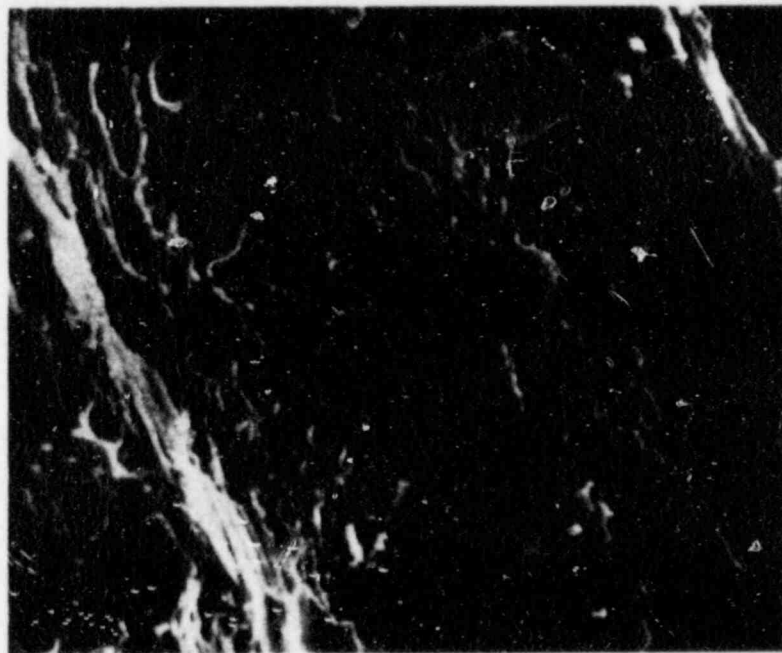
Figure 16. SEM micrographs showing a representative area on the fracture surface exposed by sectioning near the termination of the surface crack shown in Figures 4B and 7. Partially masked by pronounced smearing (on the right) is ductile tearing similar to that on the anti-bounce cracked weld joint in Figure 15.

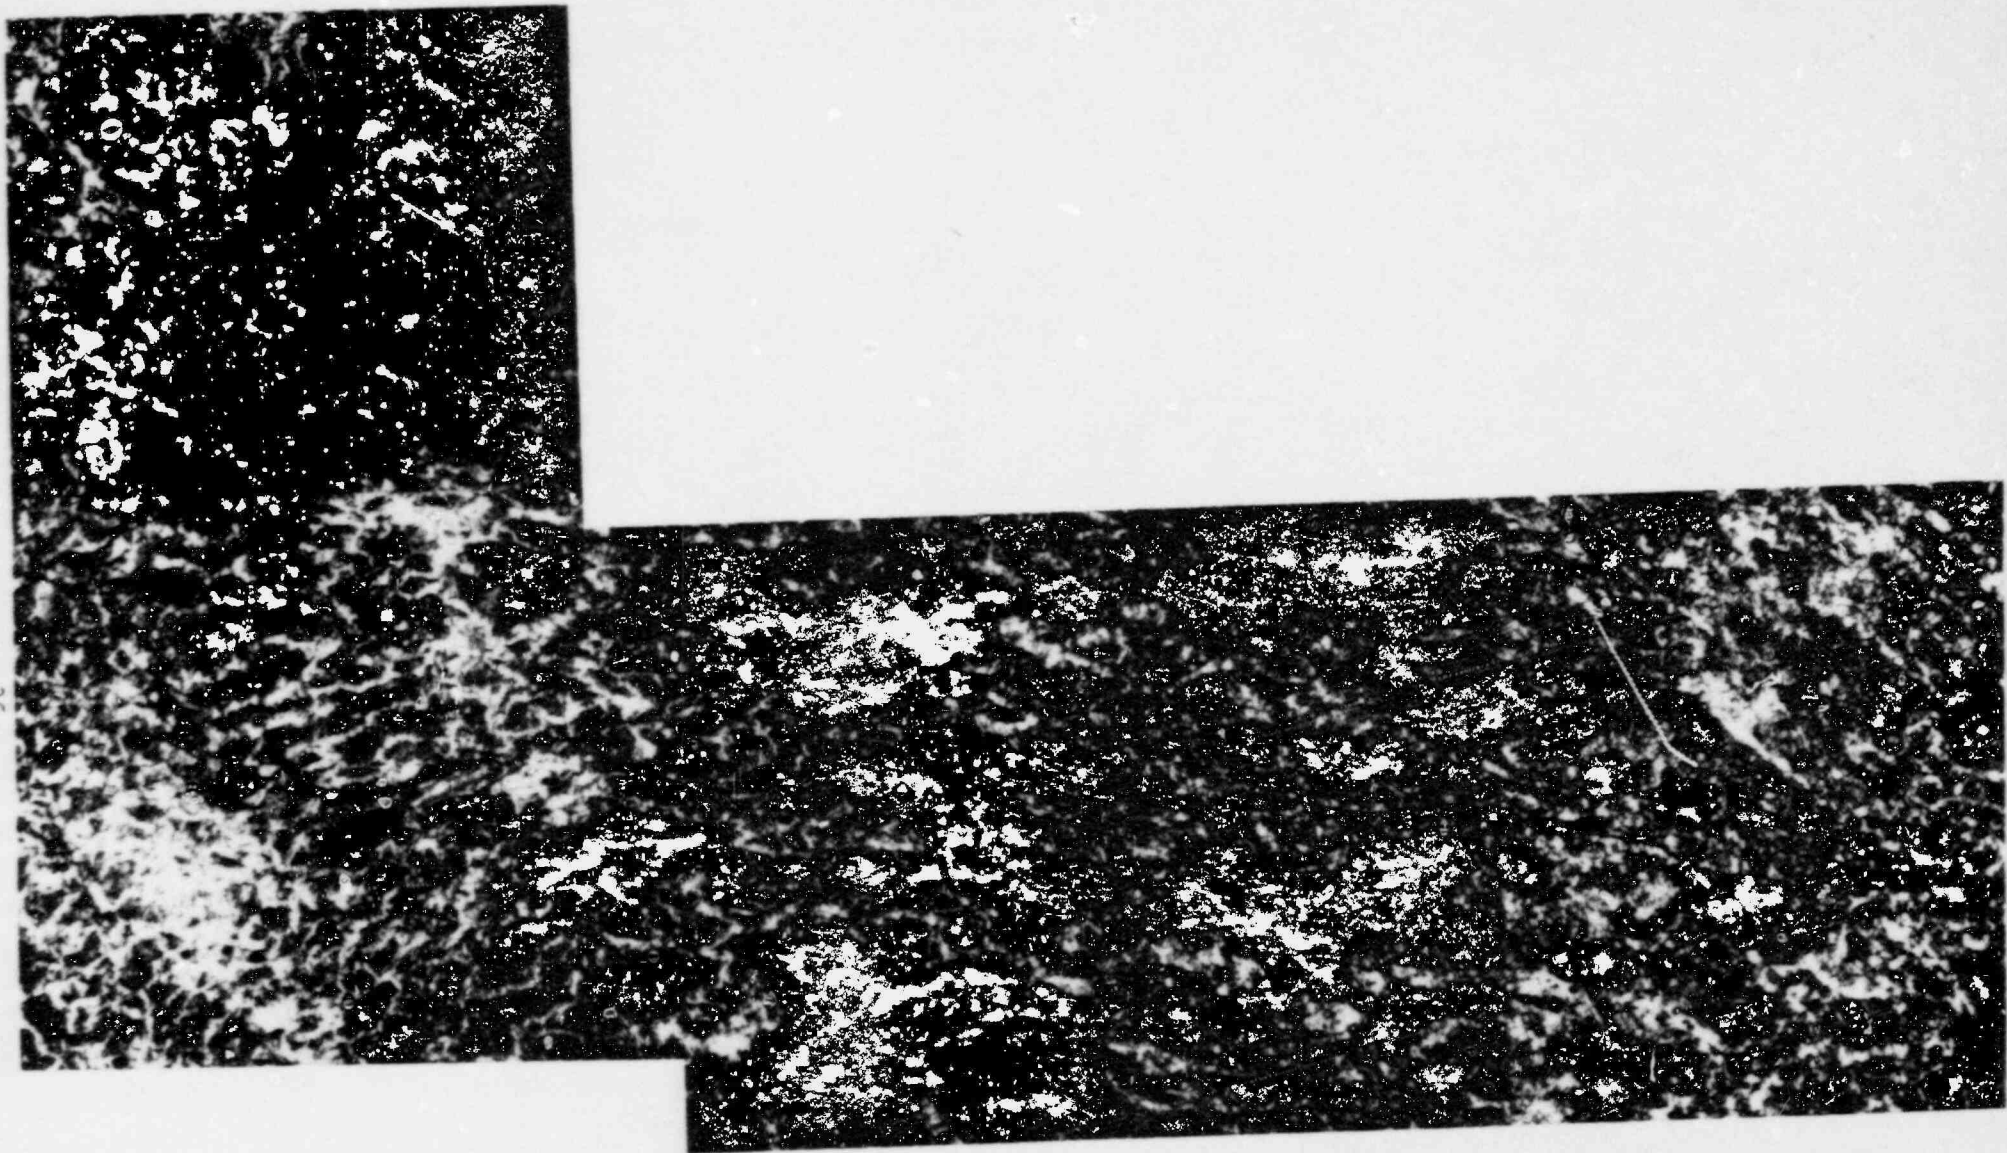
Figure 18. Composite micrograph showing a metallographically prepared cross section of the center-pole to pole-shaft weld after polishing the section in Figure 17 a little deeper. The crack, which was so tight at this location that it could not be delineated at 7X magnification, extended from the surface to the root of the weld, with a sharp change in direction near the root at the upper left. The black spots are either etching effects or porosity.

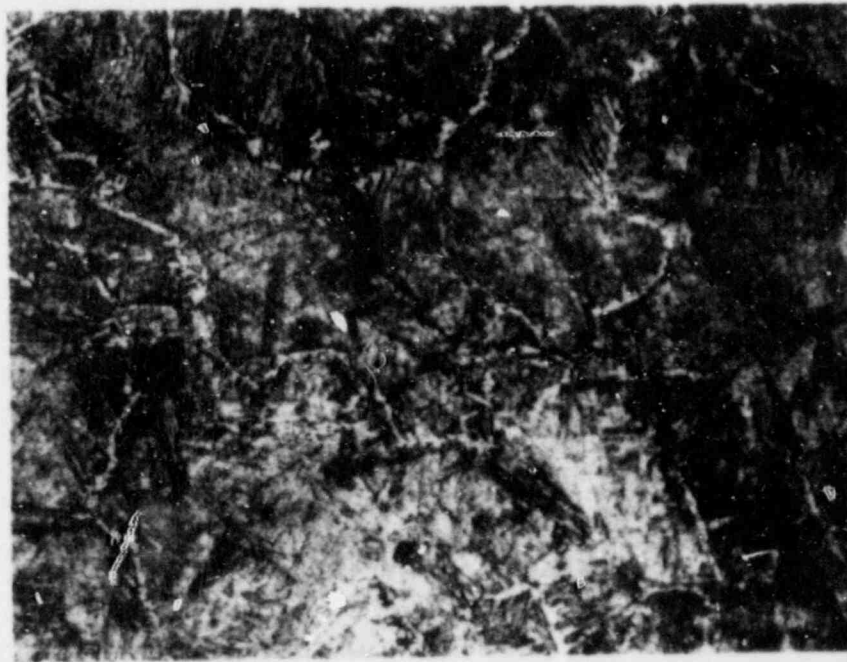
500X

Figure 19. Micrograph showing a metallographically prepared cross section near the root of the anti-bounce lever to pole-shaft weld at the end of the surface cracking shown in Figure 8. At this stage of sectioning, about 1/2 inch of the circumferential length of the finish ng end of the weld had been ground away.
