LICENSEE EVENT REPORT (LER)

FACILITY NAME (1) McGuire Nuclear Station - Unit 2										DOCKET NUMBER (2) 0 5 0 0 0 3 7 0										PAGE (3) 1 OF 4																					
TITLE (4) REACTOR TRIP BREAKER FAILURE DUE TO MECHANICAL FAILURE																																									
EVENT DATE (5)						LER NUMBER (6)						REPORT DATE (7)						OTHER FACILITIES INVOLVED (8)																							
MONTH			DAY			YEAR			YEAR			SEQUENTIAL NUMBER			REVISION NUMBER			MONTH			DAY			YEAR			FACILITY NAMES						DOCKET NUMBER(S)								
0 7			0 2			8 7			8 7			0 0			9 0			0 1			0 3			2 5			8 8									0 5 0 0 0 0					
OPERATING MODE (9) 3						THIS REPORT IS SUBMITTED PURSUANT TO THE REQUIREMENTS OF 10 CFR 8. (Check one or more of the following) (11)																																			
POWER LEVEL (10) 0 0 0 0						20.402(b)						20.405(e)						XX 50.73(a)(2)(iv)						73.71(b)

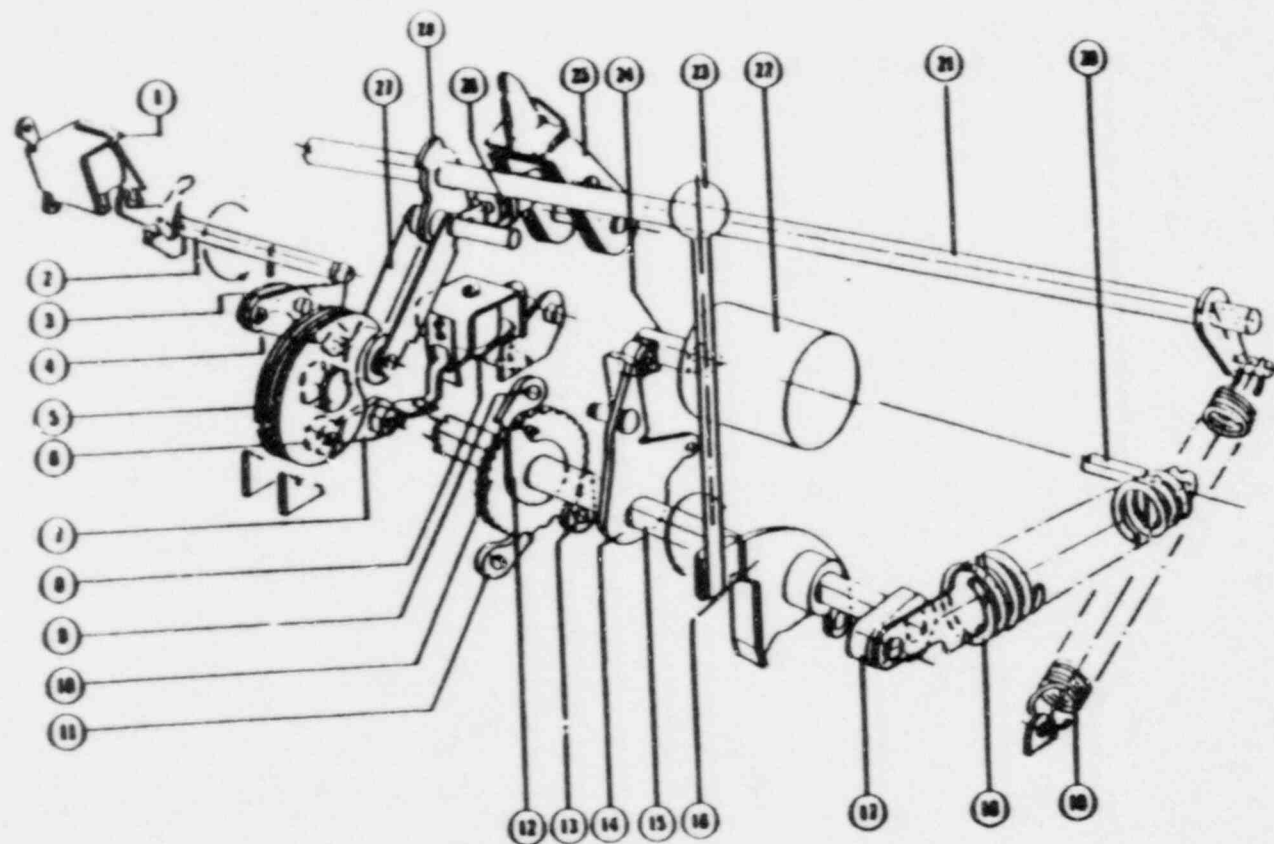
Figure 2

The failed weld on breaker B-4 is located on the pole shaft (21) where the center pole lever (28) passes through. The majority of the weld remained on the pole shaft due to a more complete fusion of the weld to the pole shaft than to the center pole lever. Operational ability of the failed breaker was maintained during cycling due to the common top connection pin in the main drive link (27)
