LICENSEE EVENT REPORT (LER)

FACILITY NAME (1) CRYSTAL RIVER UNIT 3	DOCKET NUMBER (2) 0 5 0 0 0 3 0 2	PAGE (3) 1 OF 0 8
--	--------------------------------------	----------------------

TITLE (4) **Broken Stem Nut in "B" Feedwater Main Block Valve Results in a Feedwater Transient and a Subsequent Reactor Trip**

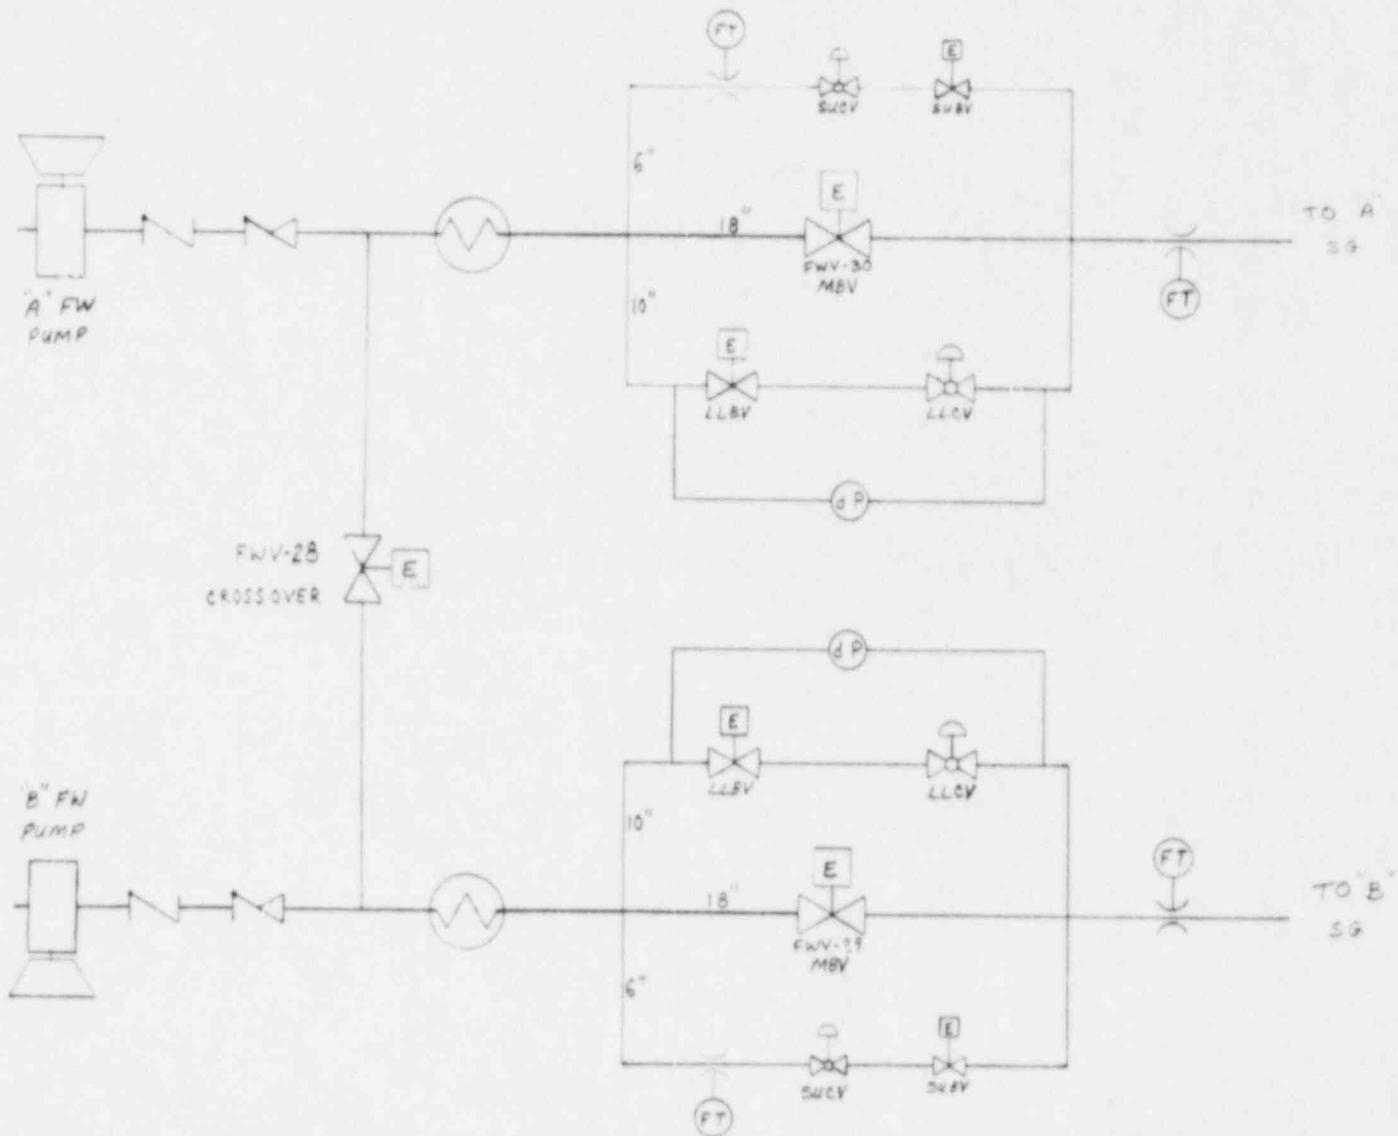
FIGURE I

In an attempt to lessen the severity of the FW transient in progress, a control room operator opened the FW crossover valve FWV-28 [SJ,20] (see Figure 1). When this valve was opened, a "close" signal was also sent to the MBV's, as designed. Within seconds, the FW flow to "B" SG decreased such that an underfeed condition occurred. Approximately one minute later at 1149, a reactor trip occurred due to high RCS pressure on 2 out of 4 Reactor Protection System (RPS) [JC,CH] channels.

5. Q - Provide P&ID's for the MFW system and ICS system schematics.
A - Figure #1 of LER 88-006 shows the arrangement of the FW valves. Item #1 describes the ICS control of FW from 0% to 100% power. Additional drawings have been provided to the Project Manager.
