**RELIABILITY SUMMARY REPORT FOR THE BAILEY
862 SOLID STATE LOGIC MODULE**

Prepared by : Public Service Electric and Gas Co.
Nuclear Department
Engineering and Plant Betterment

Original Report Issued : March 31, 1988

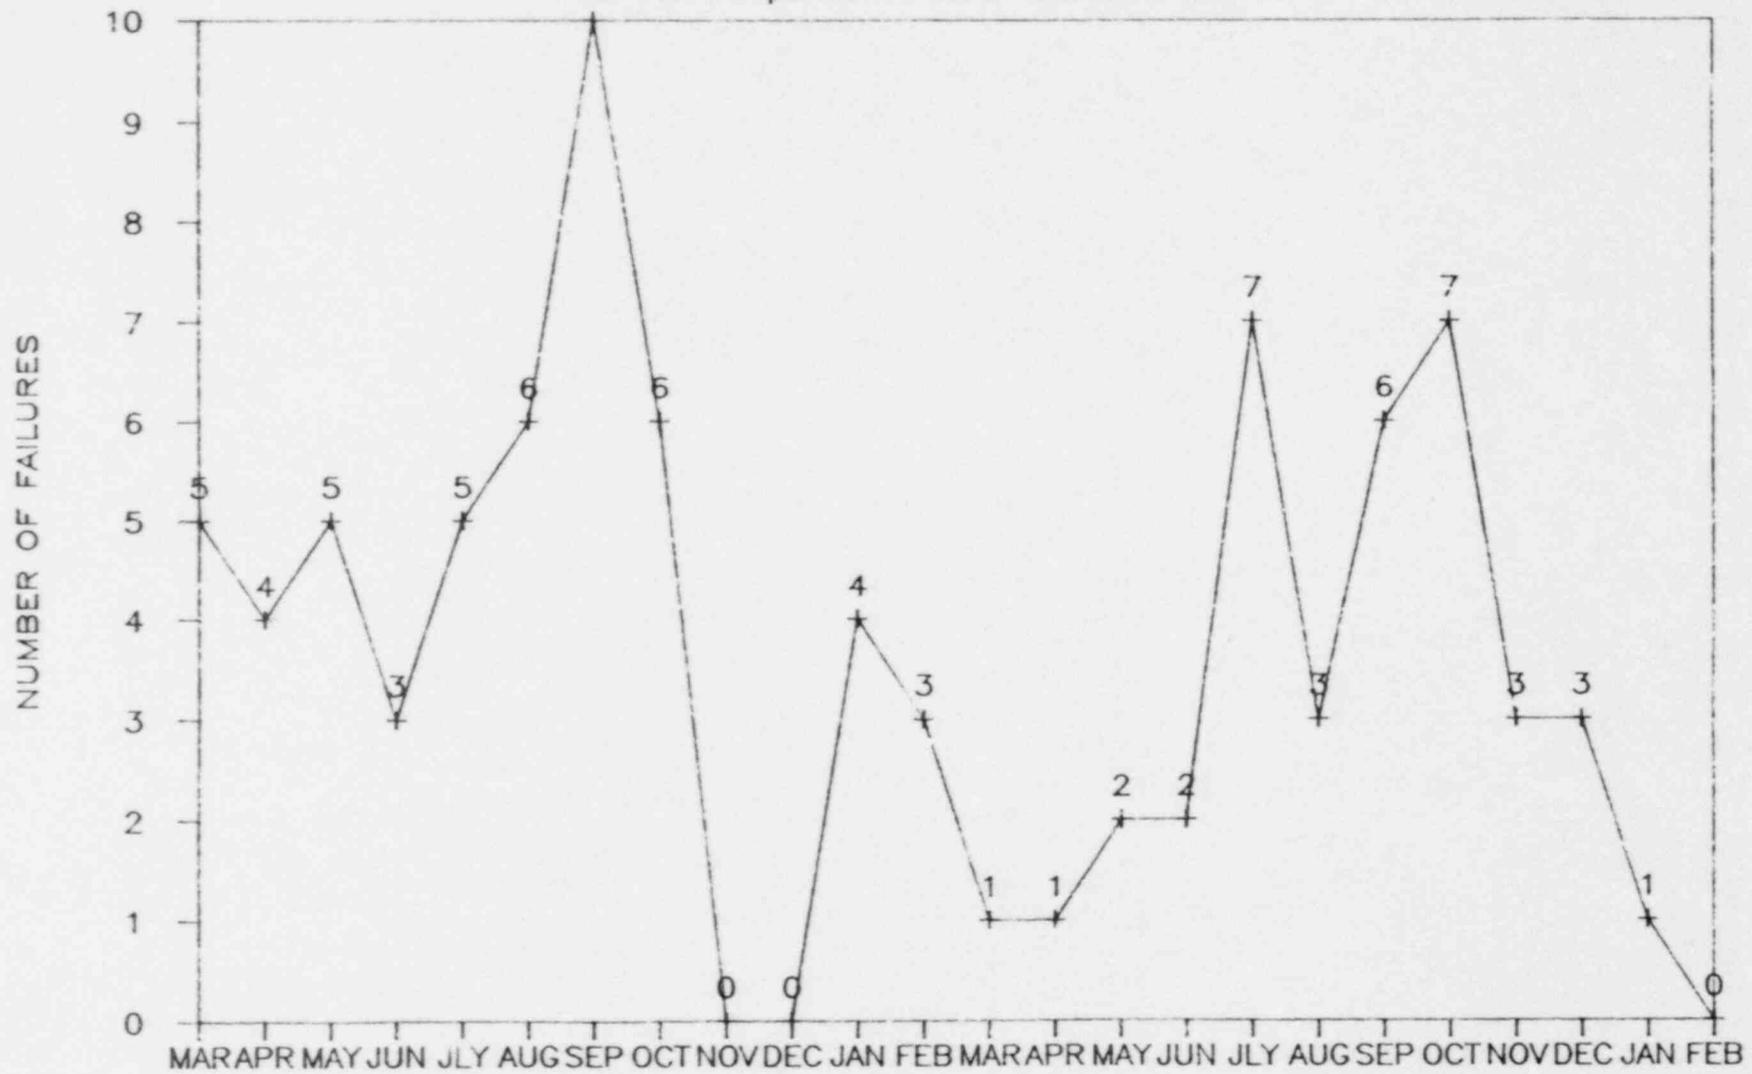
ATTACHMENT # 1

The in-service SSLM failures vs. time are graphed in Attachment # 1 for the period of March 1986 through February 1988.

As a result of the unexpected increase in failures which occurred in July 1987, PSE&G re-examined pertinent parameters in an attempt to identify the cause of the increase. The re-examination of these parameters, together with several additional months of data has led to the conclusion that the increase in failures experienced through the summer months is a result of higher average Relative Humidity in the Lower Equipment Control Room (LECR), which houses the 862 system. While Relative Humidity is maintained within the design basis of the room, and within the qualification limits

of the SSLM, the average Relative Humidity was found to increase by approximately 30% (35% to 65%) from Winter to Summer months.

BAILEY LOGIC MODULE FAILURES

10 For the period - March 86 thru Feb 88

The data indicates that a lag time exists between changes in LECR Relative Humidity and changes in SSLM failure rates. To eliminate the unnecessary stresses associated with the high humidity, PSE&G has begun design of a modification which will maintain the LECR RH between 20% and 60%. Portions of the change are scheduled to be installation complete in June 1988.
