LICENSEE EVENT REPORT (LER)

FACILITY NAME (1) PLANT HATCH, UNIT 2	DOCKET NUMBER (2) 0 5 0 0 0 3 6 6	PAGE (3) 1 OF 17
--	--------------------------------------	---------------------

TITLE (4)
FAILED VALVES DISCLOSE DESIGN DEFICIENCIES AND TECHNICAL SPECIFICATION VIOLATION

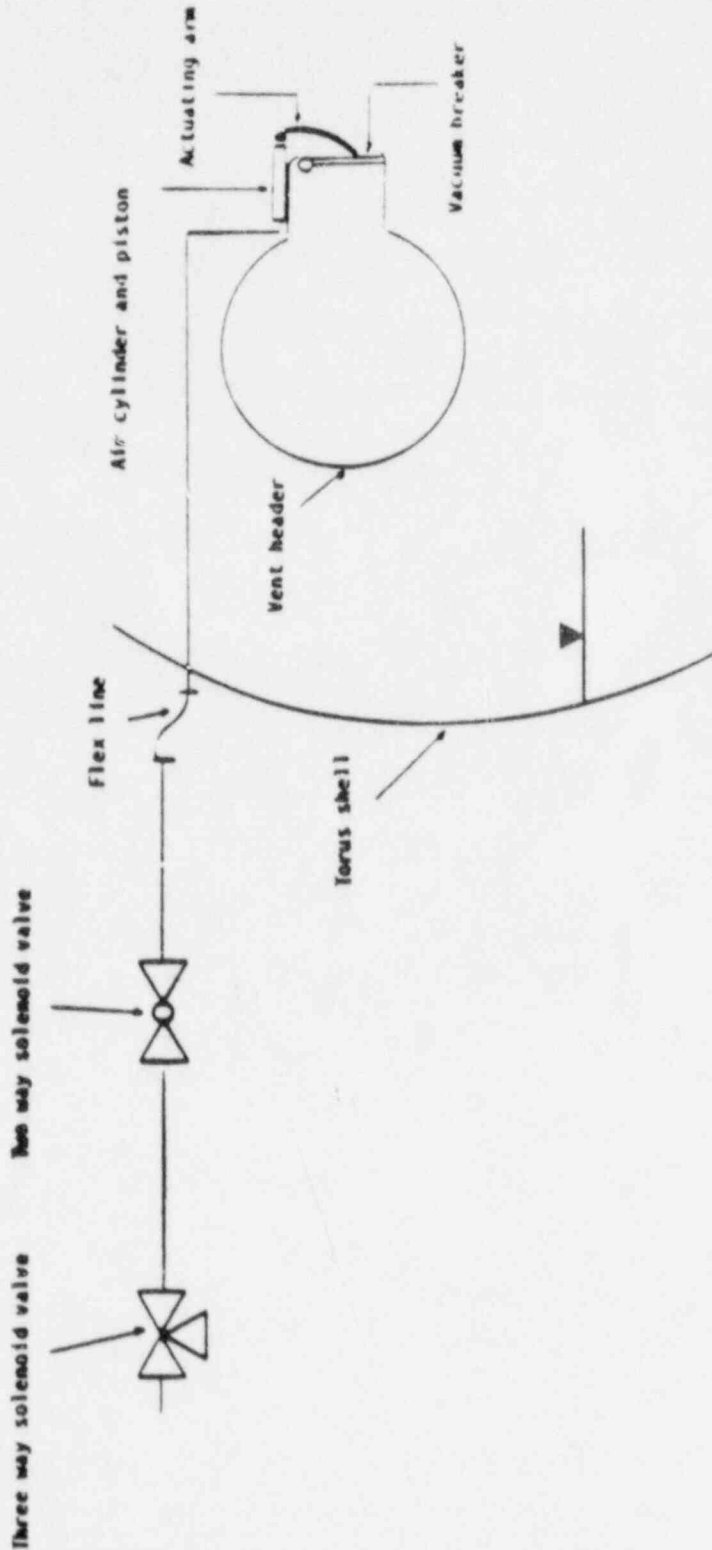
Figure 1

The instrument air lines used for testing of the Unit 1 and Unit 2 drywell to torus vacuum breakers are part of the primary containment system. The solenoid valves are the secondary barrier used to secure primary containment integrity. The pneumatic actuators (air cylinder and piston on figure 1) are the primary barrier.

Simplified Elevation View
Air Supply Lines and Torus
Internal Components (NIS)

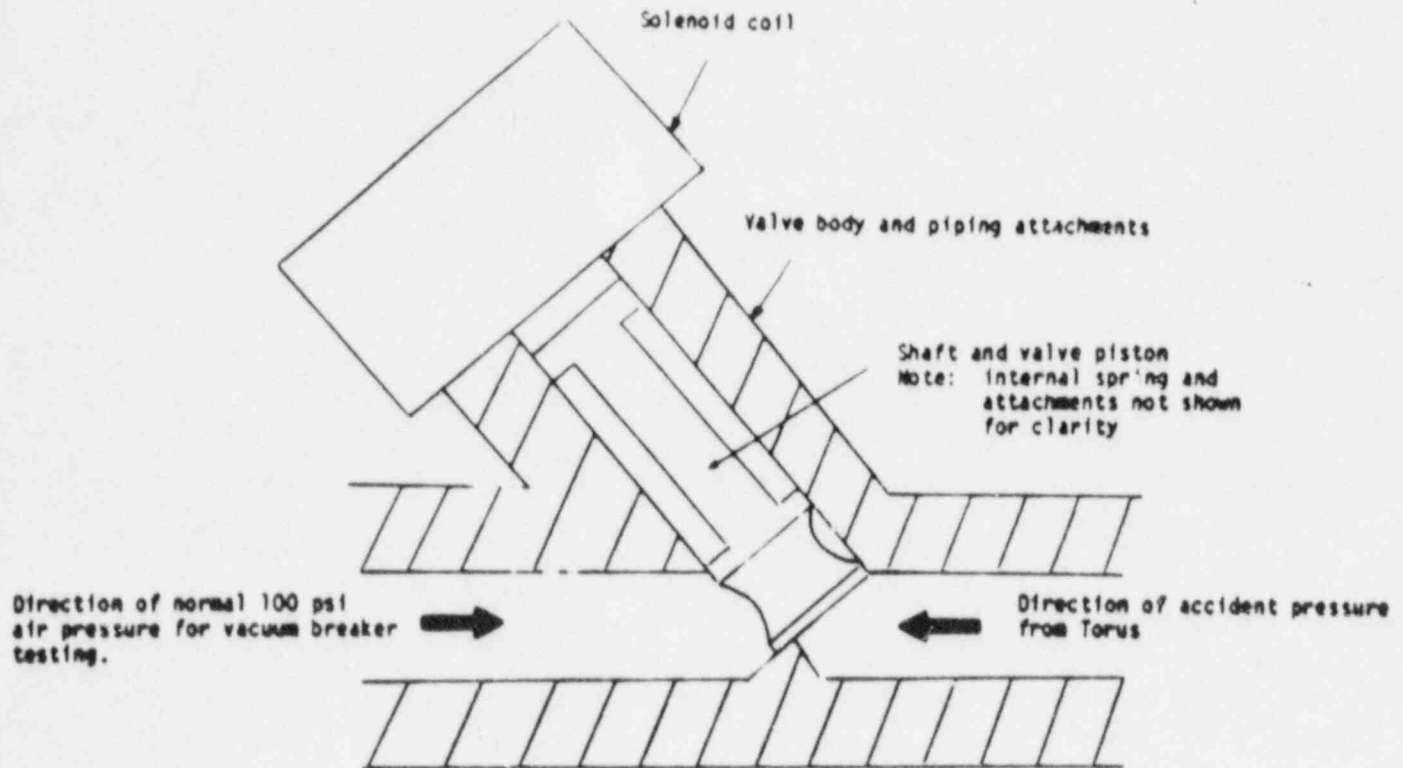
Figure 2

Engineering personnel determined that when the valves were previously tested in the reverse direction, the test pressure would tend to drive the valves onto the valve seats. This would tend to decrease any leakage that would be present. When the valves were now tested in the accident direction, the test pressure appeared to lift the valve off of its seat. See figure 2 for valve details.

Simplified Elevation View
Solenoid Valve (NTS)
