NUCLEAR ENGINEERING SCIENCES DEPARTMENT
Nuclear Reactor Facility
University of Florida

Re: University of Florida Training Reactor
Facility License: R-56, Docket No. 50-83

Pursuant to the reporting requirements of paragraph 6.6.2(3)(c) of the UFTR Technical Specifications, a description of a potential abnormal occurrence as defined in the UFTR Technical Specifications, Chapter 1 is described in this interim 14-day report to include NRC notification, occurrence scenario and current solution status. The potential promptly reportable occurrence involved the failure of Safety Channel #1 circuit to provide proper power indication for several seconds on two occasions, the second during a test run.

March 15, 1988
Safety Channel #1 Circuit Failure

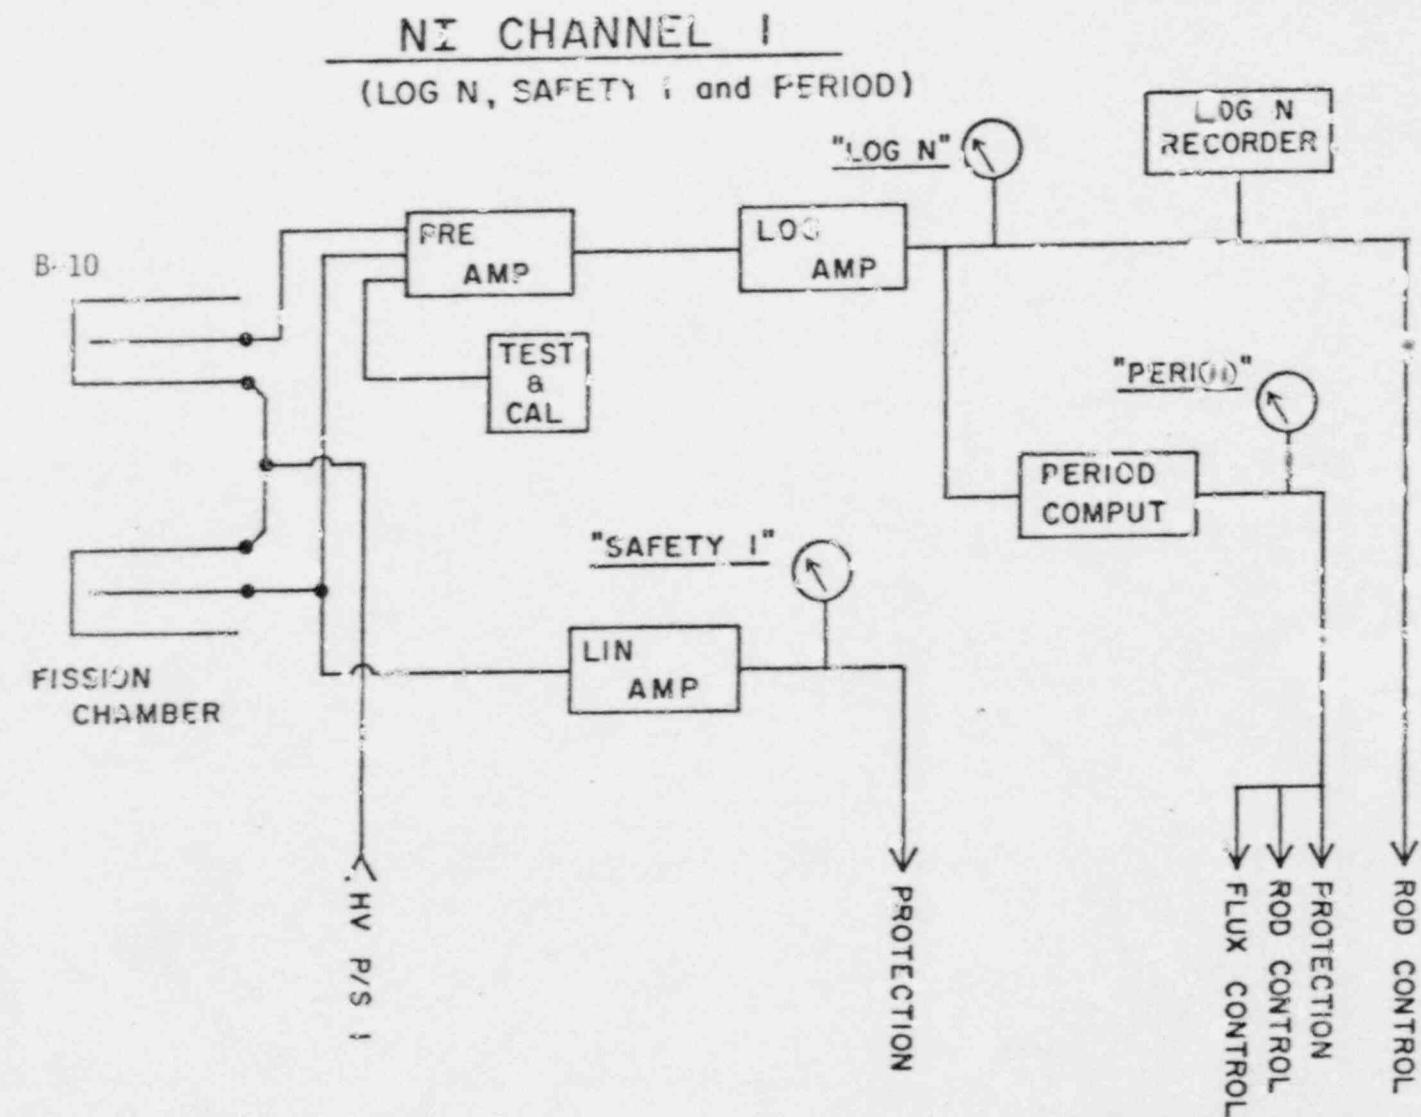
Figure 1-8. NI CHANNEL 1: UFTR Nuclear Instrumentation Channel 1 Diagram
(Log N, Safety #1 and Period Channels).

The immediate indications were that an intermittent fault had developed in the circuitry for Safety Channel 1 (part of the wide range drawer) but not in any other section of the wide range drawer. With the reactor secured, Maintenance Log Page #88-9 was initiated to investigate the problem. The wide range drawer was de-energized and the linear channel circuit board removed for visual inspection. All components and connections were verified in good condition. Discussion of the failure mode indicated a possible failure of a capacitor, possibly an intermittent short circuit which was followed by a recharging of the capacitor. A capacitor in the feedback loop (in parallel to the primary feedback/current limiting resistor) was identified as the most likely component failure. The capacitor was removed and failed a bench test; the capacitor had open-circuited. The probable cause was now evaluated to be a short circuited capacitor that remained open from high current, resulting in first maximum feedback from the short then normal feedback from the feedback resistor as supported by the initial downscale indication followed by return to normal noted by SRO Whaley. The component was replaced with a substitute of different manufacturer under 10 CFR 50.59 Evaluation #88-4 with identical specifications intended to restore the circuit to normal operation.

Except during the transient, the functions of indication and trip were not inhibited or changed (except for situations where high circuit noise might cause erratic meter indications); that is, there was only a temporary loss of indication and trip function in Safety Channel #1. Since this capacitor is a noise suppression device in a DC circuit, the impact of this failure on system operation is minimized because this is a DC amplifier where the feedback coefficient is set by a precision resistor.

The reactor has been put on administrative shutdown per Attachment I¹⁷ and the RSRS met on March 22, 1988 with this event as one item on its agenda. All agree the situation is being addressed properly although the exact cause of the event has not yet been identified. Via a series of troubleshooting maintenance activities, the problem has been isolated to the fission chamber, preamp or connections shown in Attachment V which is Figure 1-8 of the UFTR Safety Analysis Report. There is a strong possibility that cleaning connectors on these components may have corrected the problem per conversation with one vendor.

At this point a procedure is being prepared for RSRS review and approval to allow declaring the UFTR operable pending successful completion of all normal checks and proposing to permit restart as a test to verify proper operation of Safety Channel #1 by monitoring voltage levels in the linear channel section of the preamplifier with respect to ground, the current drawn by detector operation from high voltage supply and the high voltage power supply output voltage. Voltage measurements are the measurement of choice to prevent monitoring from affecting the operation of the system; the voltage measurements will be made by devices with large input impedances and will not draw significant current from the monitored points. In general, current measurements must be made in such a way as to minimize the potential for altering the signal parameters; to minimize the potential for such effects, the input to the high voltage filter in the preamplifier has been selected as the current monitoring point.
