LICENSEE EVENT REPORT (LER)

FACILITY NAME (1) Limerick Generating Station Unit 1 DOCKET NUMBER (2) 0 5 0 0 0 3 5 2 PAGE (3) 1 OF 0 6

TITLE (4) Inadvertent Start of an Emergency Diesel Generator During the Installation of Test Equipment Due to a Procedural Deficiency

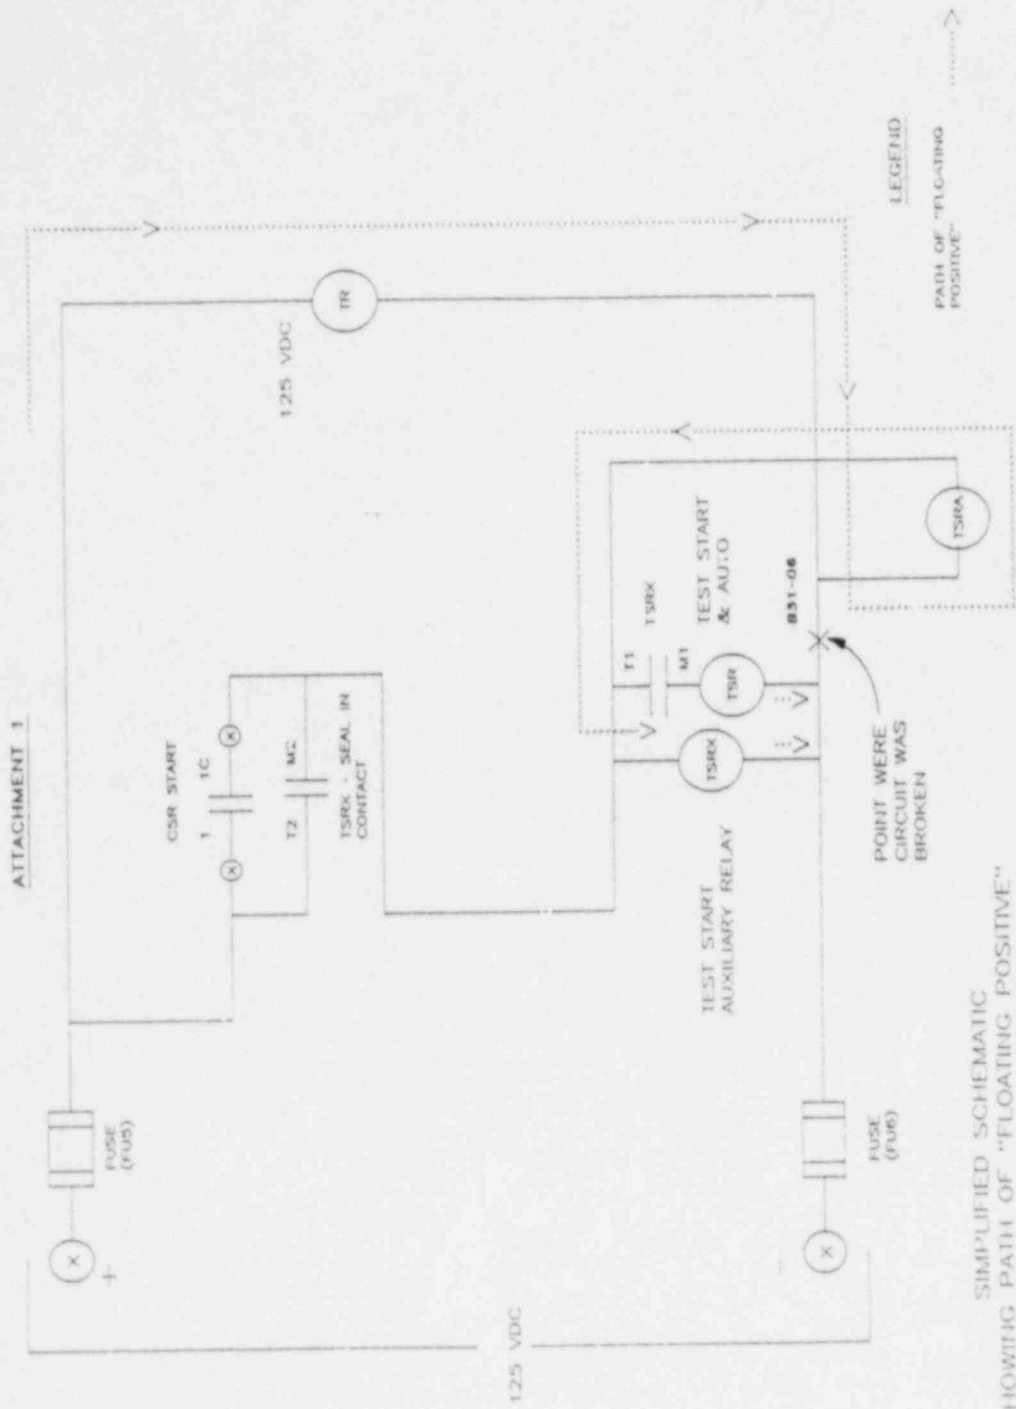
ATTACHMENT 1

During the loosening of the screw on terminal B31-06, the negative leg was lost momentarily, and positive leg voltages were realigned through the circuit. When the negative leg was restored, a voltage drop was developed across the TSR (test start relay) and TSRX (test start auxiliary relay) relays (see Attachment 1). This potential caused both a voltage spike and the relays to energize. The TSRX relay has a seal-in contact that kept the start circuit energized. The D13 Diesel Generator started as designed when its test-start logic was energized. The Diesel Generator was tripped by placing it in "pull-to-lock" and was declared inoperable.

The cause of this event was a deficiency in Special Procedure SP-ST-012, "D13 Diesel Generator Slow Start Testing". The procedure instructed the technician to loosen a terminal screw in order to connect electrical test equipment to contact B31-06 with the circuit energized. Disturbance of the connection caused the energization of the test-start relays and resulted in the D13 diesel start.

SIMPLIFIED SCHEMATIC
SHOWING PATH OF "FLOATING POSITIVE"
FOR LER 88-022

Special Procedure SP-ST-012, "D13 Diesel Generator Slow Start Testing" was revised to include instructions to render the diesel inoperable during testing and remove control fuses to de-energize the test circuit prior to connecting test equipment. The test was then successfully run. There are no other slow start procedures for the other diesels.

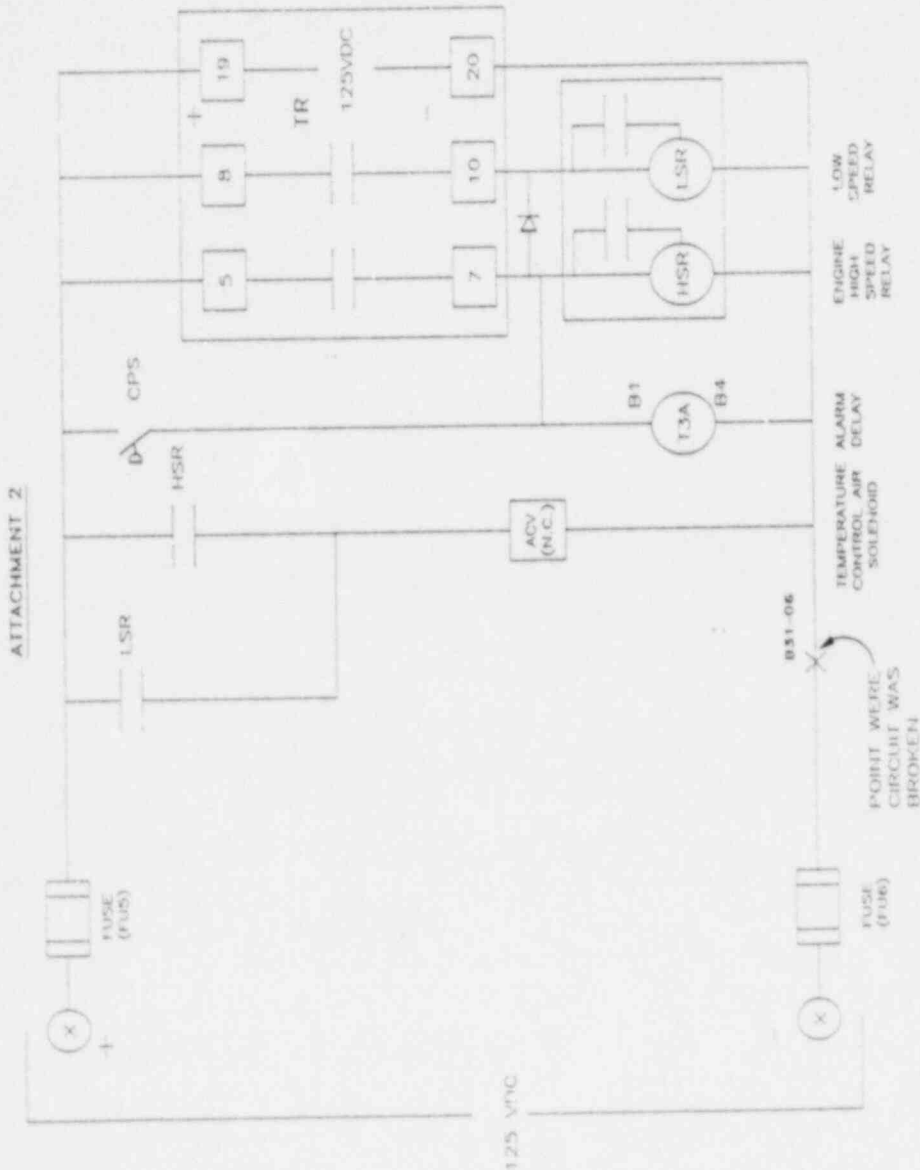
During the performance of the special test procedure, the TR relay failed. The normal backup to the TR relay - the coolant pressure switch (CPS) - had been disabled as part of the test. During the inadvertent start, the failure of the TR relay coincident with the disabled CPS made it impossible to load the diesel because this configuration caused the HSR (high speed relay) and LSR (low speed relay) relays not to function as designed. (See Attachment 2).

SIMPLIFIED SCHEMATIC
SHOWING FAILED IR RELAY
FOR LER 88-022

The TR relay was replaced, and the Diesel Generator was declared operable June 10, 1988 at 0840 hours, after a successful test run. The Diesel Generator was inoperable for approximately 23 hours.

Immediately following the start of the D13 diesel generator, it was placed in a tripped condition and declared inoperable. Further investigation revealed the failed TR relay; which was replaced.
