UNITED STATES
 NUCLEAR REGULATORY COMMISSION
 REGION II
 101 MARIETTA STREET, N.W.
 ATLANTA, GEORGIA 30323

Report No.: 50-297/88-01

Facility Name: North Carolina State University

Inspection Conducted: March 1-4, 1988

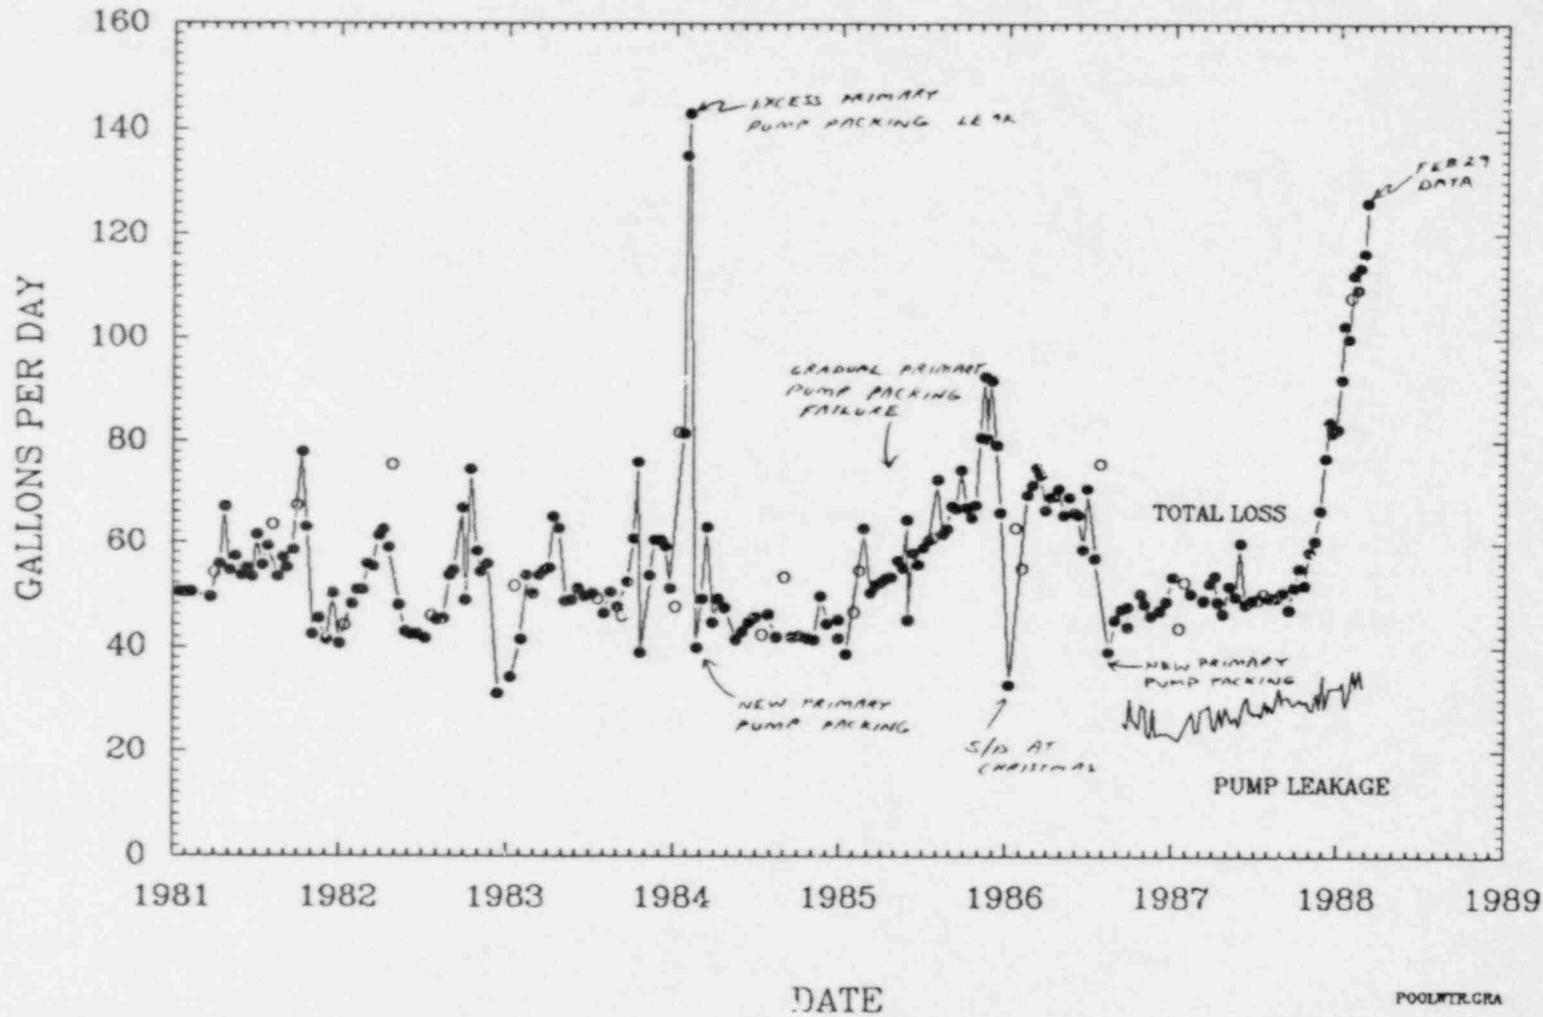
FIGURE 1

The facility was shutdown on February 29, 1988 to investigate an increased rate of water makeup to the reactor pool. Over the preceding weekend, total water loss from the primary system had increased to approximately 190 gallons per day. Of this, only 50 to 60 gallons per day could be attributed to evaporation from the pool surface and to reactor coolant pump packing losses; the pump runs continuously, even with the reactor shutdown. This loss did not result in lowering the pool level to the Technical Specification minimum of 17 feet. The loss rate of about 0.16 inches of level per hour was much less than the 7-inch loss in two hours defined as an unusual event in the PULSTAR Emergency Plan. The licensee estimated the reactor service water makeup system could increase pool level at the rate of six inches per hour.

The licensee maintains a log and plot of makeup to the primary system. From those records, the licensee constructed Figure 1, "Primary Water Loss History." From the figure, it can be seen that increases in water losses have been experienced in the past, but that those earlier large losses could be correlated with leakage from the primary pump. (That leakage is directed to the waste processing system, and does not reach the environment). The running plot is not annotated; so the increase in makeup that started in November 1987 did not, early on, look different from earlier experience. The licensee has made measurements of pool surface evaporation in the past and measurement of pump packing leakage is not difficult. Had there been a program in place to resolve makeup into estimates of identified and unidentified leakage, or to make measurements when the gross makeup rate reached some threshold, the current leakage might have been discovered earlier.
