LICENSEE EVENT REPORT (LER)

FACILITY NAME (1) Sequoyah, U	DOCKET NUMBER (2) 0 5 0 0 0 3 2 8	PAGE (3) 1 OF 0 6
----------------------------------	--------------------------------------	----------------------

Spurious Spike on Particulate Channel Of Upper Compartment Radiation Monitor Resulted In Containment Ventilation Isolation

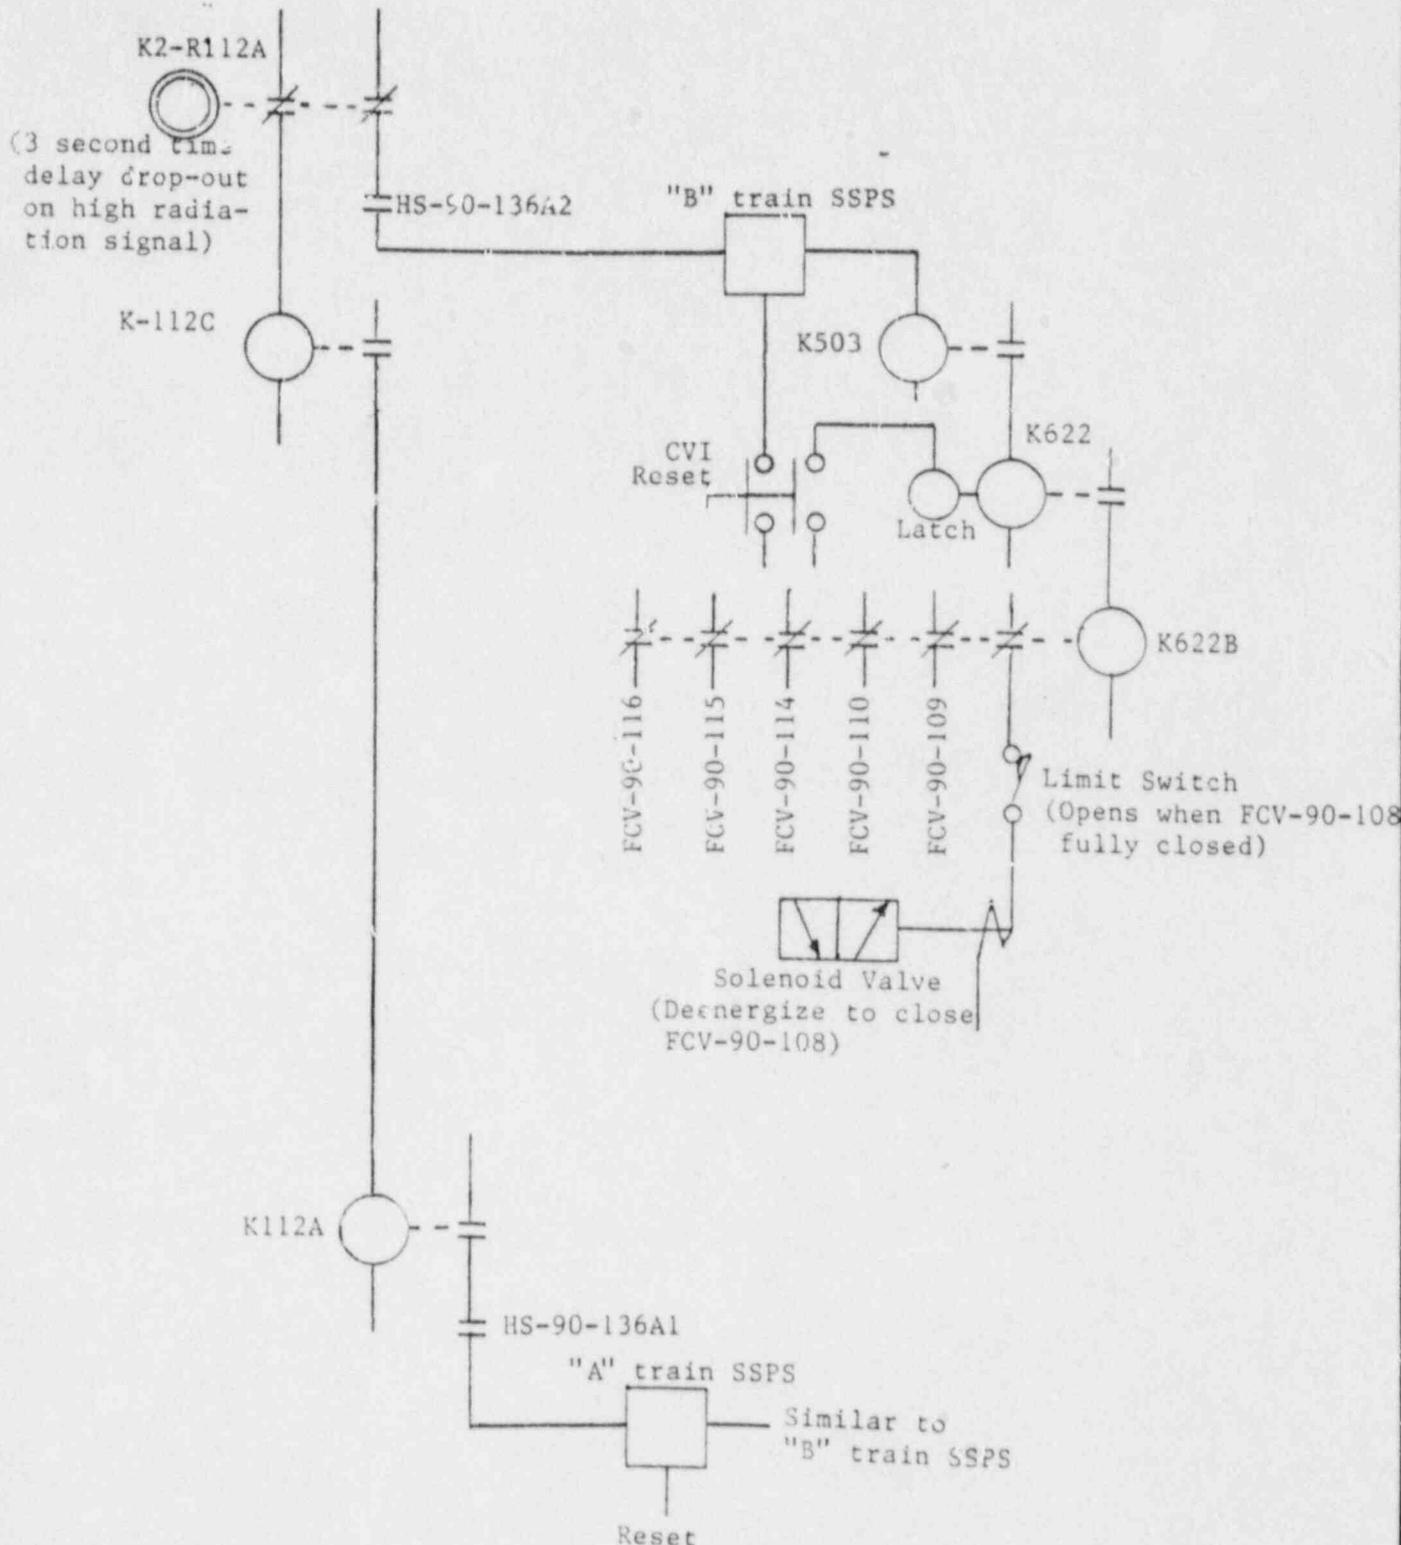
Figure 1
(Simplified Schematic)

Subsequent to the event, an investigation was initiated to determine the cause of "B" train valves not isolating. The electrical schematics were reviewed to determine the proper operation of the containment isolation system when the particulate channel of 2-RM-90-112 actuated. Detection of high radiation by 2-RM-90-112 causes relay "K2-R112A" to deenergize (refer to Figure 1 on page 5).

Relay "K2-R112A" is a time delay drop-out type relay which contacts change state three seconds after the coil becomes deenergized. One set of normally closed contacts between terminal points 1 and 7 of relay "K2-R112A" inputs through RM block switch HS-90-136A2 directly into "B" train SSPS. Another set of normally closed contacts between terminal points 3 and 9 of relay "K2-R112A" are used to control separation relay "K112C", which in turn controls separation relay "K112A."

A normally open contact of relay "K112A" inputs through RM block switch HS-90-136A1 into "A" train SSPS. Upon an input signal to either train of SSPS, the master relay "K503" of the train energizes, which in turn energizes slave relay "K622." A mechanical latch serves to seal-in the slave relay once it has become energized. A normally open set of contacts of the slave relay closes, causing auxiliary relay "K622B" to energize. Normally closed contacts from relay "K622B" open when the relay energizes, causing solenoids associated with pneumatically operated valves to deenergize. Deenergizing the solenoids allows the valves to close, thus performing their isolation function. Limit switches which are designed to open when the valves are fully closed, prevent the valves from automatically reopening if the CVI signal is reset.

The improper operation of the latching mechanism supports the conclusion that the cause of the "B" train equipment not isolating was that the spike which occurred on June 19, 1988, was of sufficient duration to exceed the three second time delay associated with timer "K2-R112A", as well as the response time associated with the separation relays and "A" train SSPS, but was not long enough for the "B" train isolation valves to fully close. The actual response time of the "B" train equipment documented on the most recent performance of Surveillance Instruction (SI)-247.100 "Response Time Testing of the Engineered Safety Feature Instrumentation" was 5.878 seconds and the response time of the valves alone was 2.608 seconds.

TVA will replace/repair the mechanical latch mechanism for slave relay "K622" for unit 2 "B" train SSPS during the next unit 2 refueling outage.
