LICENSEE EVENT REPORT (LER)

FACILITY NAME (1) Sequoyah, Unit 1 DOCKET NUMBER (2) 05000327 PAGE (3) 1 OF 06

TITLE (4) Unclear Planning Of Work Activities Resulted In A Loss Of Power To A 6.9 kV Shutdown Board And Subsequent Start Of All Four Diesel Generators

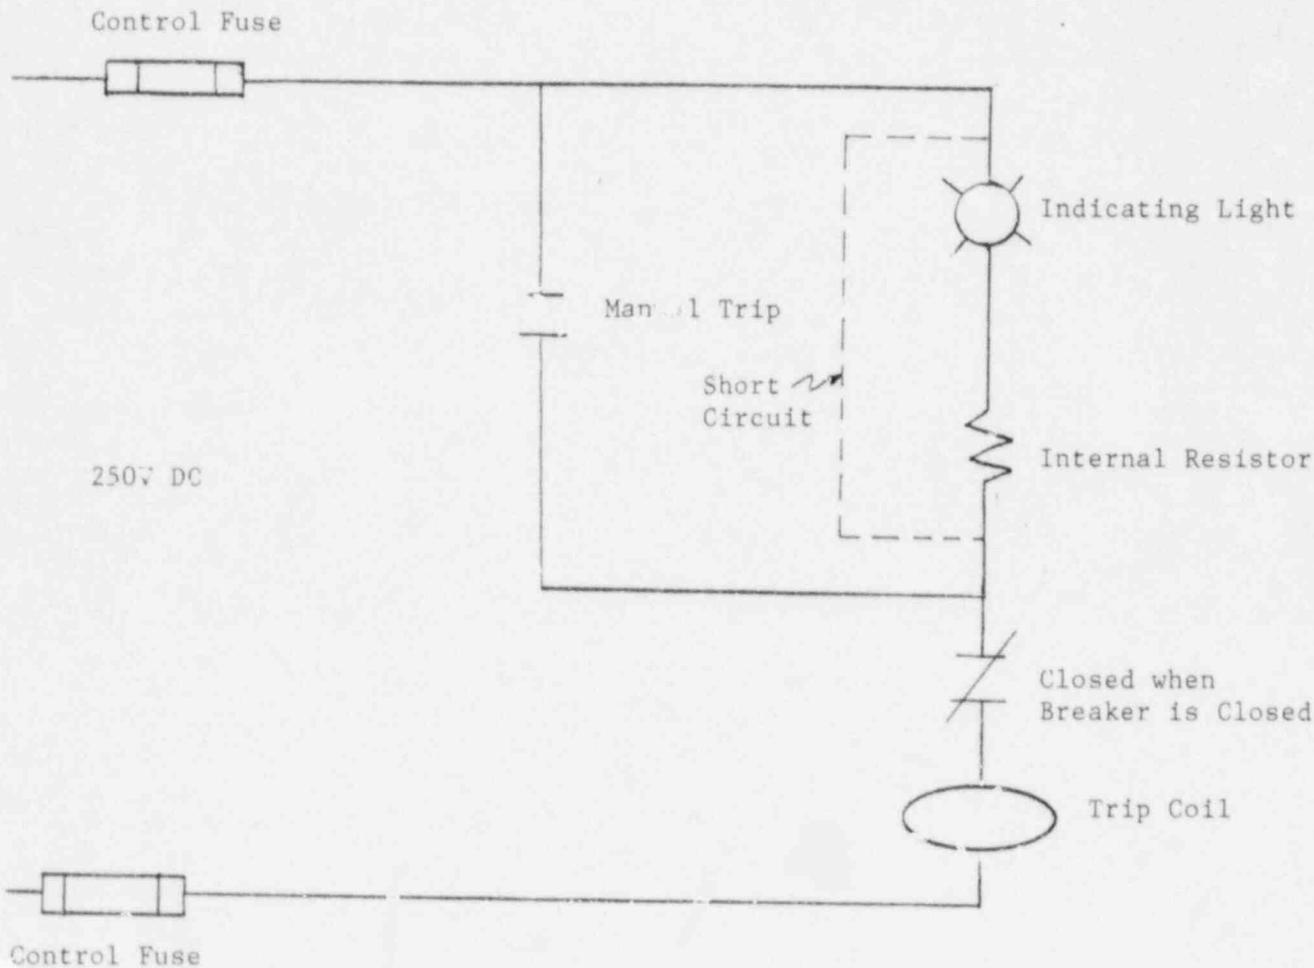
Before this event occurred, at approximately 2248 EDT, Operations personnel had authorized the performance of Work Request (WR) B292853 to repair/replace the red indicating light assembly for breaker 1722. This breaker, which is normally closed, is the normal feeder breaker for 6.9 kV shutdown board 1B-B from 6.9 kV unit board 1C (EIIS Code EA). The indicating light assembly, which is energized when the subject breaker is closed, is located on panel 1-M-1 in the main control room (EIIS Code NA) and is an integral part of the 250 volt DC control circuit (EIIS Code EI) for breaker 1722. That is, the indicating light assembly is connected in series with the trip coil for breaker 1722 and serves a two fold purpose; (1) it provides positive indication that breaker 1722 is closed, and (2) it provides positive indication that continuity exists through the breaker trip coil (see attached figure).

The immediate cause of the automatic start of all four D/Gs was an undervoltage condition on 6.9 kV shutdown board 1B-B that resulted from the trip of feeder breaker 1722. As shown in the attached figure, the indicating light assembly for breaker 1722 is connected in series with the subject breaker's trip coil as part a 250 volt DC control circuit. The circuit is designed to provide breaker position indication and verification of trip coil continuity. The resistance of the light and its internal ceramic resistor limit the current flow through the trip coil such that the current is well below the value at which a breaker trip will occur. However, when EM personnel cut the tie wrap that was holding the wires to the indicating light assembly the internals of the assembly fell apart and caused a momentary short circuit across the assembly. As a result of the short circuit, the trip coil experienced the full 250 volts and, as designed, tripped feeder breaker 1722. The trip of feeder breaker 1722 caused breaker 1726 to trip and created a loss of power condition to 6.9 kV shutdown board 1B-B. The loss of power to the shutdown board actuated the associated undervoltage relays which then sent an emergency start signal to all four D/Gs.

A contributing cause of this event is the difficulty in removing the small lamps associated with the indicating light assemblies. The excessive force that is sometimes required to remove the lamps can result in a broken lamp (with the base of the lamp remaining inside the socket), or it can result in broken socket (both of which occurred in this event). Either of these cases necessitates repair or replacement of the indicating light assembly and increases the potential for an unwanted trip of the associated breaker.

To prevent recurrence of this event, TVA will instruct WR planners to ensure that each WR on an indicating light assembly that can affect ESF equipment contains a requirement to take the appropriate action necessary to prevent a potential undervoltage condition (e.g., lifting the leads or swapping to the alternate feeder breakers) before work on an indicating light assembly can begin. In addition to improved WR planning, TVA has restructured the WCG at SQN. The newly restructured WCG is composed of a multidiscipline staff including engineers, technicians, senior reactor operators, etc. The WCG now utilizes a system concept that provides expertise in specific areas and facilitates the identification of potential problems. As a result, TVA anticipates better control over SQN work activities.

TVA will also review this event with Operations personnel to ensure they are aware of the potential problems that can arise from such routine activities as changing out indicating lamps. This review will emphasize the necessity of carefully removing the burnt-out lamps to prevent the potential for breaking the lamp while leaving the base inserted in the socket.
