POWER REACTOR EVENTS

United States Nuclear Regulatory Commission

September-October 1982/Vol. 4, No. 6

1.1 Pressurizer Code Safety Valve Problem

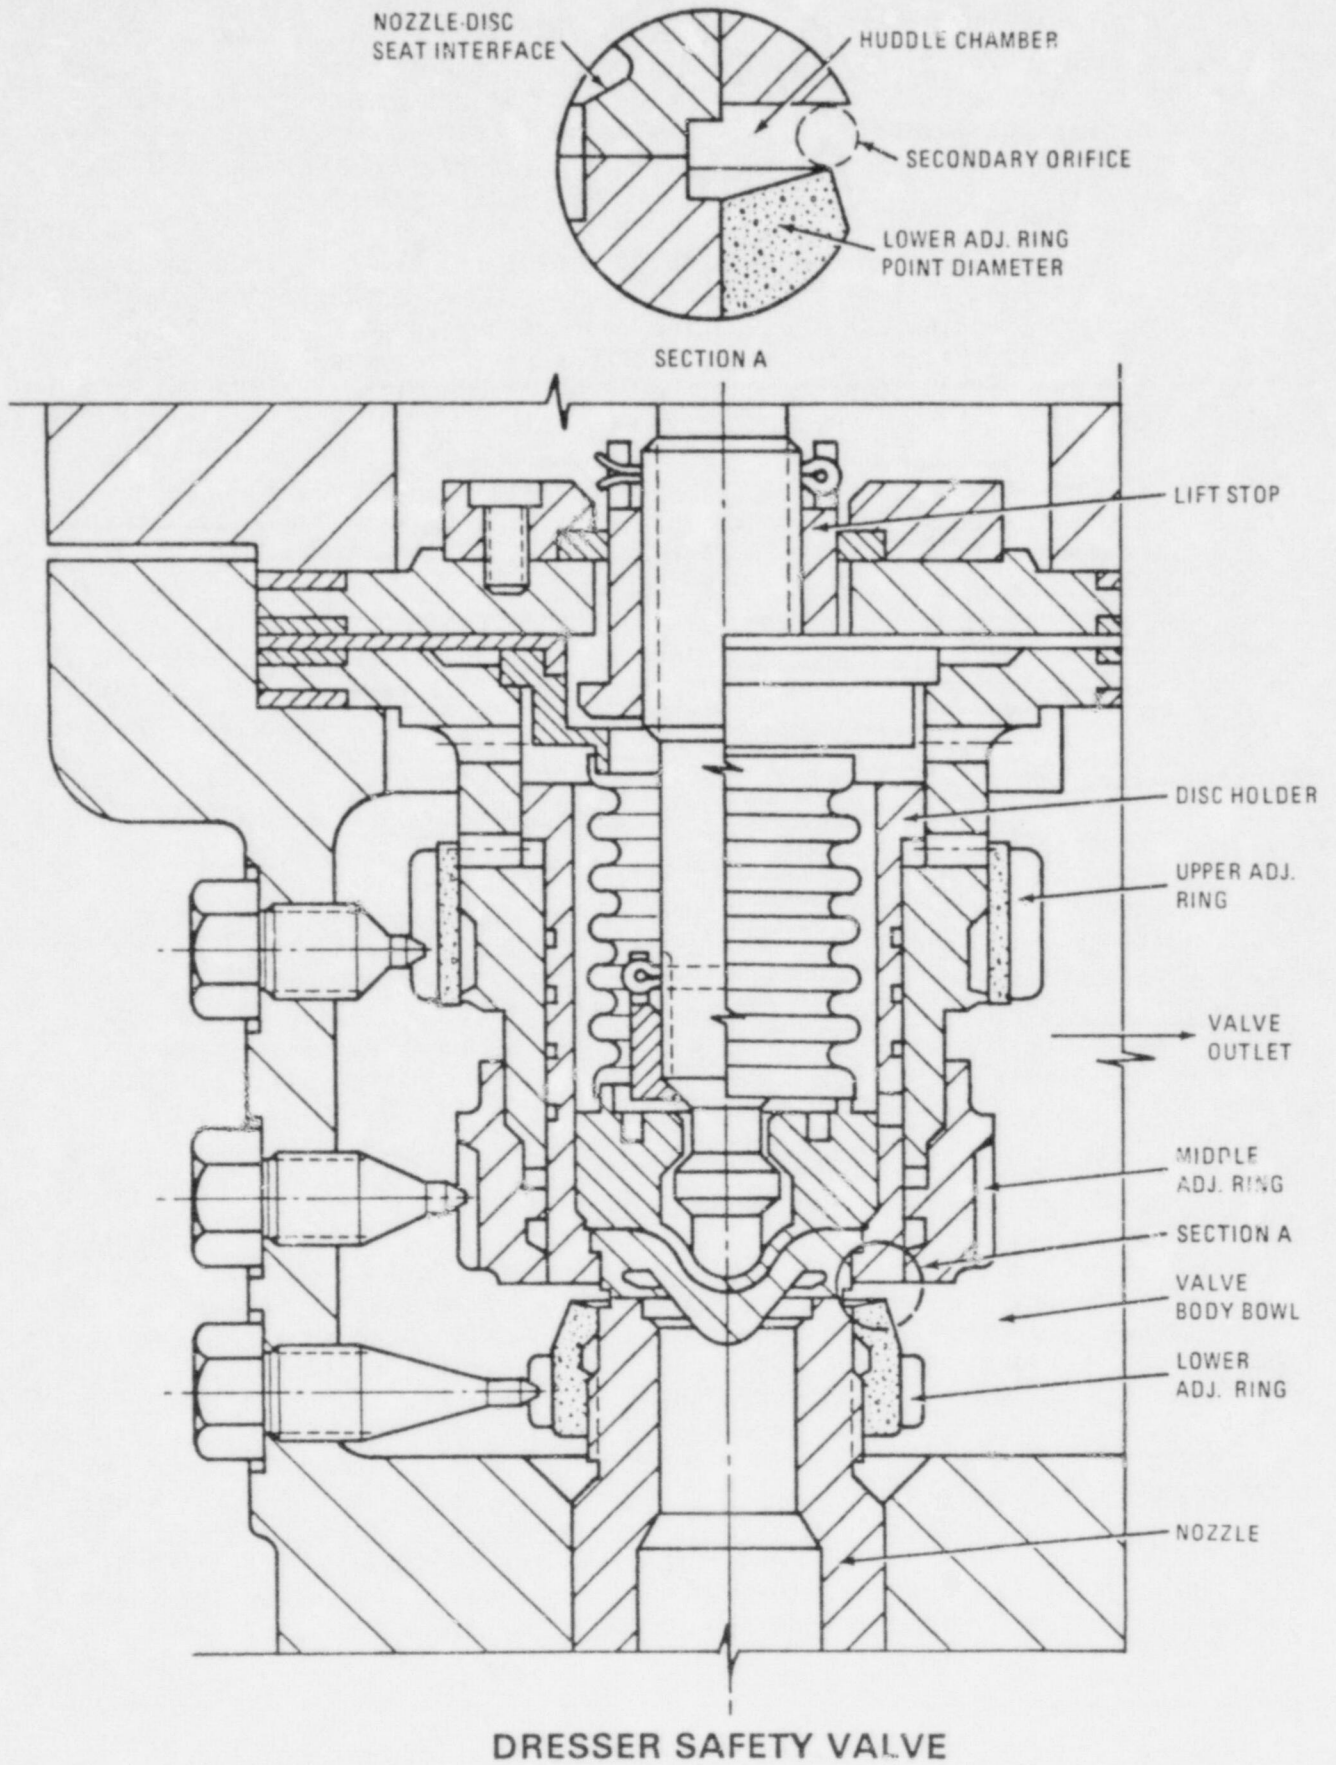
Figure1

During the EPRI tests, the Dresser 31739A valve was shown to achieve less than rated lift in the presence of high backpressure when the "huddle chamber" shown in Figure 1 (Section A) was opened up with ring

settings of -13, 0, -48 (lower, middle, upper). In the tests, the percent of rated flow achieved was significantly higher than the percent of rated lift achieved (which is reasonable since valves are conservatively derated from actual expected flow). In actual plant conditions, high backpressure is caused by high relief flows; if relief flow is reduced, then the backpressure is also reduced.
