**LICENSEE EVENT REPORT (LER)**

FACILITY NAME (1) Duane Arnold Energy Center		DOCKET NUMBER (2) 05000-331	PAGE (3) 1 OF 7
---	--	--------------------------------	--------------------

TITLE (4)  
Inadequate Test of the Reactor Mode Switch to Shutdown Position Rod Block Function and Rod Block Monitor

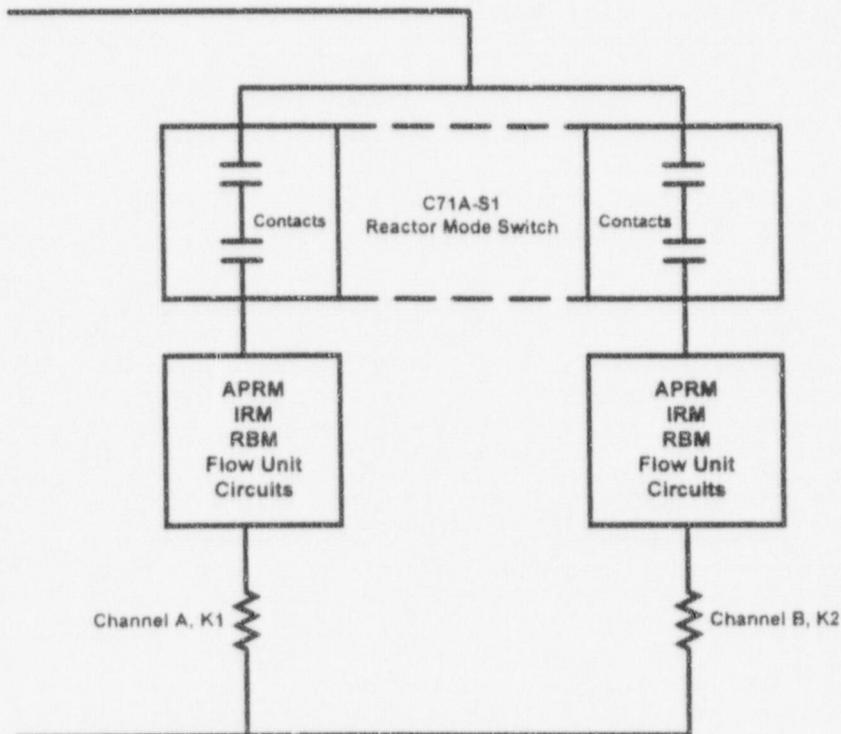
Figure 1. Simplified "Reactor Mode Switch - Shutdown Position" Rod Block Function Circuit, Channel A/B

On June 24, 1997, the plant was operating at 100% rated thermal power (RTP). At approximately 1500 hours, during a review of a cyclic functional test procedure (STP 41A012-CY, Reactor Mode Switch In Shutdown - Instrument Functional Test) for its adequacy to meet Improved Technical Specifications (ITS) requirements, it was determined that the procedure did not fully satisfy the surveillance requirement in the current Technical Specifications (TS), Tables 3.2-C/4.2-C. Table 3.2-C requires that both channels of the "Reactor Mode Switch - Shutdown Position" rod block function be operable when the plant is in Mode 3 or 4 (hot/cold shutdown) and if one channel is inoperable, a rod block must be initiated. Because the existing procedure only required that a rod block actuate during the test and did not verify that each channel is capable of initiating a rod block by itself, it was determined that the procedure would not fully satisfy the TS requirement as proper performance of one channel could mask inoperability of the second channel. The "Reactor Mode Switch - Shutdown Position" rod block function has two channels actuated from the single Reactor Mode Switch (RMS). Either one is capable of initiating a rod block (see Figure 1).

For the event on June 24, the procedure (STP 41A012-CY) had been revised to verify that a rod block was generated when the RMS was placed in the "SHUTDOWN" position; however, it had not been revised adequately to verify that each channel was capable of initiating a rod block by itself. The fact that a single switch (the RMS) initiated both channels could have contributed to the interpretation that the two channels in TS Table 3.2-C were referring to the two Rod Block channels and not separate RMS input channels. The Bases of the ITS provide more detail on what testing is required and led the procedure writer to question the adequacy of the original testing. Detailed review of the RMS drawings was then necessary to determine that the RMS actuates two separate sets of contacts, one set for each of the Rod Block channels.

Note: Normally, relays K1 and K2 are energized. De-energizing either relay generates a rod block. Current test procedure cannot determine which relay is de-energized (or which channel is activated). Current Tech Spec requires both channels to be operable.
