U. S. NUCLEAR REGULATORY COMMISSION  
REGION V

Report No: 50-528/88-20

Facility Name: Palo Verde Unit 1

Inspection at: Wintersburg, Arizona (Palo Verde Site)

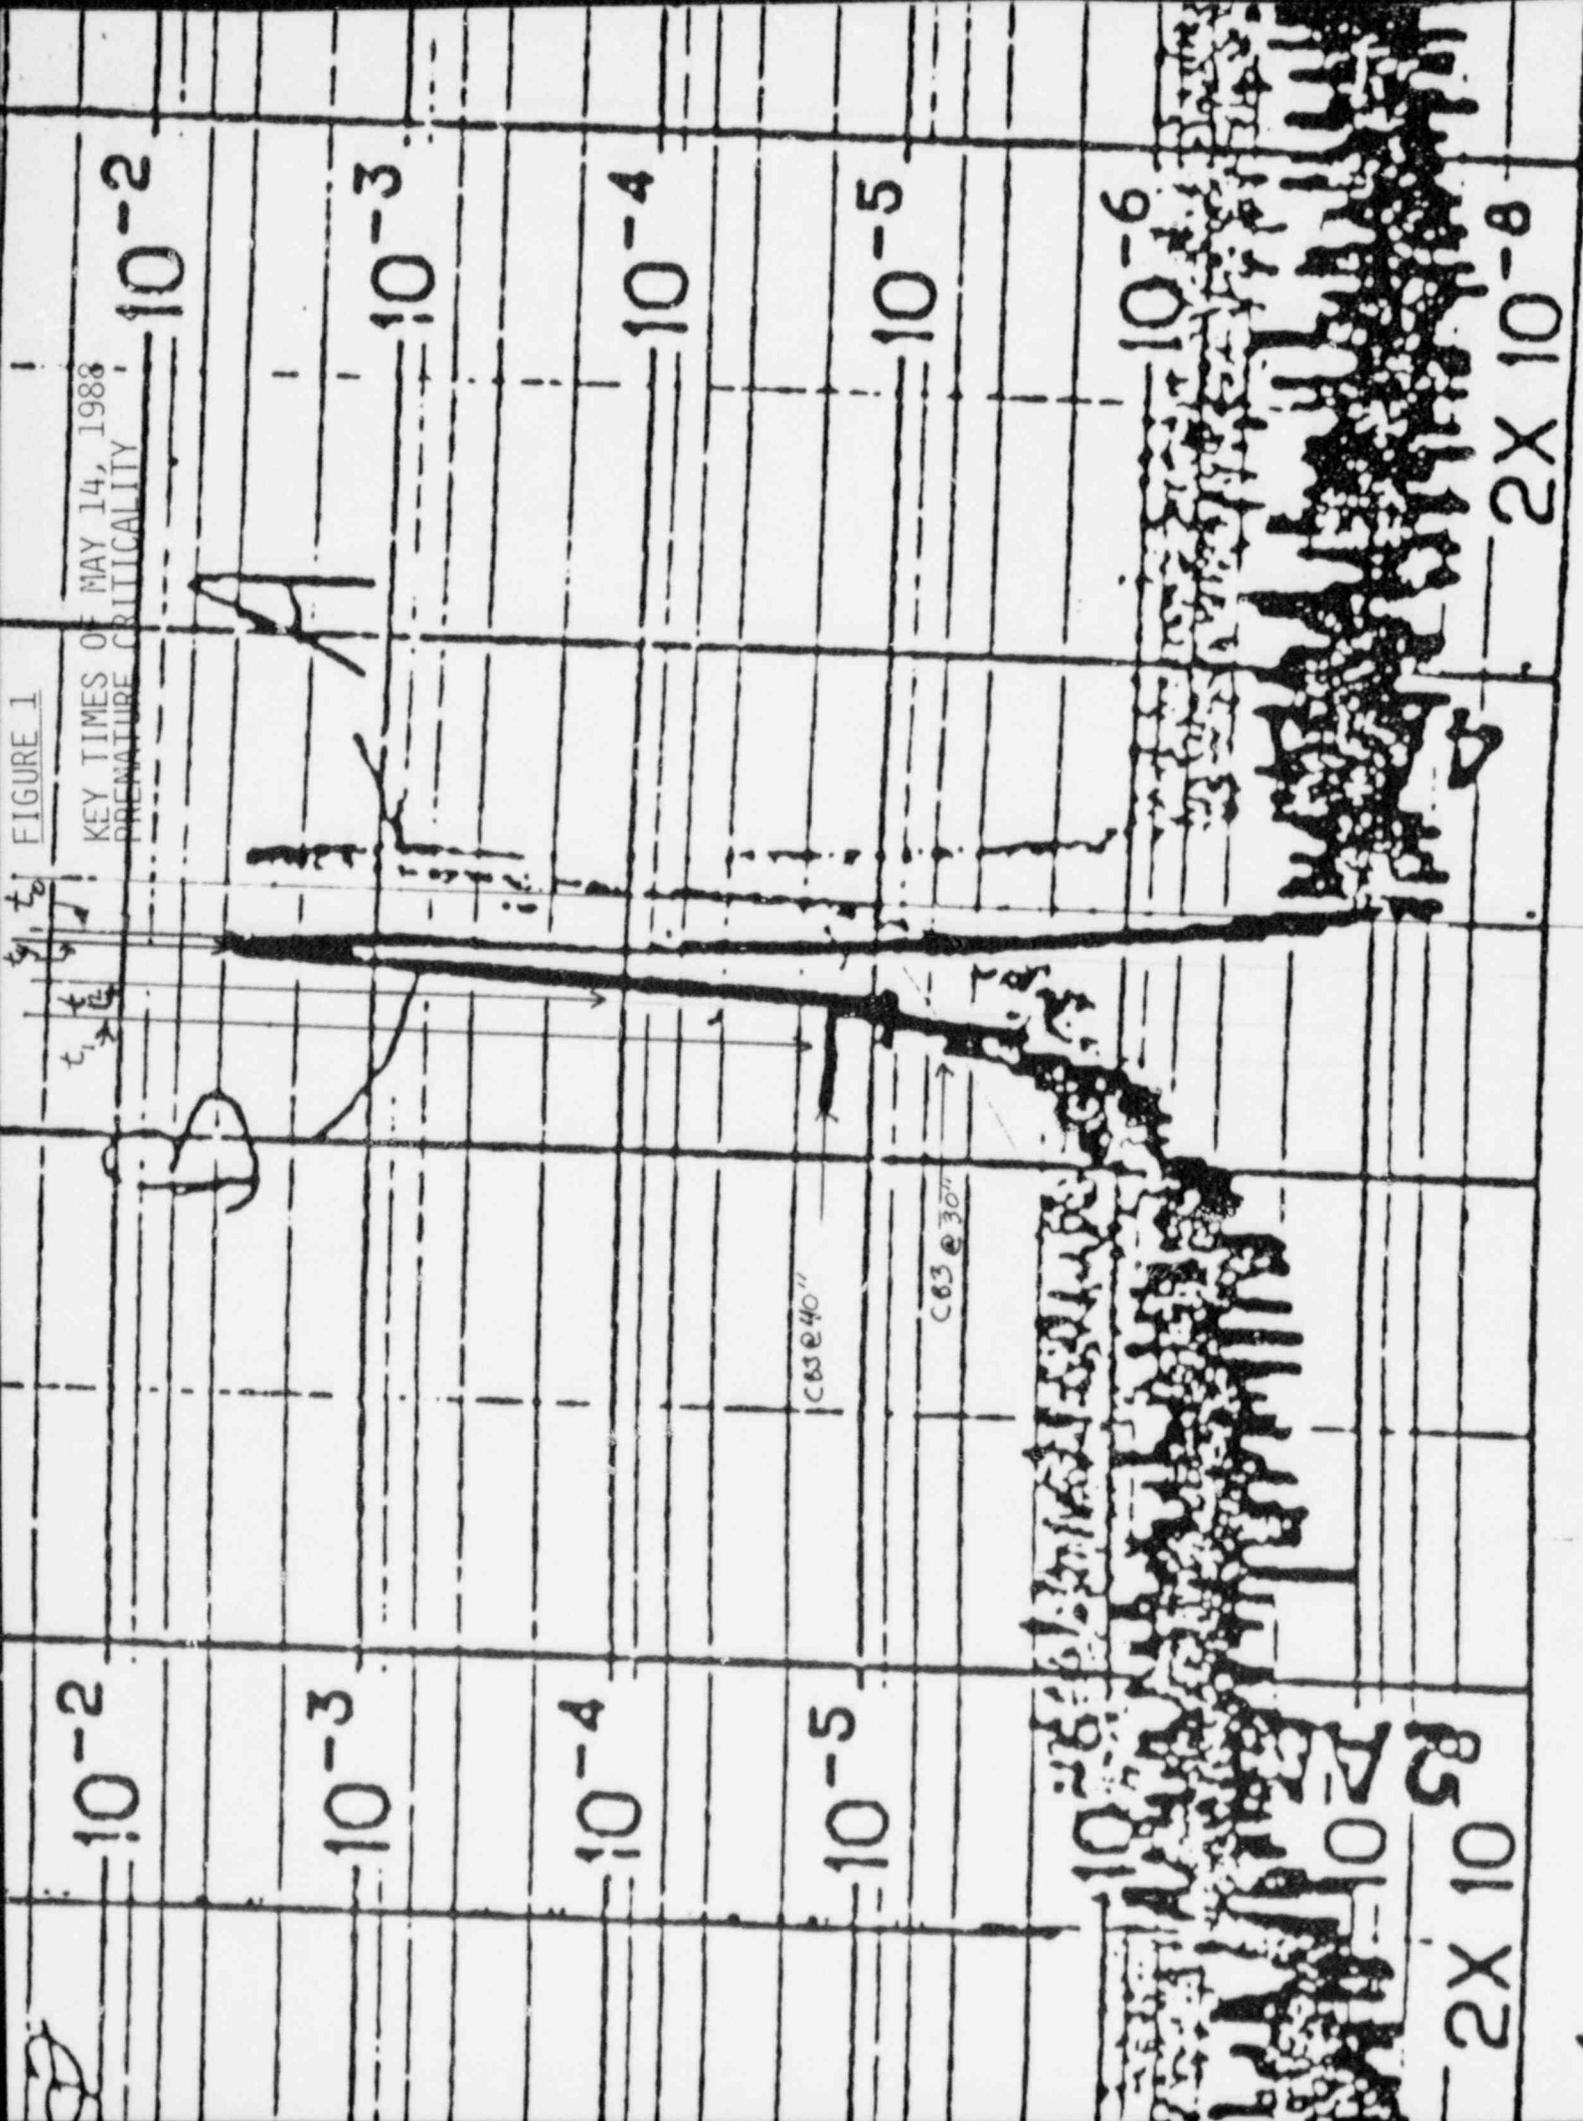
FIGURE 1

KEY TIMES OF  
MAY 14, 1988  
PREMATURE CRITICALITY

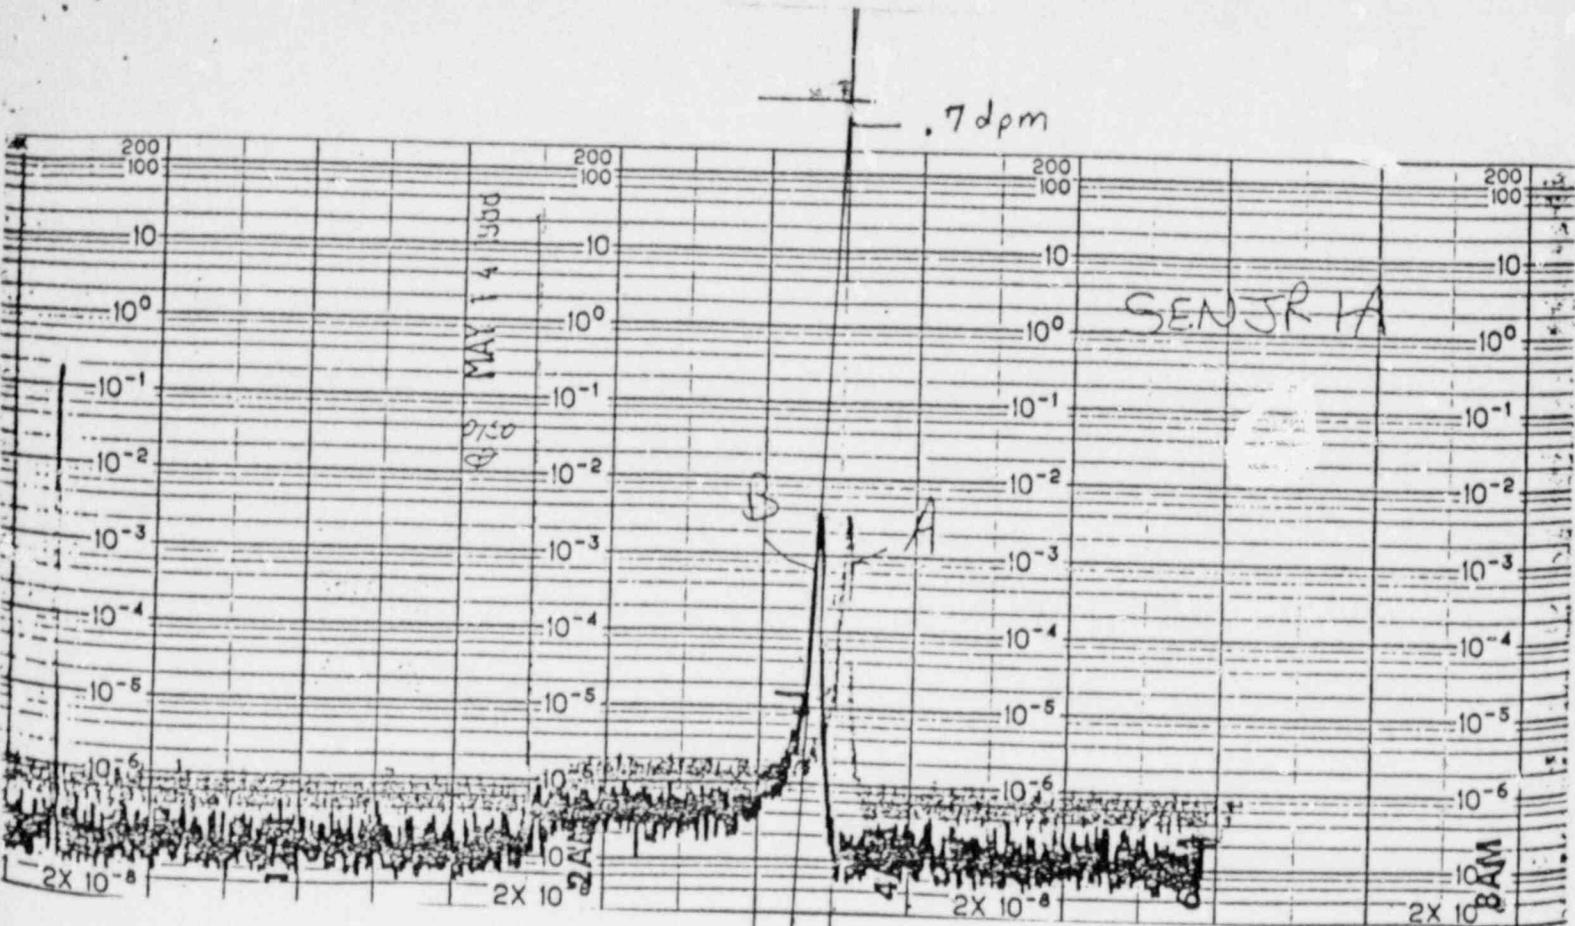
By interpolation from  $SUR = .7$  dpm @ 60",  $SUR = 0$  @ 47.3" GP 3  
 = ECRP

As a cross check, the CEA motion reconstruction/alarm typer record indicated GP 3 remained at about 60" for 2 min 42 sec. As shown in the expanded log power graph, the time interval from  $1.5 \cdot 10^{-5}$  to  $10^{-3}$  amps is approximately 3 minutes, relatively close agreement, given the measurement difficulty.
