SUBJECT: THE OPERATING REACTORS EVENTS MEETING  
July 12, 1988 - MEETING 88-28

PALO VERDE 1  
AUXILIARY TRANSFORMER EXPLOSION  
JULY 6, 1988

BRUNSWICK UNITS 1 & 2  
HIGH PRESSURE COOLANT INJECTION PROBLEMS  
APRIL 1 THROUGH JULY 12, 1988

FORT ST. VRAIN  
CORE SUPPORT FLOOR INTERNAL PRESSURE  
JULY 12, 1988

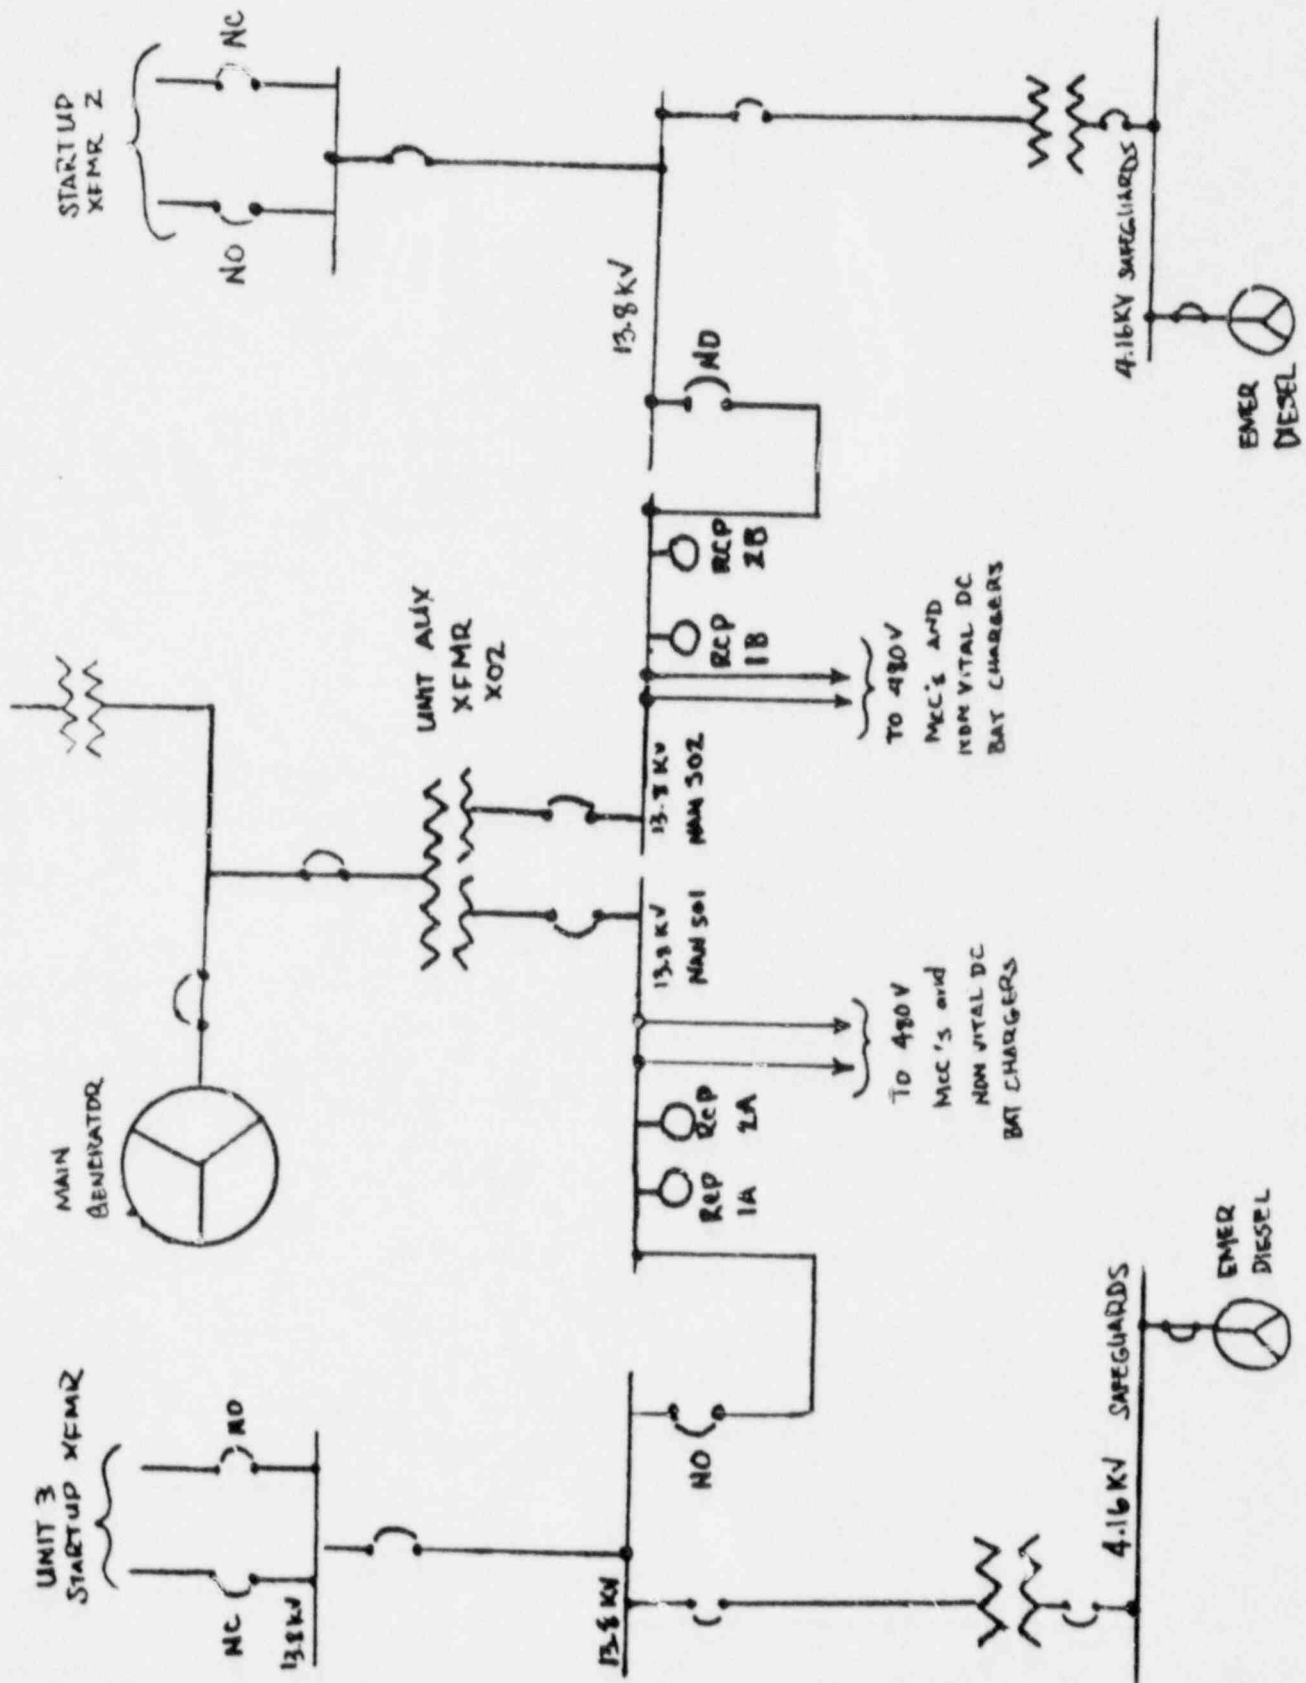
FAILURE OF PALO VERDE UNIT 1 AUXILIARY TRANSFORMER AND SUBSEQUENT FIRE LEAD TO A REACTOR TRIP AND LOSS OF FORCED CIRCULATION.

GROUND FAULT ON 13.8 KV NONVITAL BUSS.

- o UNIT AT 100% POWER PRIOR TO EVENT.
- o AT APPROXIMATELY 12:07 (MST) ON JULY 6, 1988, UNIT AUXILIARY TRANSFORMER (AXFMR) FAILED CATASTROPHICALLY AND CAUGHT FIRE DUE TO GROUND FAULT ON ASSOCIATED NONVITAL BUSS.

- o LICENSEE HAS 50-60 DAY PROGRAM TO REPLACE DAMAGED EQUIPMENT AND MAKE ROOT CAUSE ANALYSIS.
- o LICENSEE TO REVIEW ADEQUACY OF RELAY AND BREAKER COORDINATION AS PART OF THEIR FOLLOWUP EFFORT.
- o LICENSEE CONSIDERING THE INSTALLATION OF ADDITIONAL BATTERY CHARGER TO BE POWERED FROM AN ALTERNATE SOURCE.

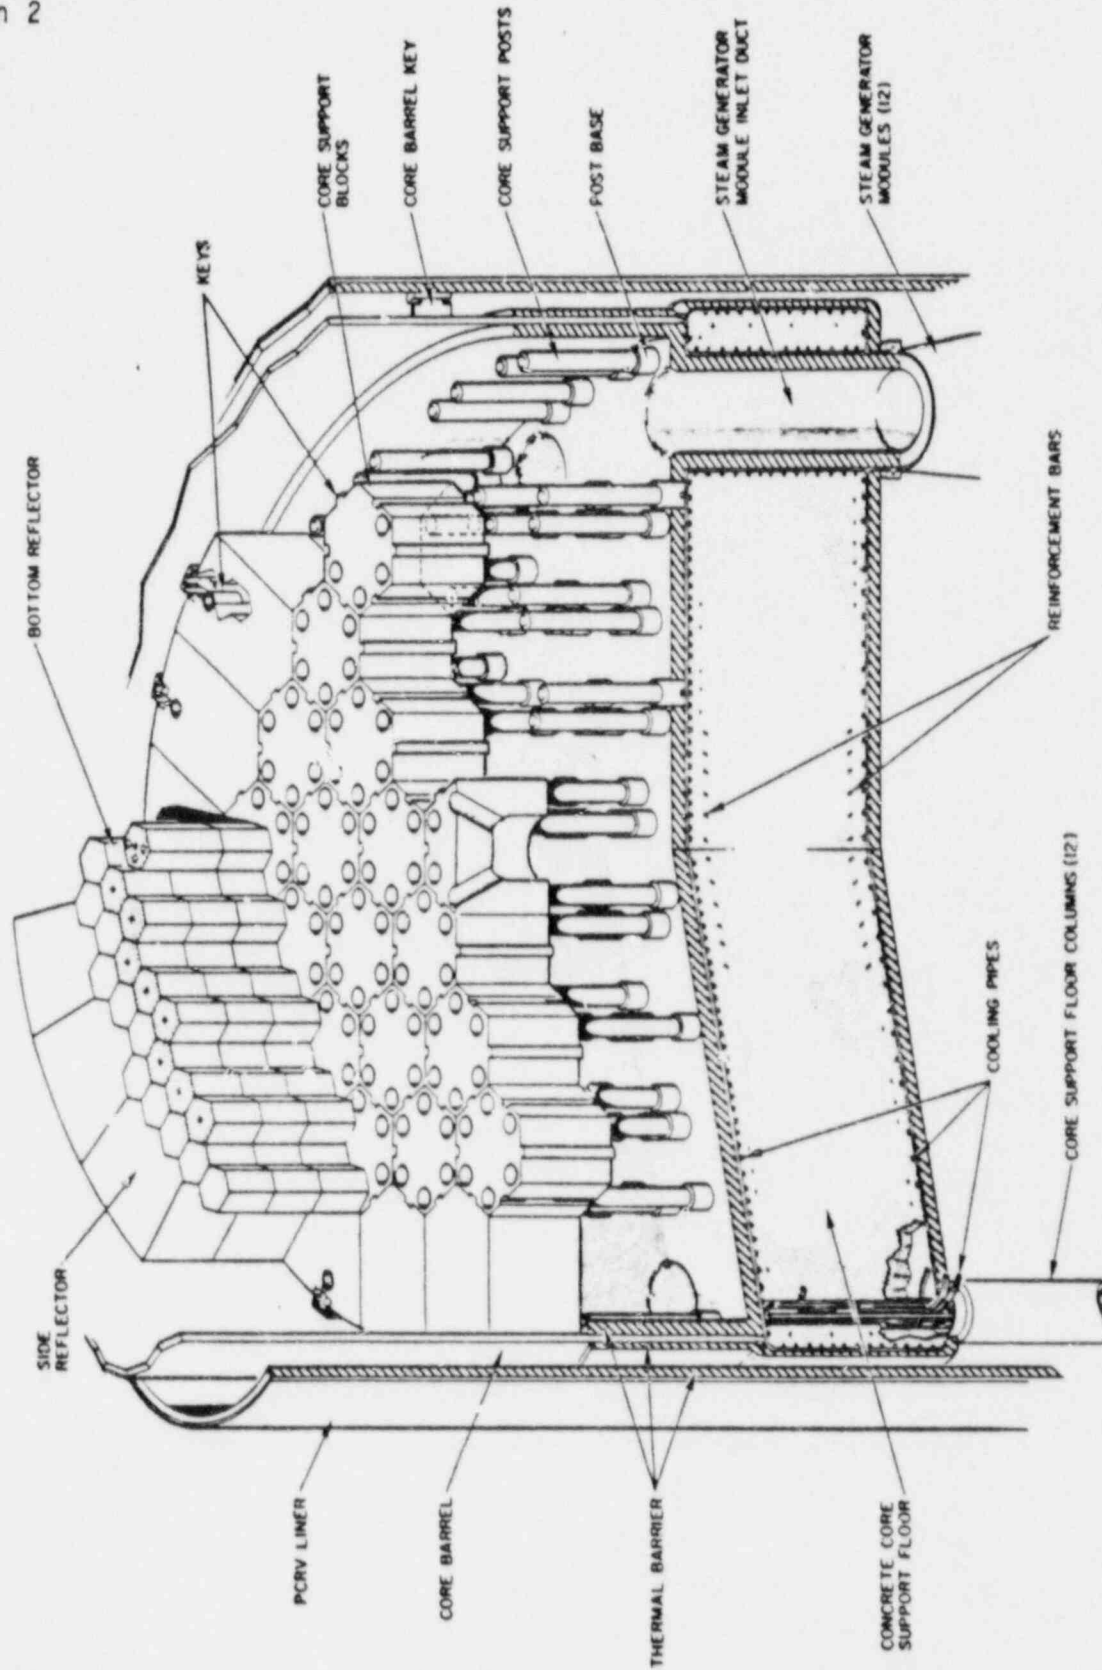
Figure 3.3-2 Core Support Arrangement

- o DEFORMATION OF CSF STEEL CASING COULD CAUSE SIDEWALL LINER TO SIGNIFICANTLY RESTRICT THE PRIMARY COOLANT FLOW PATH.
- o TOP LINER COULD BUCKLE CAUSING POSSIBLE CORE DISARRAY.

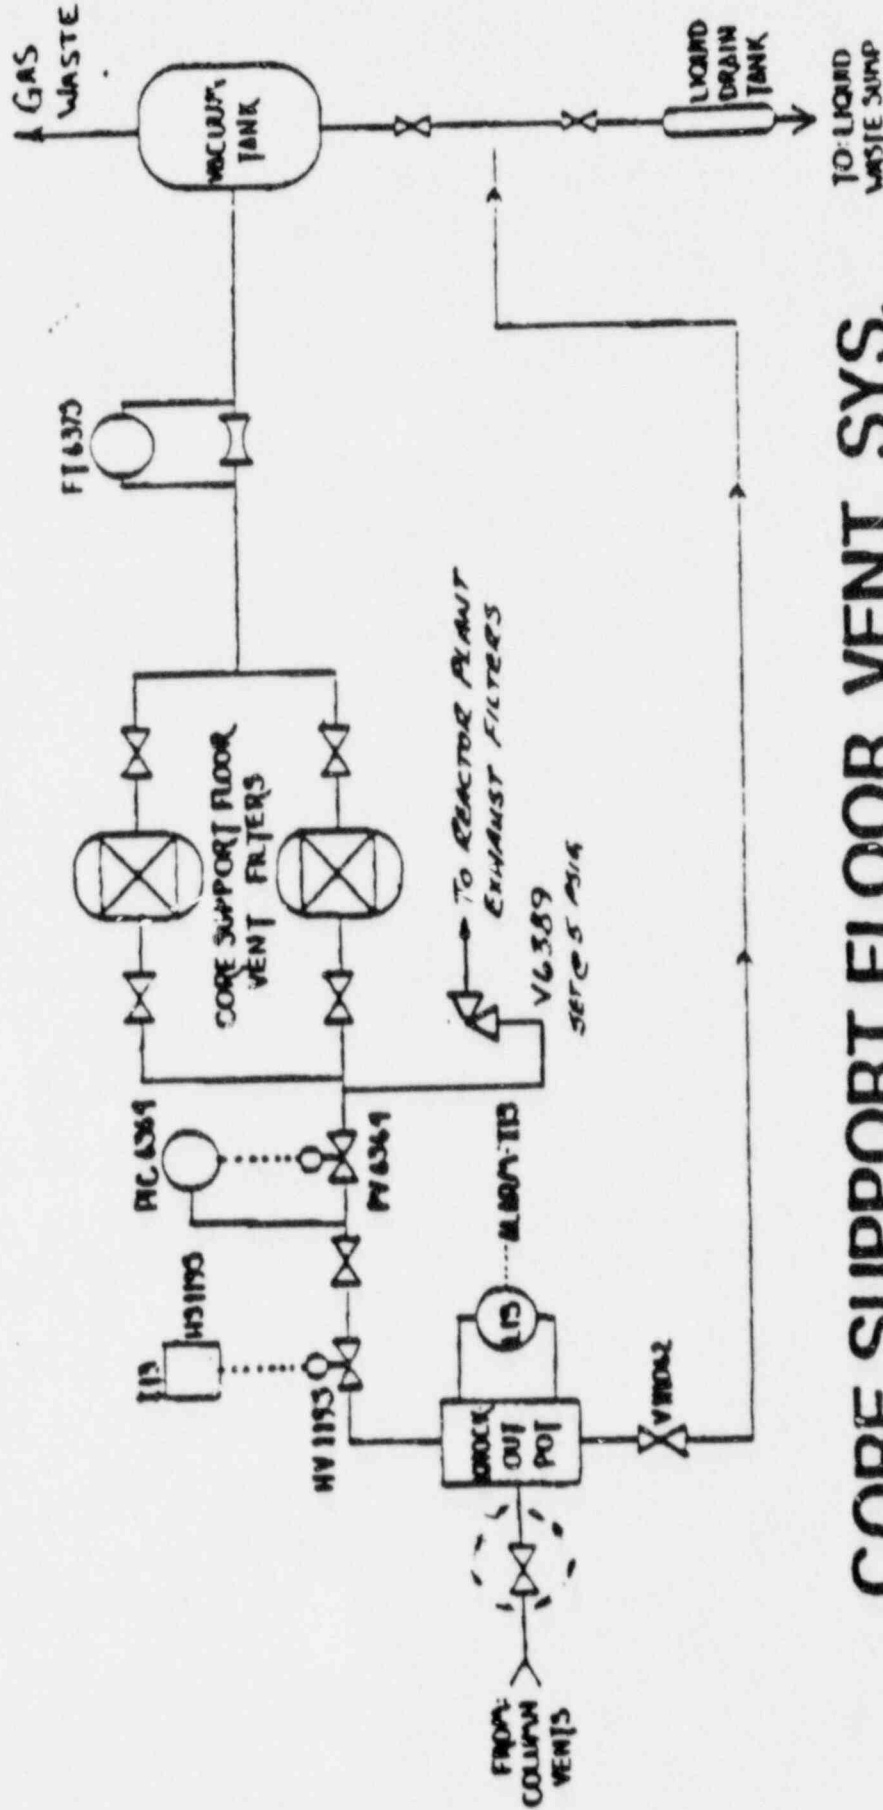
**CORE SUPPORT FLOOR VENT SYS.**

VALVE IN CORE SUPPORT FLOOR (CSF) VENT SYSTEM WAS FOUND IN MID-POSITION WHICH WOULD HAVE PREVENTED CSF PRESSURE CONTROLLER FROM CONTROLLING PRESSURE WITHIN CSF.

PROBABLY HUMAN ERROR.

REGION IV IS FOLLOWING UP.

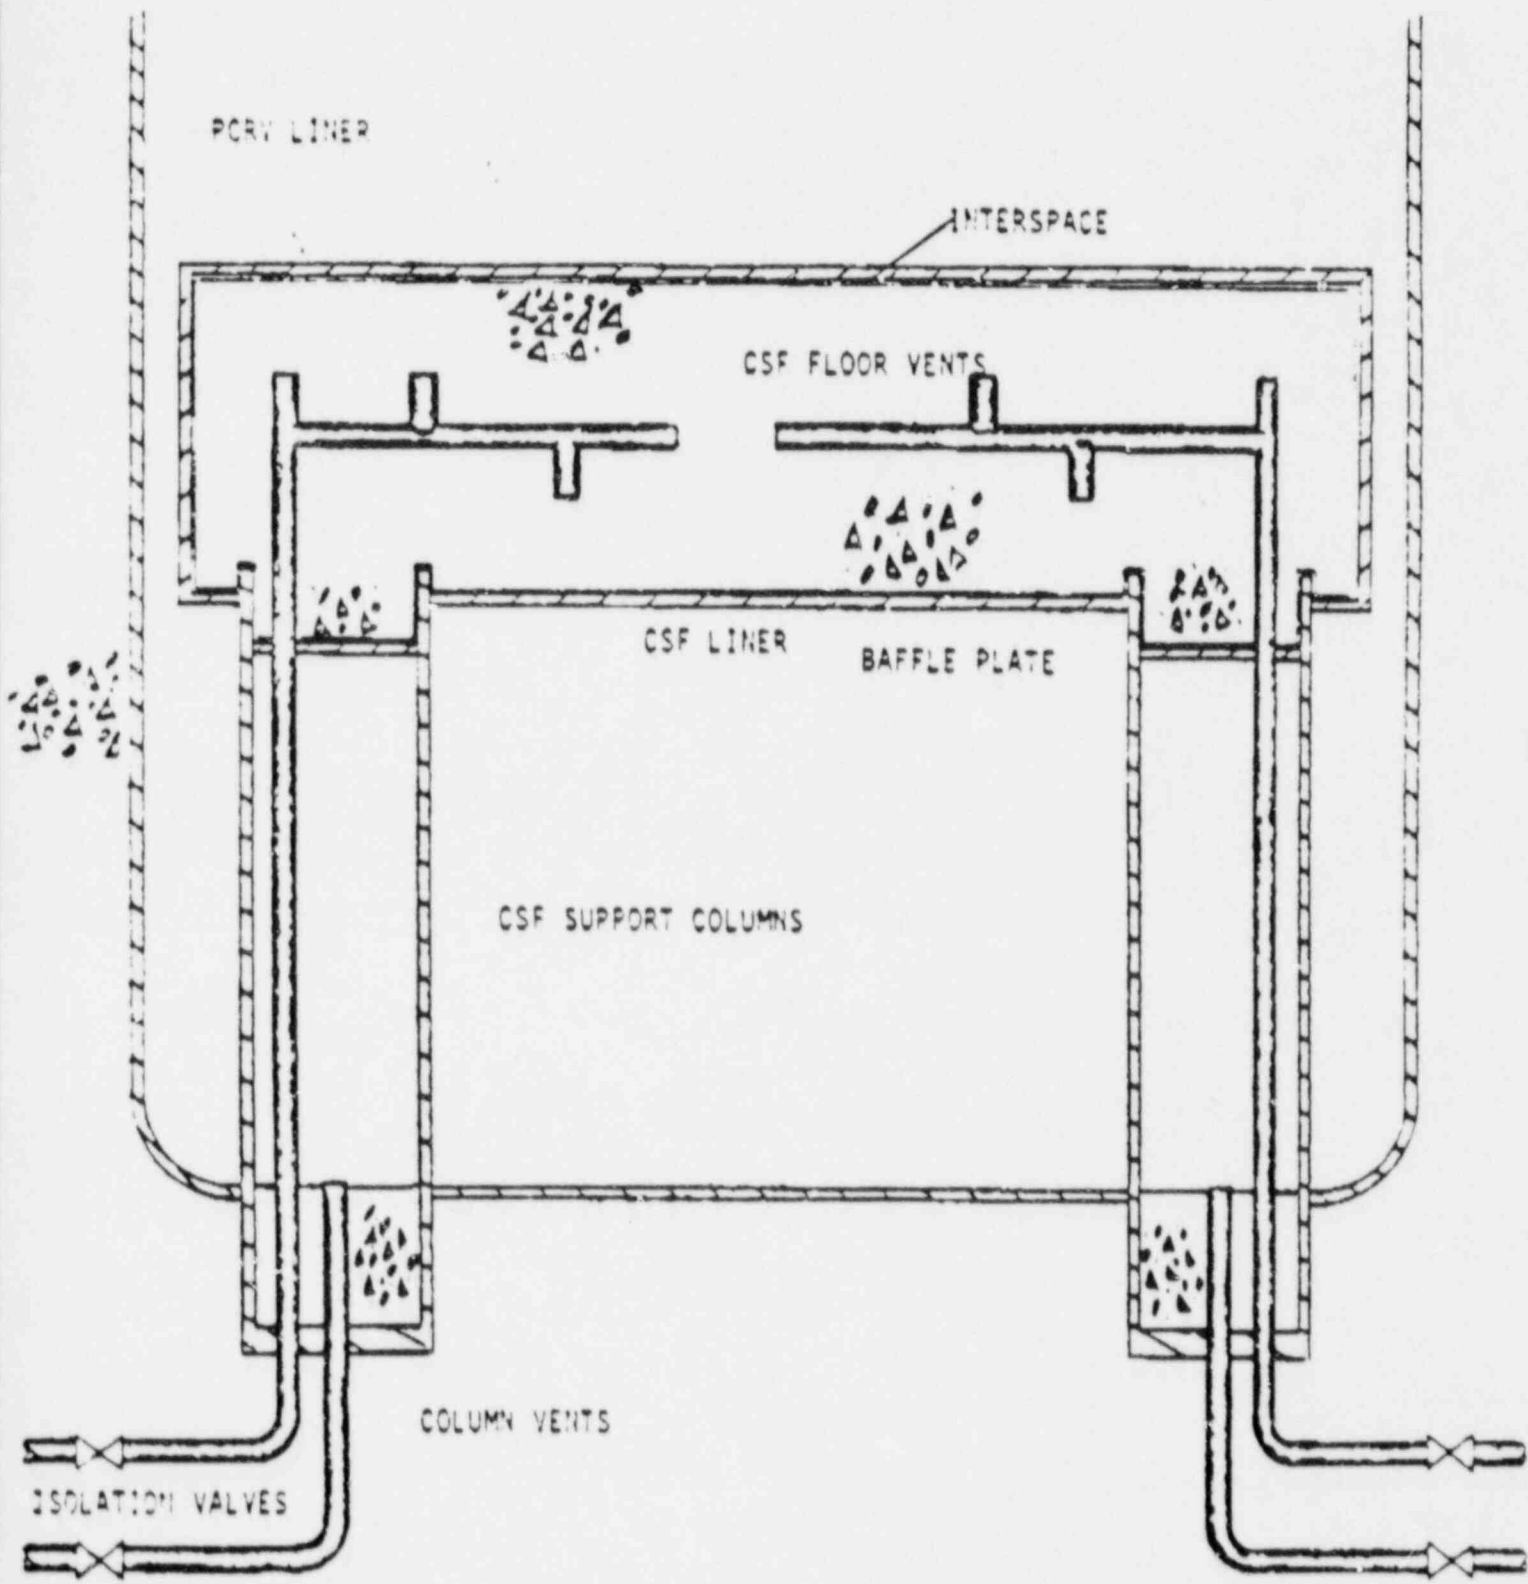
CORE SUPPORT FLOOR/COLUMN VENT SYSTEM

- o NON-SAFETY VENT SYSTEM MAINTAINS CSF PRESSURE LESS THAN 50 PSIG.
- o DURING NORMAL OPERATION PRIMARY COOLANT PRESSURE IS 700 PSIG.
- o WITH VENT VALVE CLOSED, CSF PRESSURE COULD COME IN EQUILIBRIUM WITH PRIMARY SYSTEM PRESSURE.
- o FOLLOWING RAPID DEPRESSURIZATION OF PRIMARY COOLANT, A 700 PSID COULD BE EXERTED ACROSS CSF CASING.
- o SAME SYSTEM BRIEFED APRIL 12, 1988 (BRIEFING 88-15).
