L I C E N S E E E V E N T R E P O R T (L E R)

FACILITY NAME (1) Arkansas Nuclear One, Unit Two (ANO-2) DOCKET NUMBER (2) PAGE (3)
05010101 31 61 8110F015

TITLE (4) Vibration Induced Closure of Air Volume Distribution Damper in the Control Room Emergency
Air Conditioning System Results in Degraded System Cooling and Air Mixing Capability

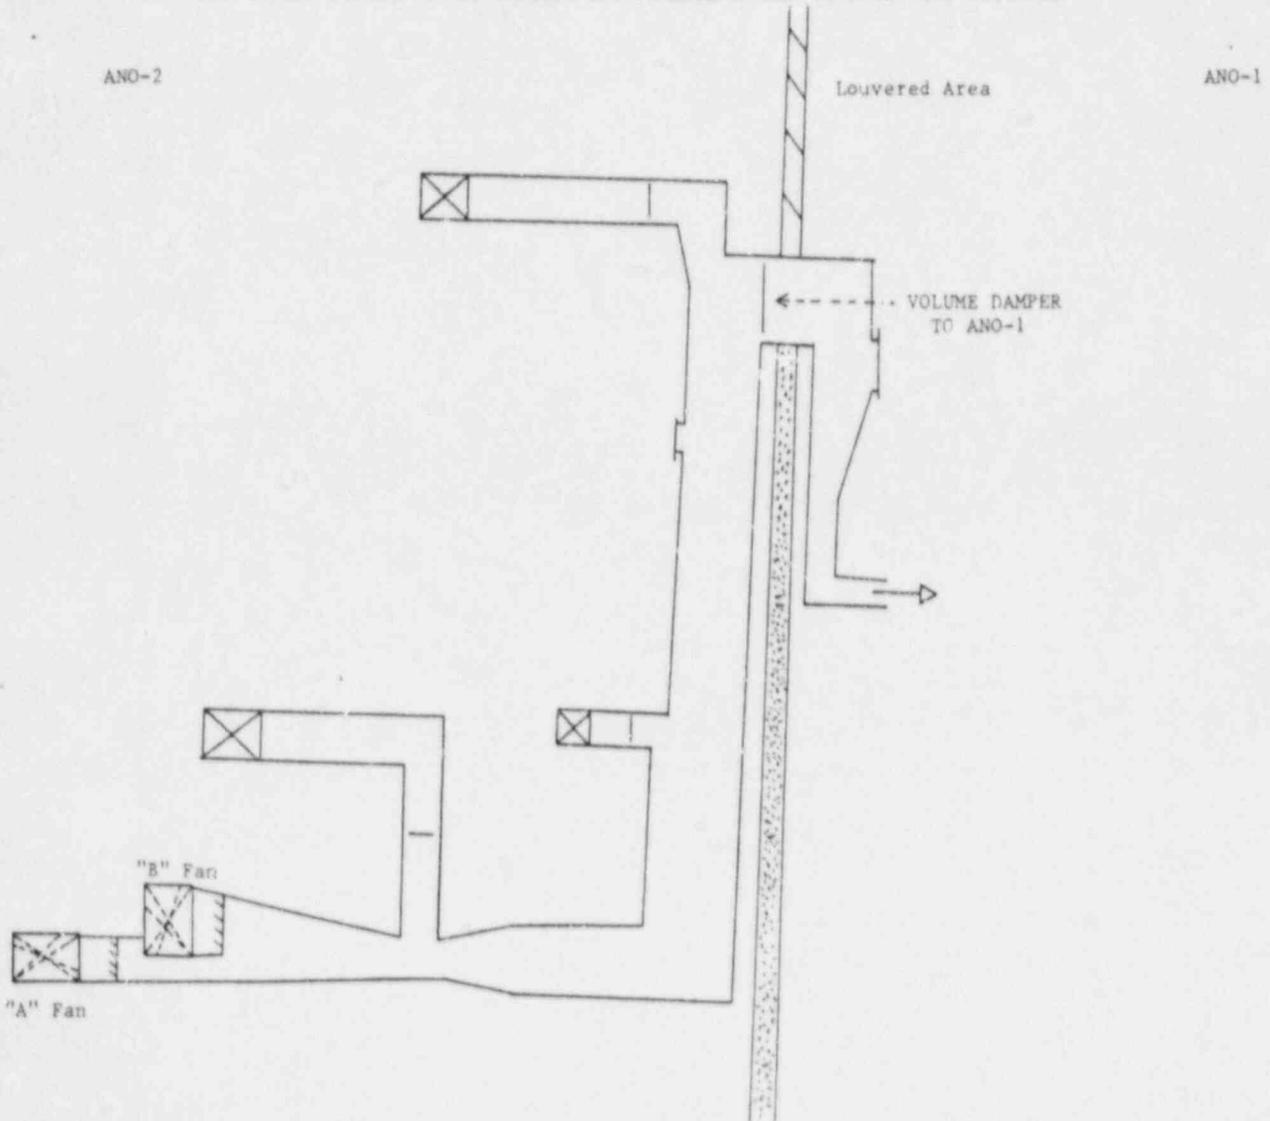
SIMPLIFIED SKETCH OF ANO CONTROL ROOM EMERGENCY AIR CONDITIONING DUCTWORK

An examination of a volume damper in the air distribution ductwork to ANO-1 indicated that the damper was closed. This restricted air flow to the ANO-1 control room and caused the total system air flow to be less than the value required by the TS for operability of the system. The test engineers opened the damper and the measured system air flow increased from a total of approximately 7500 cfm to 10,284 cfm, with approximately 3898 cfm to ANO-1. This achieved the desired 60 percent/40 percent air flow distribution between the ANO-1 and ANO-2 control rooms.

The volume damper found closed is located in a normally inaccessible vertical section of ductwork above the ANO-2 control room false ceiling near the front control room operating panels. It is not in an area where it would be subjected to inadvertent closure. The control room emergency air conditioning system is operated twice per 31 days during testing of the redundant supply fans. Each fan is operated for at least one hour to demonstrate cooling capability of the system and flow rates are verified every 18 months as required by the TS. None of these previous tests had indicated a problem with the volume damper or a degradation of system air flow. The damper is secured in position by a wingnut attached to the damper operating shaft external to the ductwork. It is believed that over the 10-year period of operation of the system, the wingnut vibrated loose finally allowing the damper to close.

The root cause of the volume damper closure was considered to be failure to provide a locking device on the damper positioning handle wingnut to prevent the wingnut from loosening by vibration. Apparently, during original design and construction of the system, this type of failure mode was not recognized. Additionally, the effect on operability of the CREACS system resulting from a failure of this single component was not adequately considered during initial design of the system.

The damper was opened and the system flow was measured and balanced immediately upon discovery of the condition. The wingnuts on all of the volume dampers in this system were securely tightened to minimize or prevent inadvertent closure of the dampers due to vibration.
