UNITED STATES NUCLEAR REGULATORY COMMISSIONDOCKET NO. 50-498 OLHOUSTON LIGHTING AND POWER COMPANY(SOUTH TEXAS PROJECT, UNIT 1)ISSUANCE OF DIRECTOR'S DECISION UNDER 10 CFR 2.206 (DD-88-3)

NRC Safety Significance Assessment Team Report on allegations related to the South Texas Project, Units 1 and 2

Docket Nos. 50-498 and 50-499

Houston Lighting and Power Company

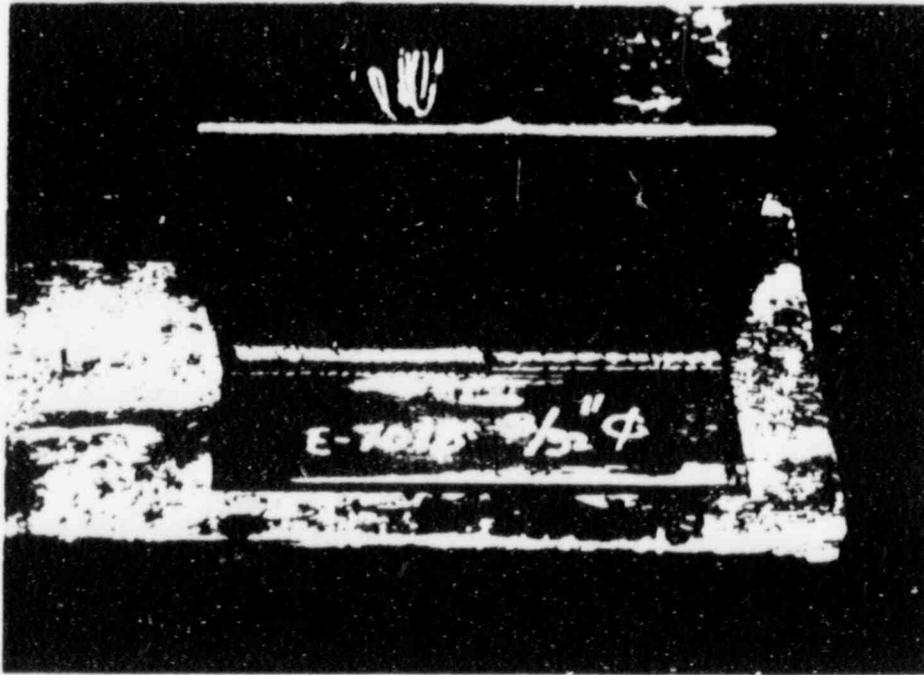
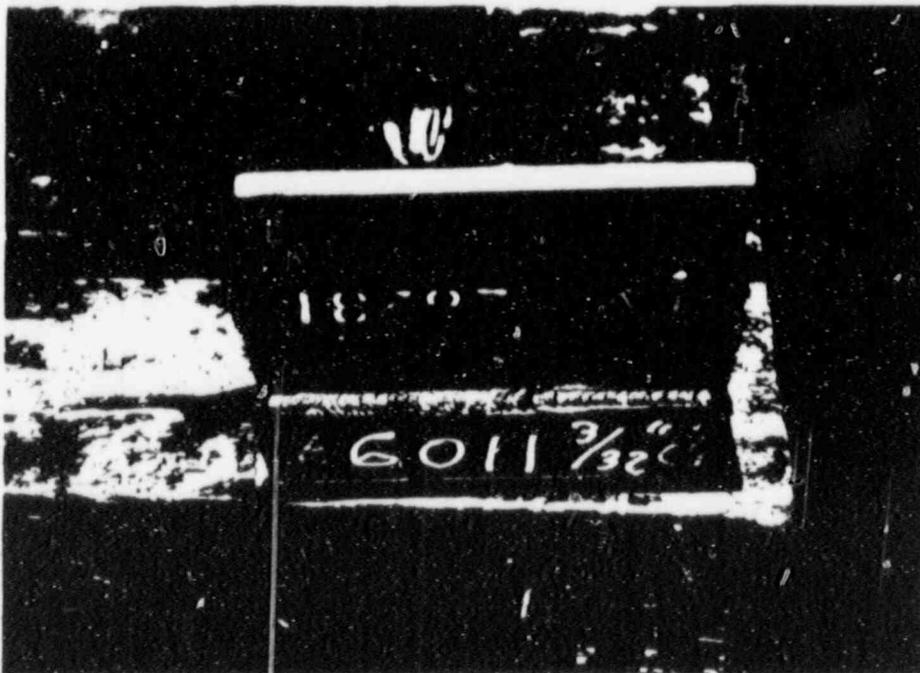
In an effort to determine whether the E7018 electrodes in the unacceptable lot had been used in place of E6010 or E6011 electrodes for HVAC welding, the SSAT requested Ebasco to prepare weldments of the same material used in the HVAC system with two different type electrodes, E6011 and E7018. This was done to ascertain the typical bead characteristics of each electrode to aid in the HVAC weld inspections. The welds made with the E7018 electrode show a smoother surface profile than welds made with the E6011 rod (see Figure 5.5-1(a) and (b)).

The SSAT conducted an extensive visual inspection of numerous welds on ducts and supports in the HVAC system in the MEAB, RCB, DGB, FHB, and the space above the control room. Although most of the welds had been painted, thereby making it difficult to fully interpret each of the weldment characteristics, the visual inspections performed on the welds were sufficient to allow the SSAT to determine whether the welds were of good quality and appeared to meet design specifications and AWS Code requirements. In addition, 14 HVAC system support construction packages were reviewed by the SSAT for dates of final signoff and completeness and compared to the filler material issue record (FMIR) dates. Also, the SSAT reviewed the certifications of the welders who performed the welds on these supports. The SSAT determined that the documents were in order, the correct welding electrodes were issued, and the welders were qualified to weld to both applicable welding procedures, WP-167 and WP-5. The SSAT also determined that these weldments had been inspected and accepted by the QC organization.

(a) Fillet Weld Using E7018 Weld Rod

(b) Fillet Weld Using E6011 Weld Rod

Figure 5.5-1 Weldments Showing Typical Bead Characteristics of E7018 and E6011 Weld Rods

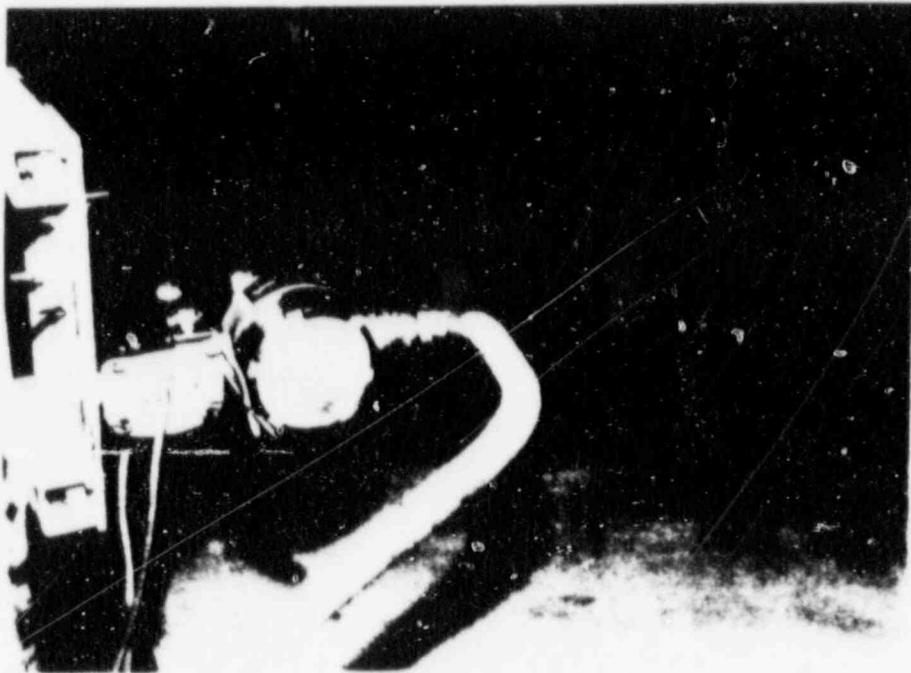
Figure 5.6-3 Flexible Conduit Installation Reviewed by SAFETEM-Dispositioned Use As Is

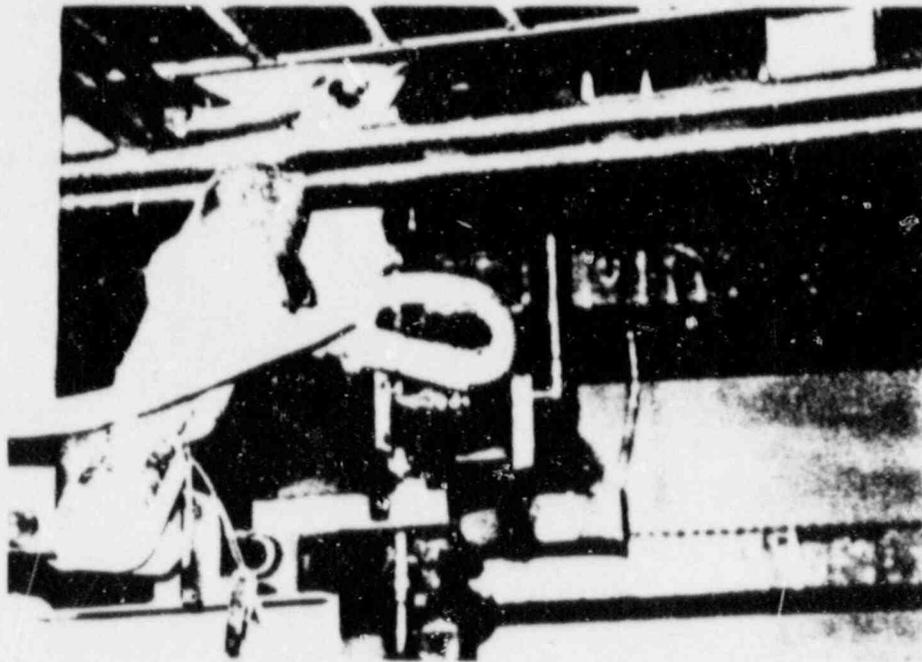
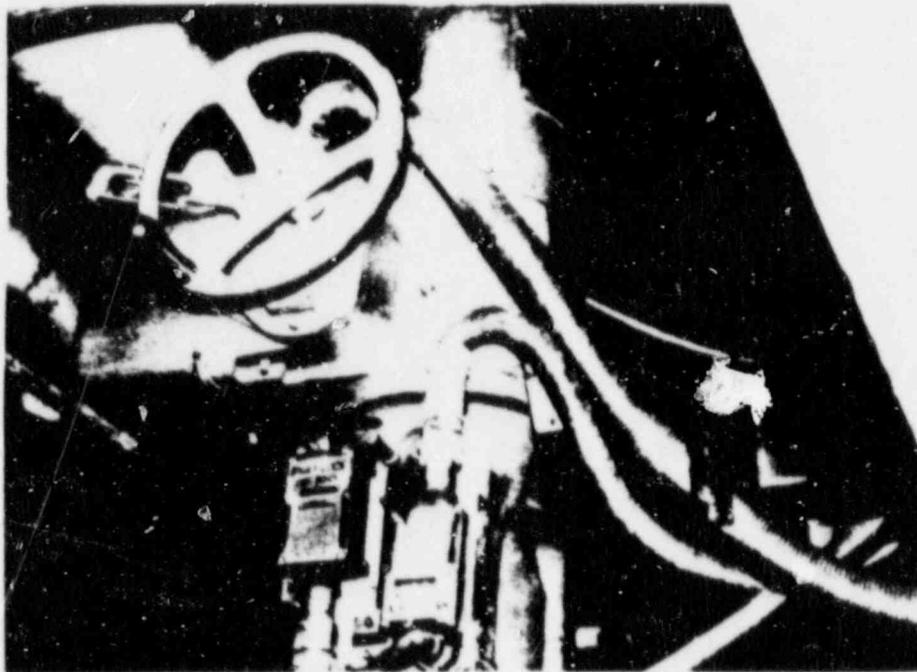
(a) Installation on Solenoid Valve - Cable Bend Radius Not Violated

(b) Installation to Limit Switch - Cable Bend Radius Not Violated

Figure 5.6-4 Flexible Conduit Installations With Apparent Bend Radius Violations

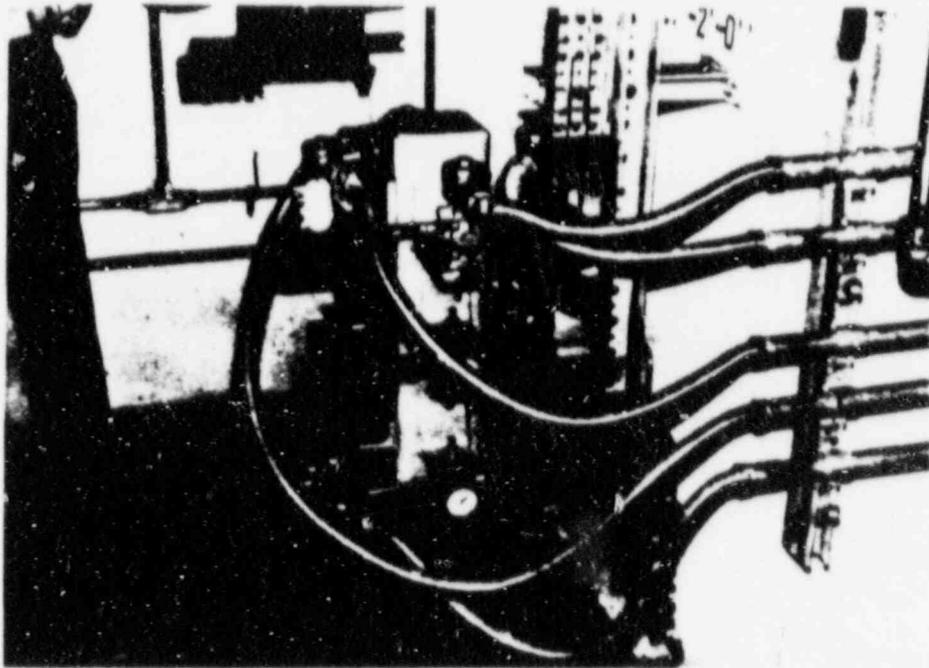
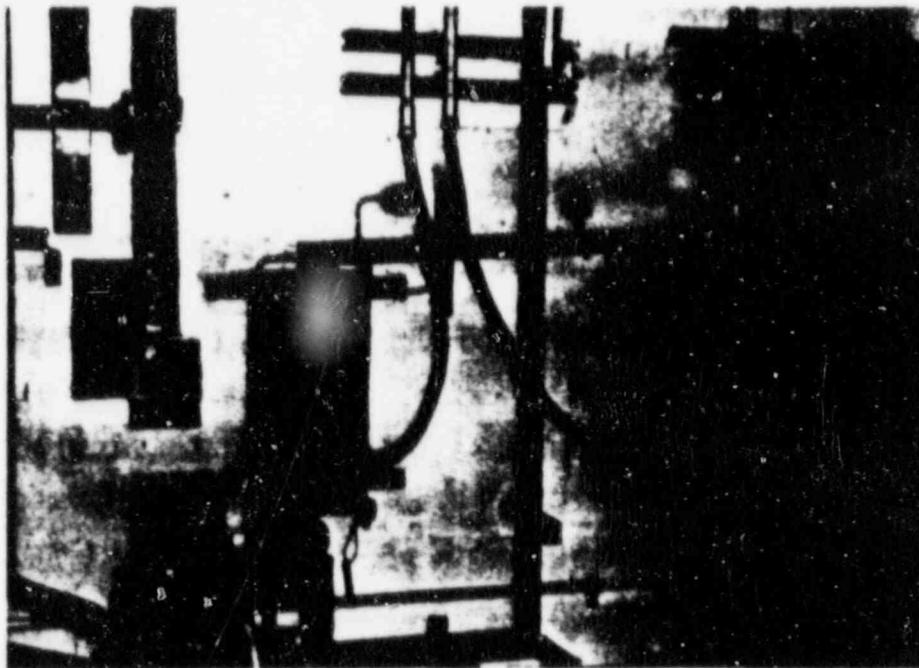
(a) Flexible Conduit to Solenoid Valves, Unit 1 Containment

(b) Flexible Conduit to Instrumentation, Unit 1 Containment

Figure 5.6-5 Typical Acceptable Flexible Conduit Installations
