LOUISIANA
POWER & LIGHT

August 3, 1988

Subject: Waterford SES Unit 3
Docket No. 50-382
Detailed Control Room Design Review (DCRDR)
Supplemental Information

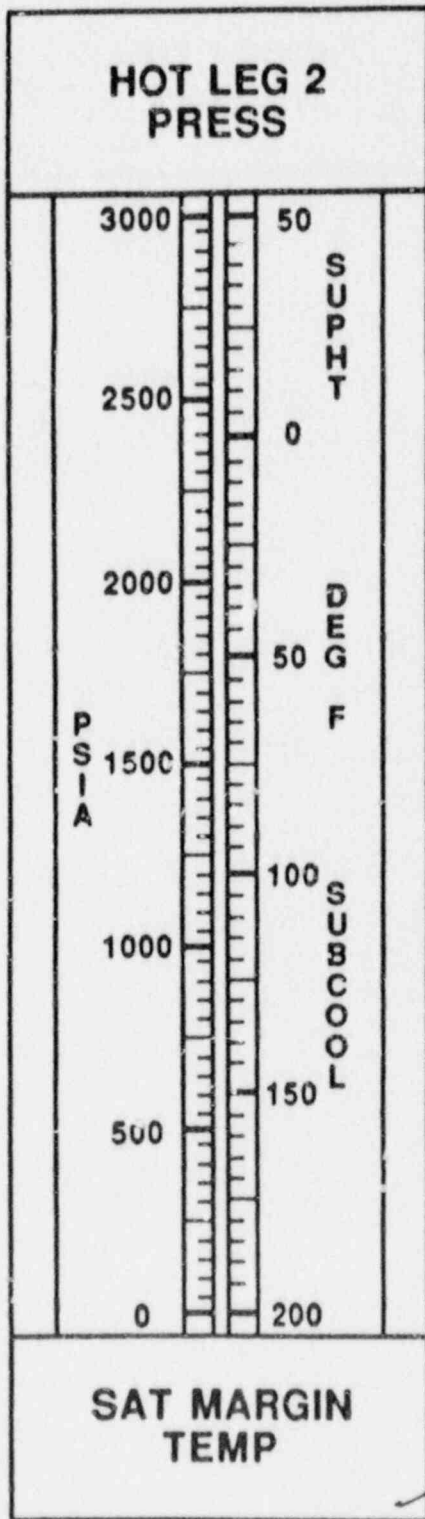
Saturation Margin Temperature Scale

Positive and negative signs will not be added to the meter faces. These are considered by the operators as being unnecessary additions to the control panels. The scales are already labeled with the abbreviations 'SUPHT' and 'SUBCOOL', which is considered sufficient indication.

LP&L is of the opinion that since Operations personnel are trained to know the difference between subcooled and superheated values (i.e., a reading in the superheat region on a saturation margin monitor would indicate superheated steam and that the core is uncovered), the current labeling convention is sufficient. Plant scales on CP-8 and LCP-43 and indicator ranges given in FSAR Table 7.4-1 (Sheets 2 & 3) provide verification that whenever a range for saturation margin temperature is given, the associated labels for subcooled/ superheat are always present. The enclosed scale provides an example of the current labeling convention used on both CP-8 and LCP-43.
